OPEN SPACE SERVICES

Playground Audit

WAB RESERVE BOW HILL

MID MURRAY COUNCIL

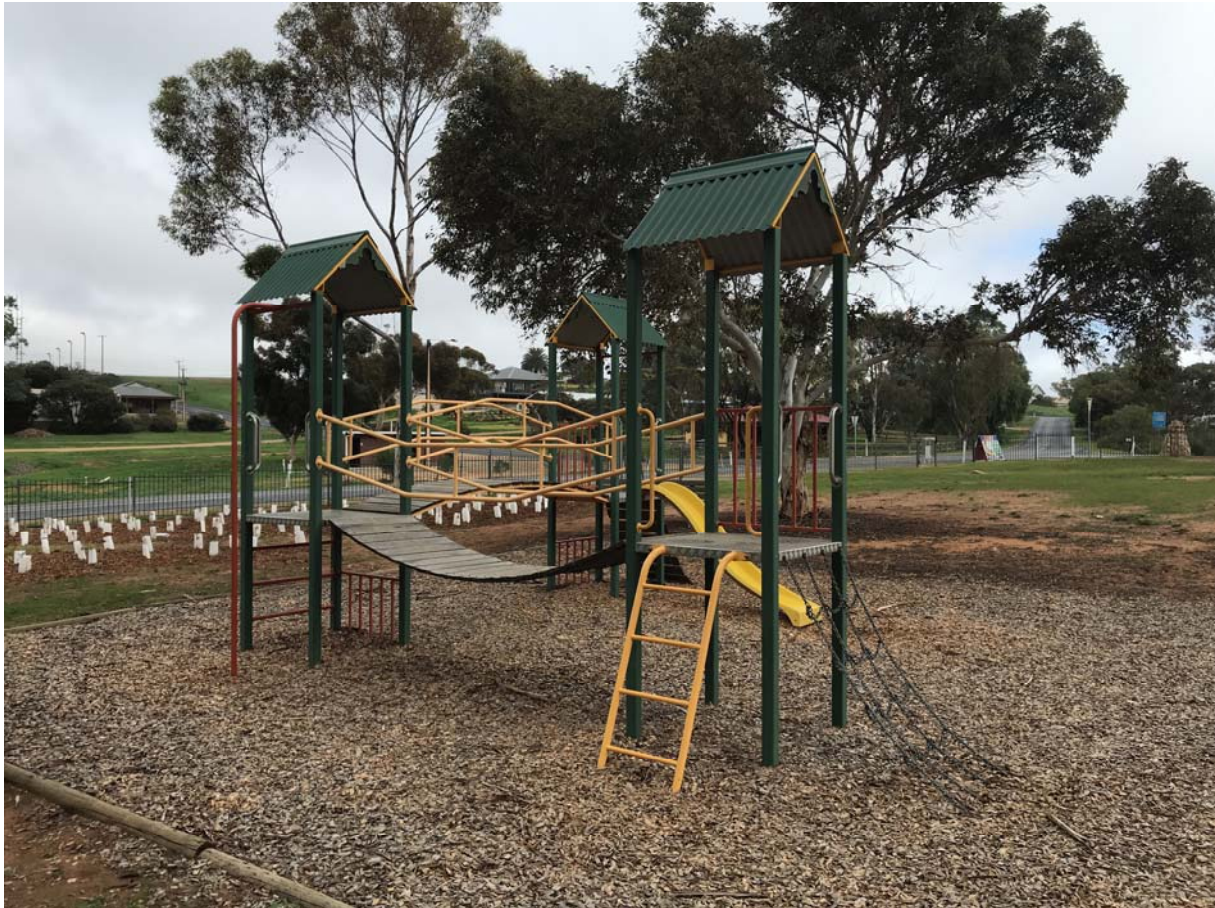
SN: WAB – 001

OPERATIONAL INSPECTION		
Play Equipment	Findings	Rating
Excessive wear of moving parts (including chain links).	The swing bridge will require replacement of the attachment links as they are worn through.	MEDIUM
Any protrusions and sharp edges.	The bolt threads on all attached chains to boards will require grinding down to be level with the nuts.	MEDIUM
Are all bolts and fasteners secure?	All fasteners were secure.	LOW
Are there any entrapments, hang points or catch points on any of the equipment?	The slide and side railings access and the swing bridge and arch bridge end points are all hang points where the pelvic probe passes through and the small head or large head doesn't.	MEDIUM
The structural adequacy and/or stability of all playground equipment including ancillary items. NOTE: Equipment that relies on a single anchor or attachment point should be carefully inspected.	The structural stability is acceptable on all the item.	LOW

Excessive corrosion, particularly within structural members.	No corrosion was found on the equipment, surface rusting is occurring on items of exposed steel.	LOW
Impact and attenuating edges of swing seats, pommels and other moving equipment that can impact users.	All edges were as designed with no areas of concern.	LOW
Foundations for exposed concrete, rot and corrosion.	No exposed concrete was found and no base corrosion was identified.	LOW
Trees for potential hazards. NOTE: This may require the skills and competencies of a professional arborist.	No trees impact this area.	LOW
Are chain links or gap areas greater than 12mm or less than 8.6mm	The chains are within spec on the chain walk, the percentage of wear is minimal.	LOW
Are all structural attachments affixed tightly to their respective anchor points and attachment points sound with no wear or pull out from fixture points?	The equipment is a series of rigid structure with no moving parts.	LOW

- The swing bridge attachment points need replacing (**Remedial**)
- The bolt threads on the swing bridge and abseil boards need grinding (**Defect**)
- Guard rails are not in specification the gaps are too wide (**Requires New Equipment**)
- Uprights to the roof are flake rusting and needs kill rust coating and repainting (**Remedial**)
- The slide tapered trap points need to be locked off so nothing gets caught (**Defect**)
- Softfall is 50mm deep and needs to be bought up to 300mm deep (**Remedial**)

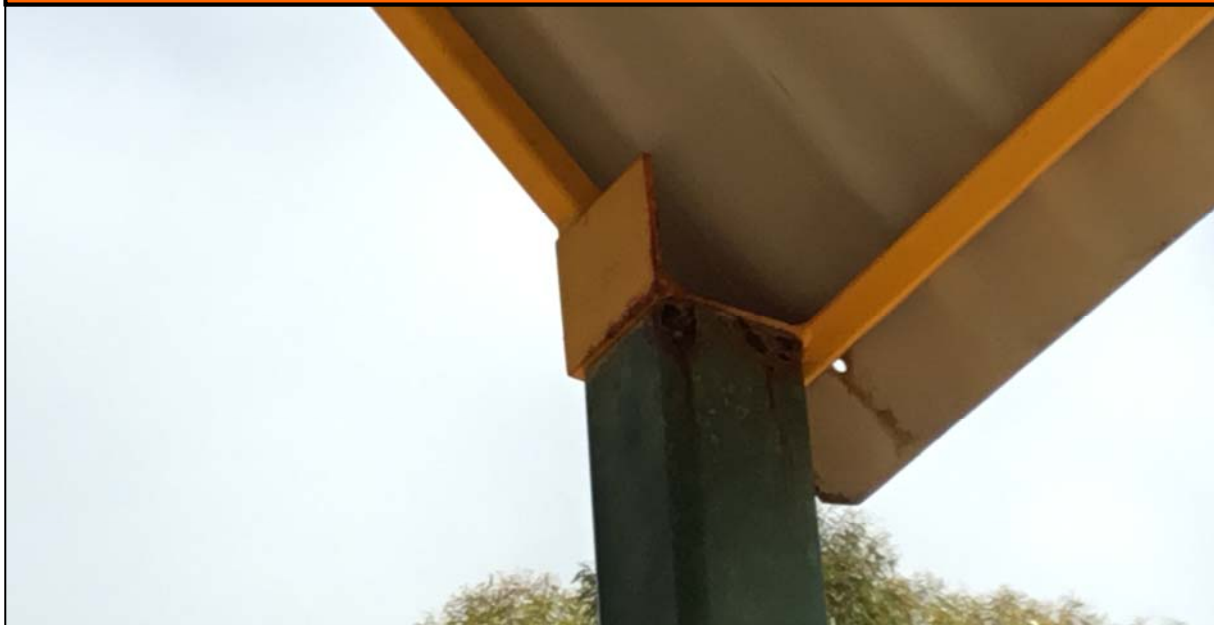
Main pay structure has several areas of rust within the top of the main upright where they join the small pitch roof, some of these areas are flake rest and are quite pronounced with rust, treatment of kill rust should be applied to stop the rust from spreading.

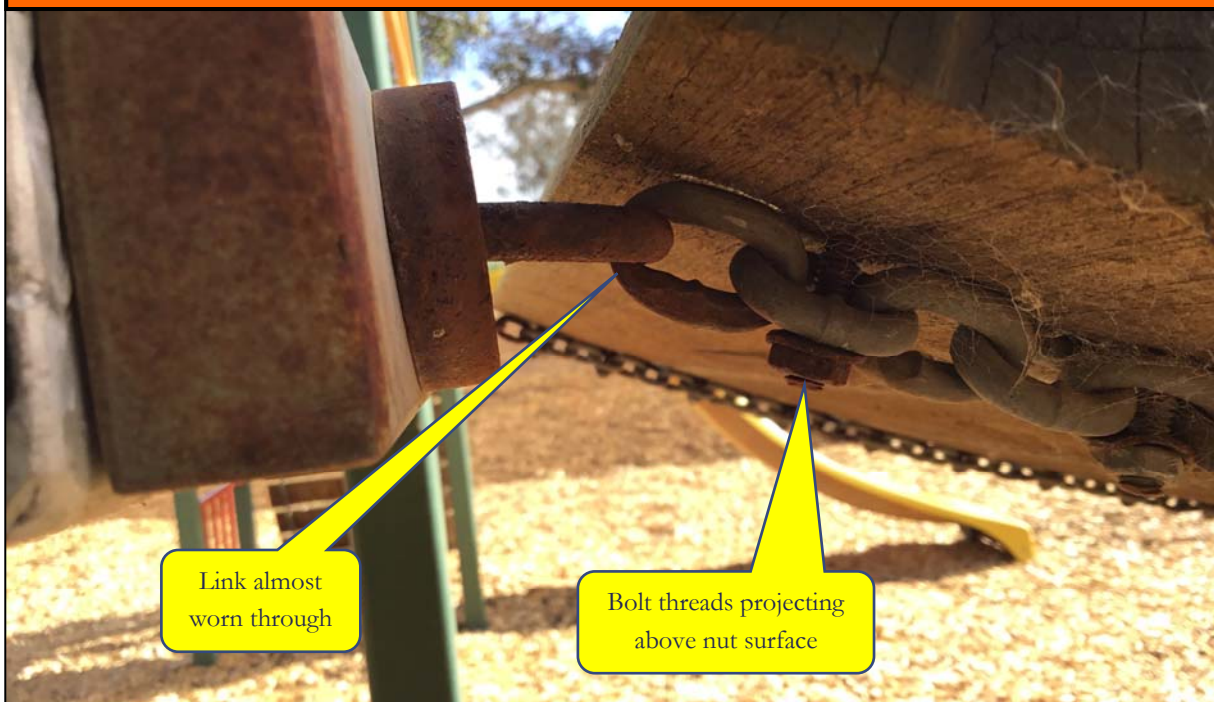
The swing bridge from the first platform to the second platform have chains that are holding onto the bolts that are fixed into the platform are almost worn through and will require replacing. The threads underneath the chains holding the chains to the boards will need to be ground down as they are very sharp to the touch and could damage or cause injury to children if they went underneath and got hit in the head with some of his jiggered threads.

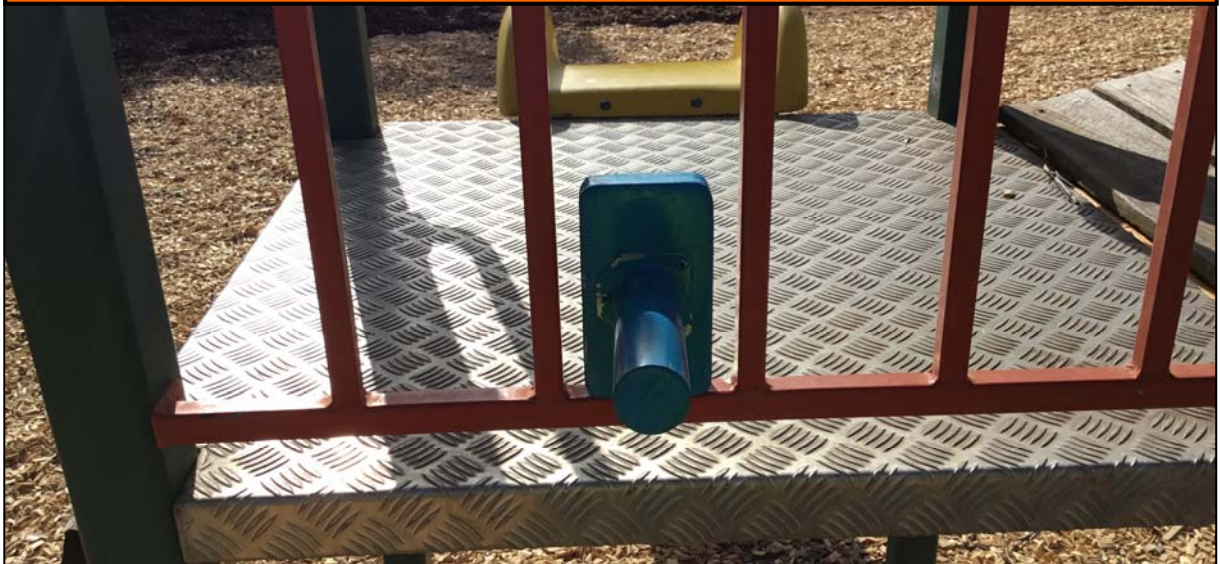
The gaps in the guard rails are all oversized and they don't comply with the current Australian standards these allow the pelvic probe to pass through very easily but traps ahead and does not allow the head probe to go through. This has rendered the area as a hang point where if a child should have slipped through, they would be hung by their head due to the size of the railing. Railings have to be less than the pelvic probe so their pelvis does not go through the gap. This is also the case with the end of the rails across the arch bridge and swing bridge at the end of the gap is larger than the pelvic probe and does allow for a hang point.

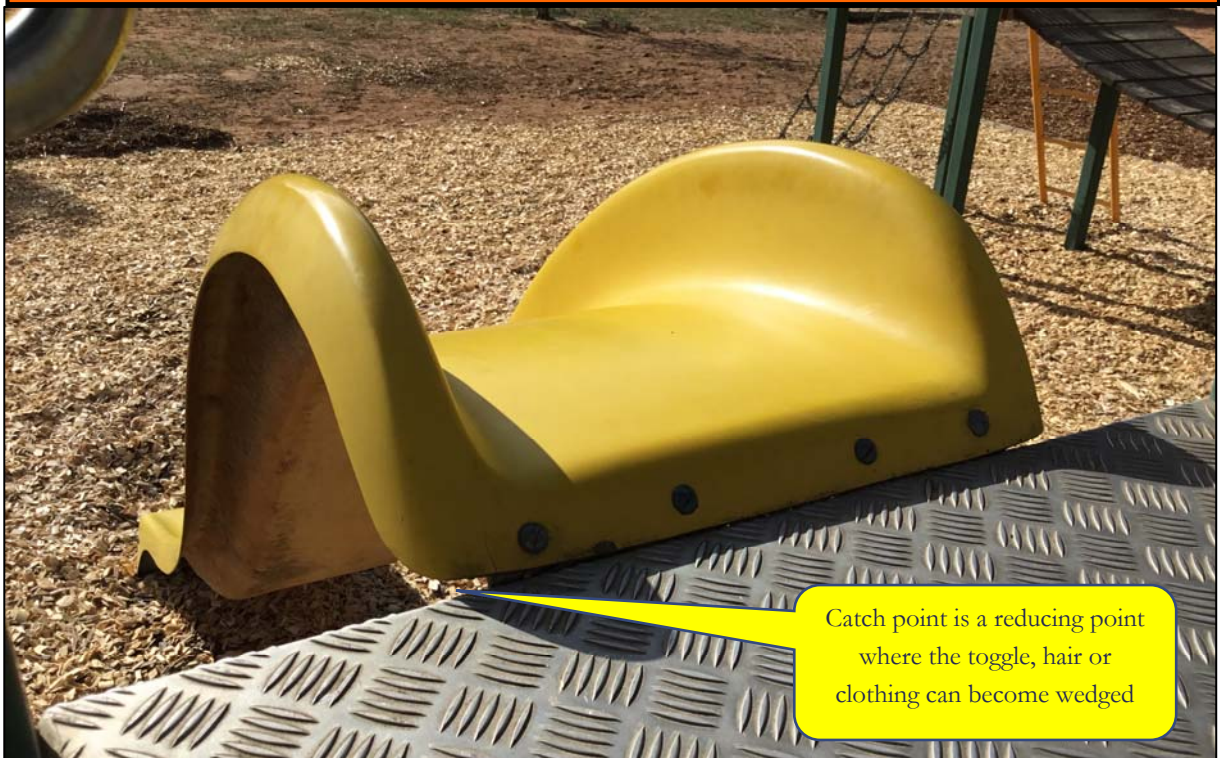
The slide also has a point where the slide meets the aluminum deck there is a gap where a toggle and long hair can get caught which is also considered a hang point once their body progress down the slide the toggle will become hung up in the top causing that area to hang up and the weight of the body to rest on the toggle point.

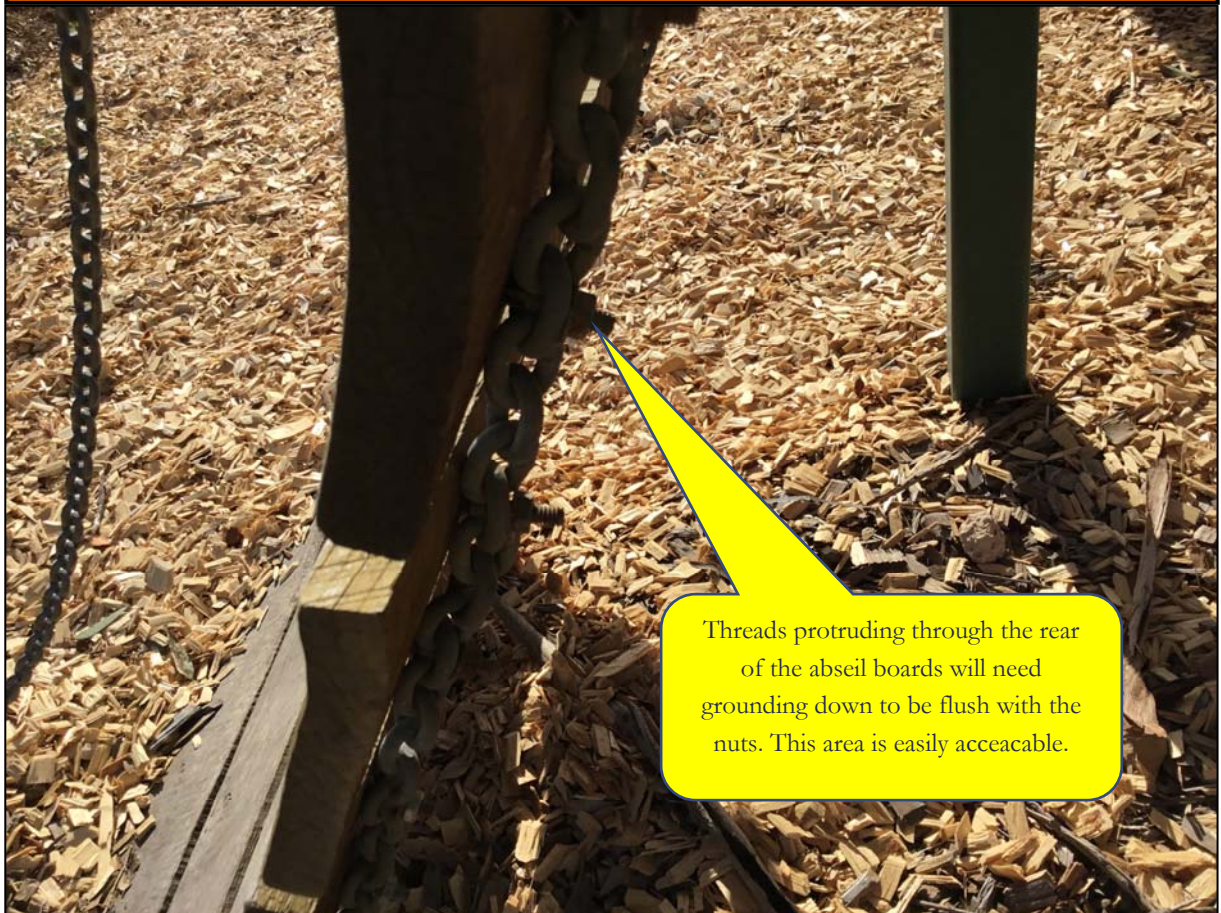
The abseil area at the end of the third platform has threads prominent within each of the bolts that hold the chain to the boards. These are points of protrusion which is not within standard.

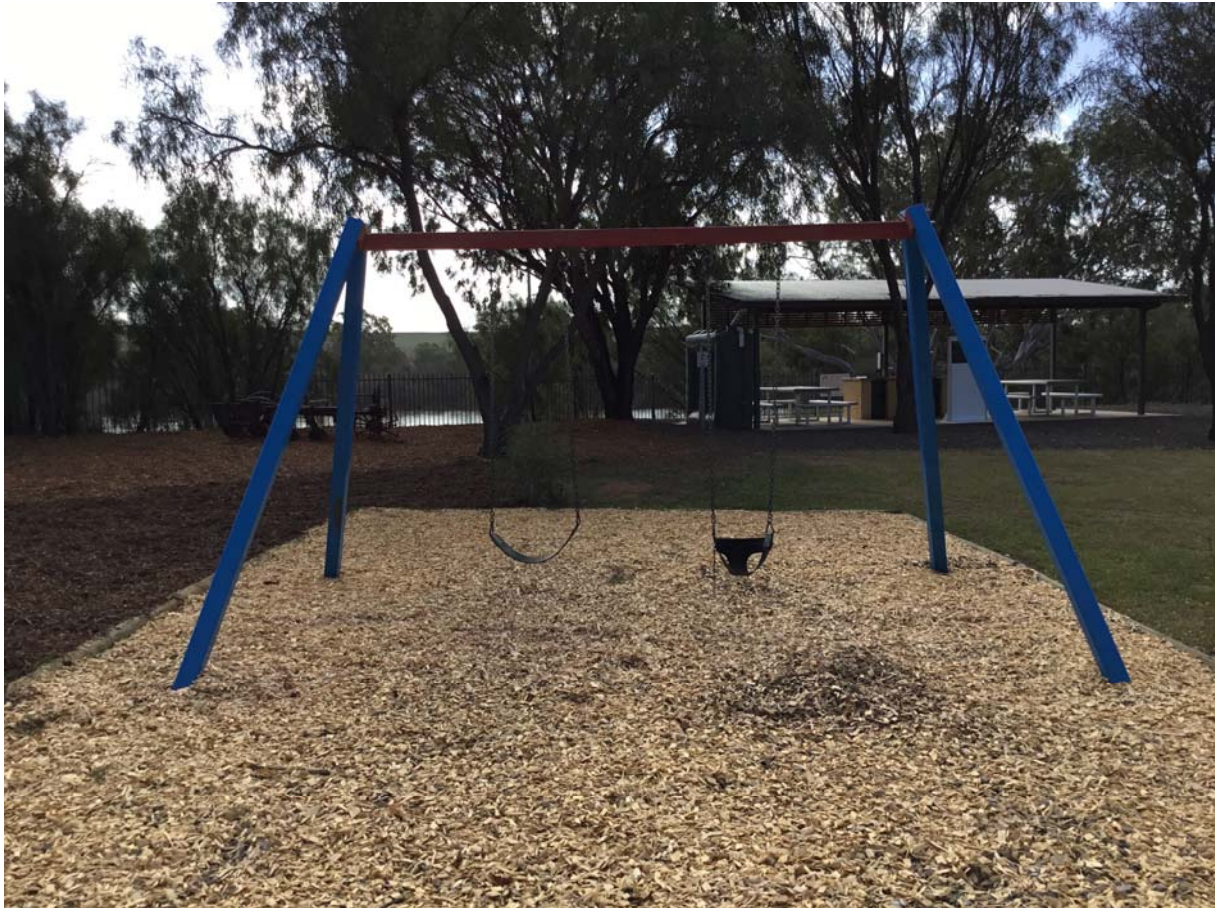
SN: WAB – 002

OPERATIONAL INSPECTION		
Play Equipment	Findings	Rating
Excessive wear of moving parts (including chain links).	The "S" hooks have very little wear and are closed.	LOW
Any protrusions and sharp edges.	No sharp edges or protrusions were found.	LOW
Are there any entrapments, hang points or catch points on any of the equipment?	No hang points or entrapment was found.	LOW
The structural adequacy and/or stability of all playground equipment including ancillary items. NOTE: Equipment that relies on a single anchor or attachment point should be carefully inspected.	All uprights were sound and had no movements.	LOW
Excessive corrosion, particularly within structural members.	Surface rust is present, there is no flake rust as yet.	LOW
Impact and attenuating edges of swing seats, pommels and other moving equipment that can impact users.	All edges were as designed with no areas of concern.	LOW
Trees for potential hazards. NOTE: This may require the skills and competencies of a professional arborist.	Small Wattles are starting to emerge close to the runout of the swings, these will require removal.	MEDIUM

Are chain links or gap areas greater than 12mm or less than 8.6mm	Chains are to standard	LOW
Are all structural attachments affixed tightly to their respective anchor points and attachment points sound with no wear or pull out from fixture points	All fixture point was sound and of the correct swivel attachment.	LOW
Comments

- Plastic cover over restraint chains is required on baby swing (**Remedial**)
- Softfall is 50mm deep and needs to be bought up to 300mm deep (**Remedial**)
- Remove wattle sapling around swings. (**remedial**)

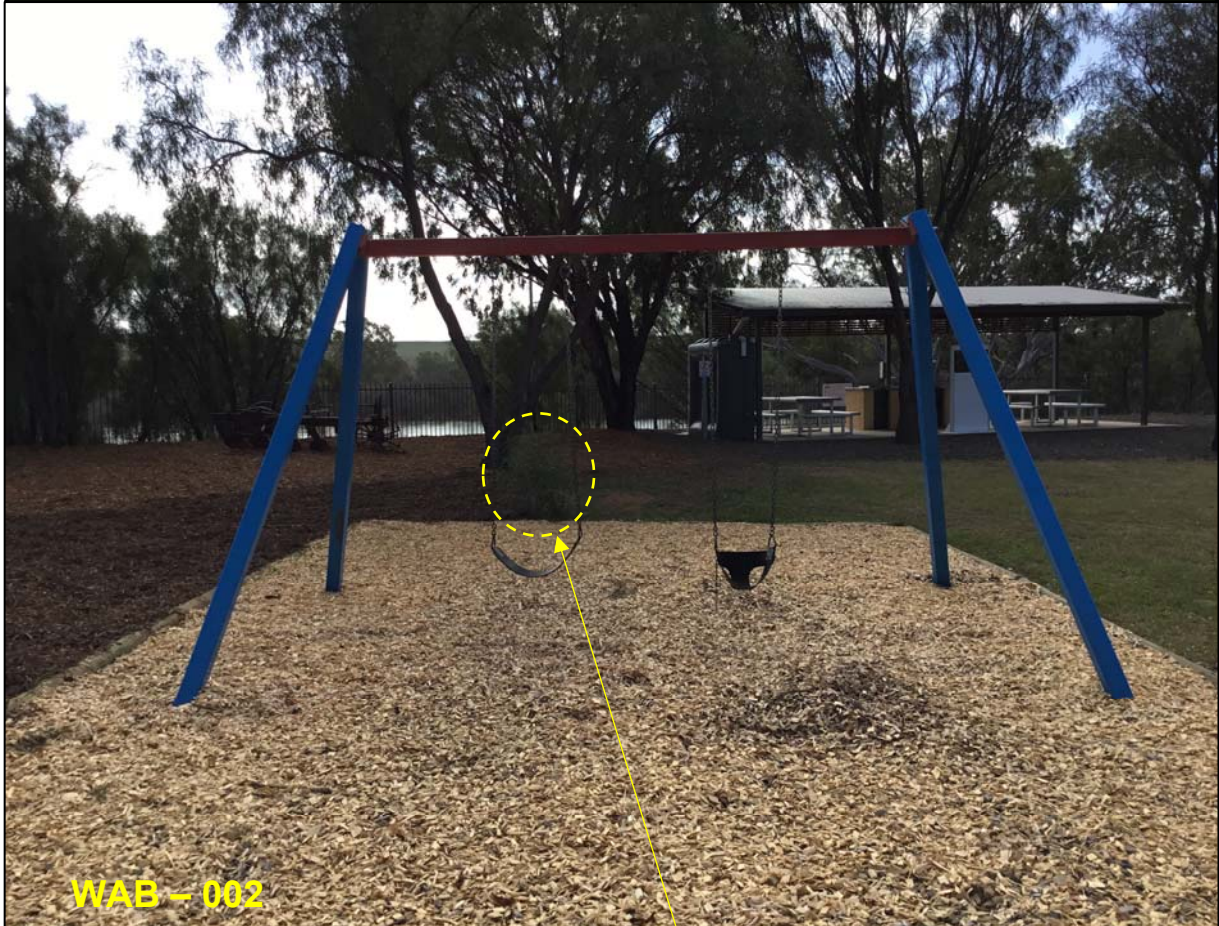
The swing has recently been topped up with mulch however in places the mulch is only 50 cm deep and does not comply with current Australian standards. The S hooks attached to swings have only a 5% wear. The chain holder for the baby seat does not have a rubber cover and should have due to small fingers getting caught within this chain. The softfall will need to be 200 mm deep with a 100 mm over fill as per standards. The frame of the swing has light surface rust but there seems to be no rust creep from the base of the uprights where they join the soil.

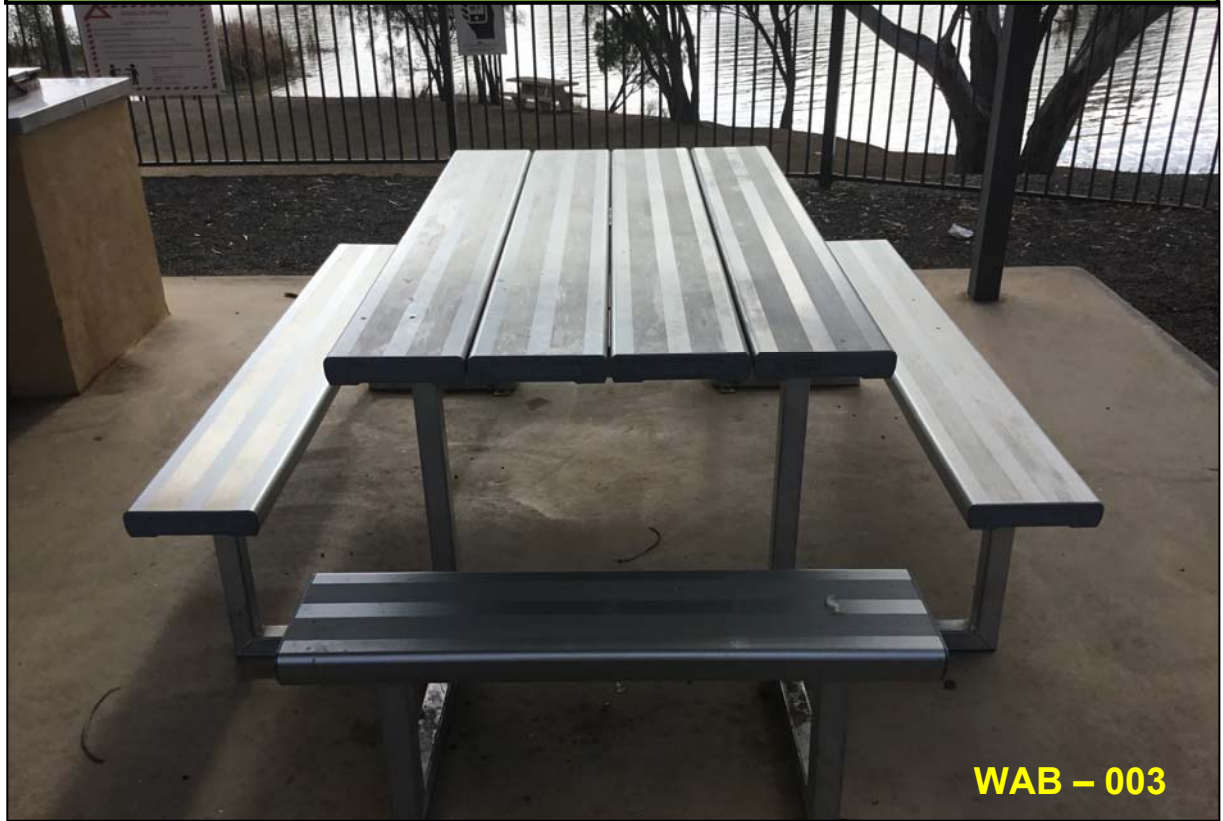
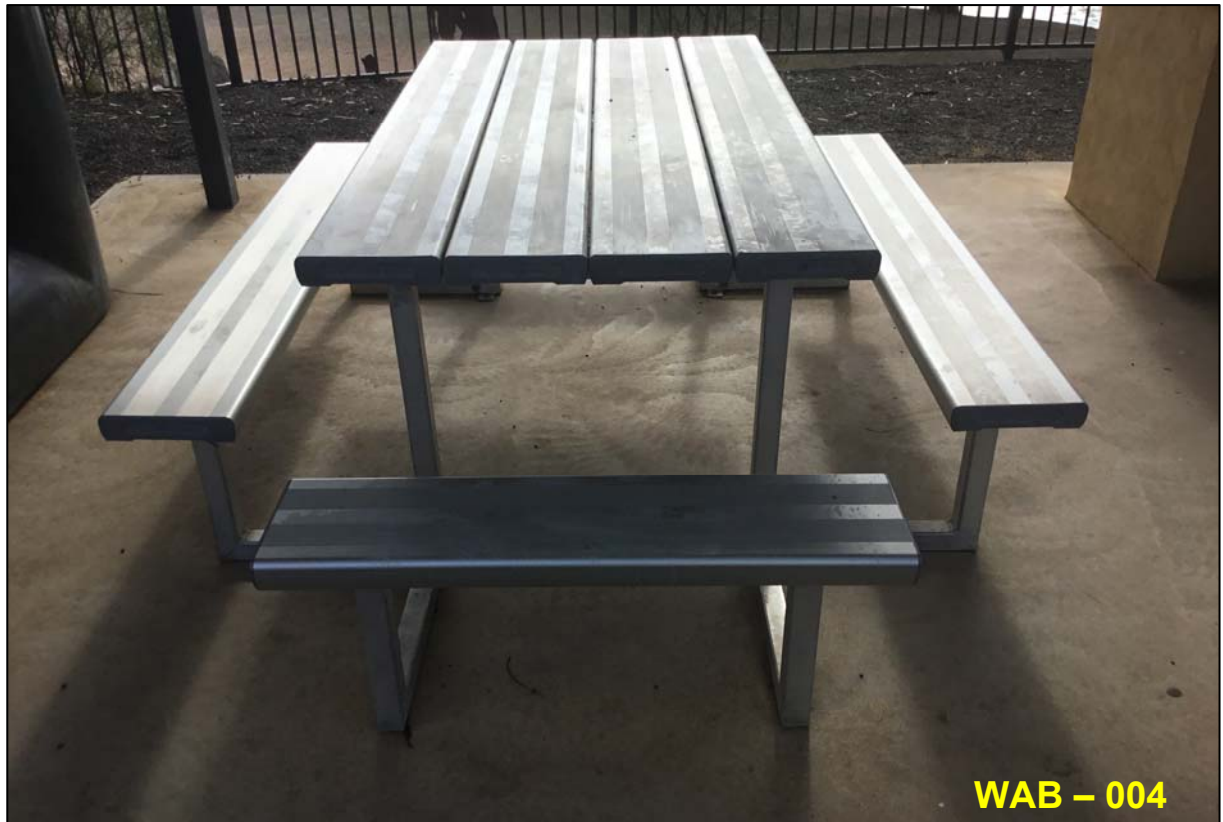
Both sets of bench seats and tables are both in good order there is no loose end caps and no loose panels within the seat structure. The seats are also bolted to the concrete and it has very little movement within that area and cannot be moved.

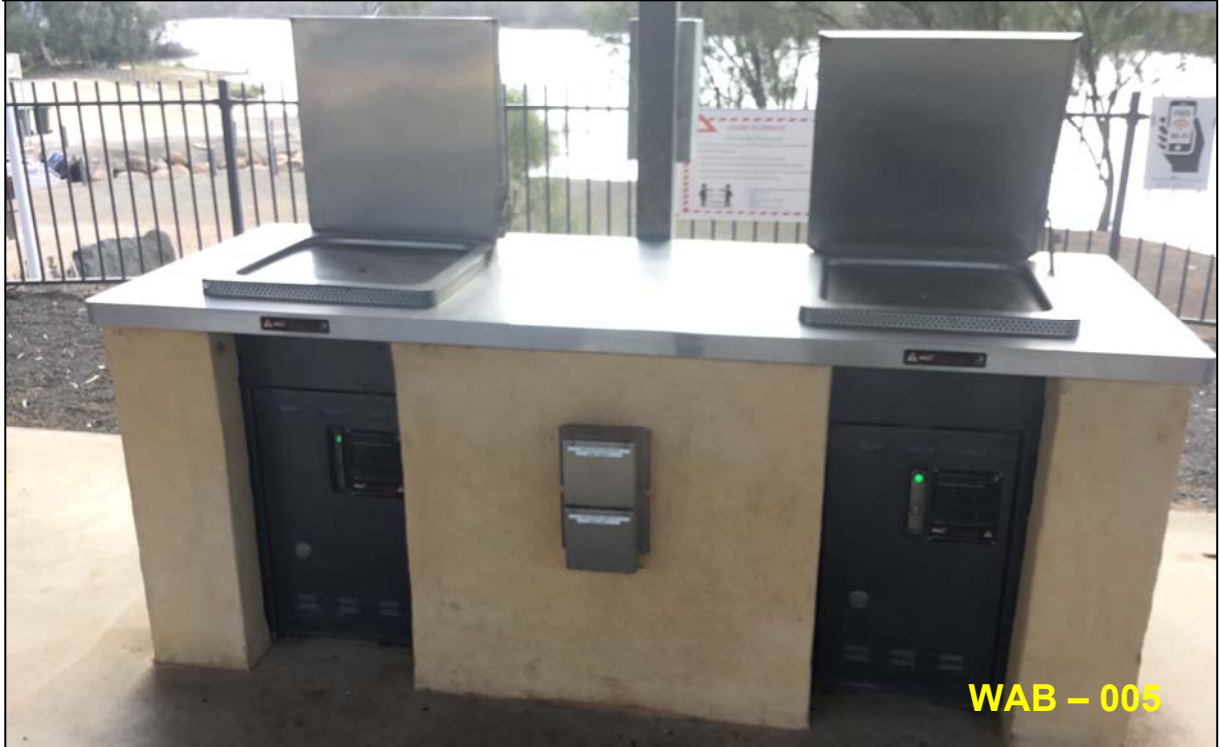
This barbecue is clean with no areas of protrusions, the corners still have beer plastic caps in place there no jag points within the top decking of the barbecues. Both isolation boxes are still intact no damage. Both work and are functional and also the heat at the barbecues are also functional both have green lights on

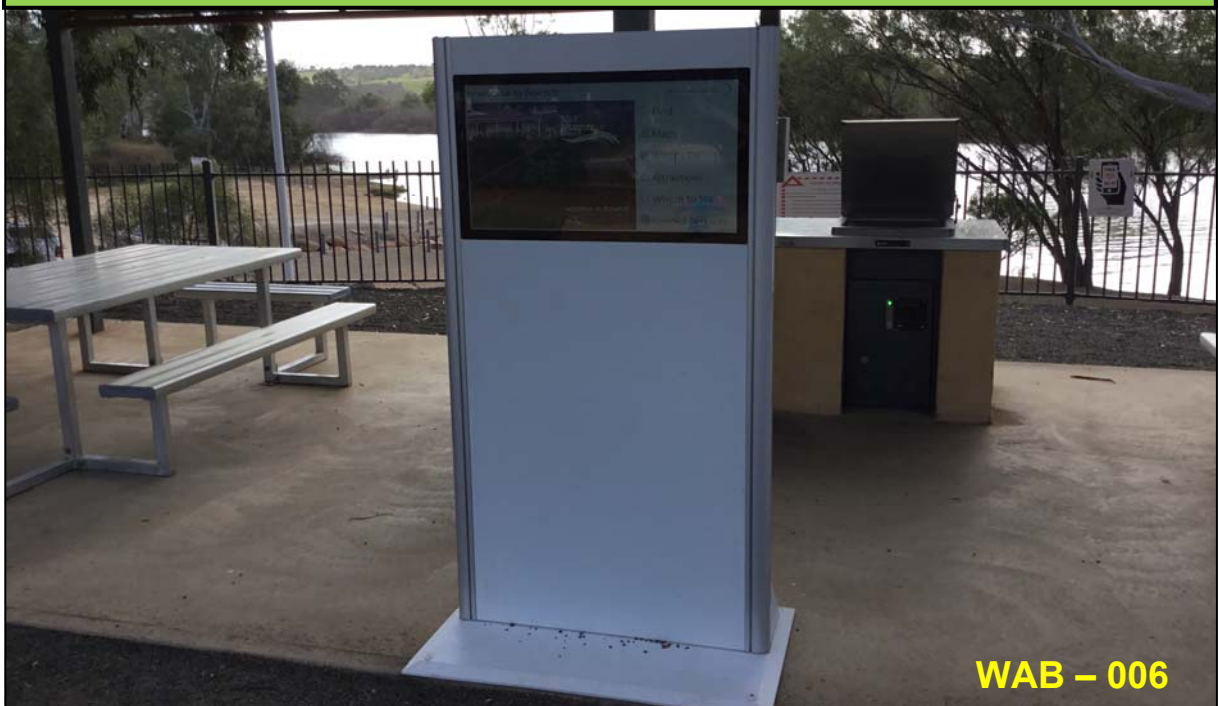
The tourist information screen is functional and is working correctly, the stand and the frame is solid with no movement, the Wi-Fi antenna is still in place and everything seems to be working as required. The program within the screen is working quite well and is fast and does not stall within the touchscreen. The shelter is also in as new condition and has no area that would be a risk or hazard.

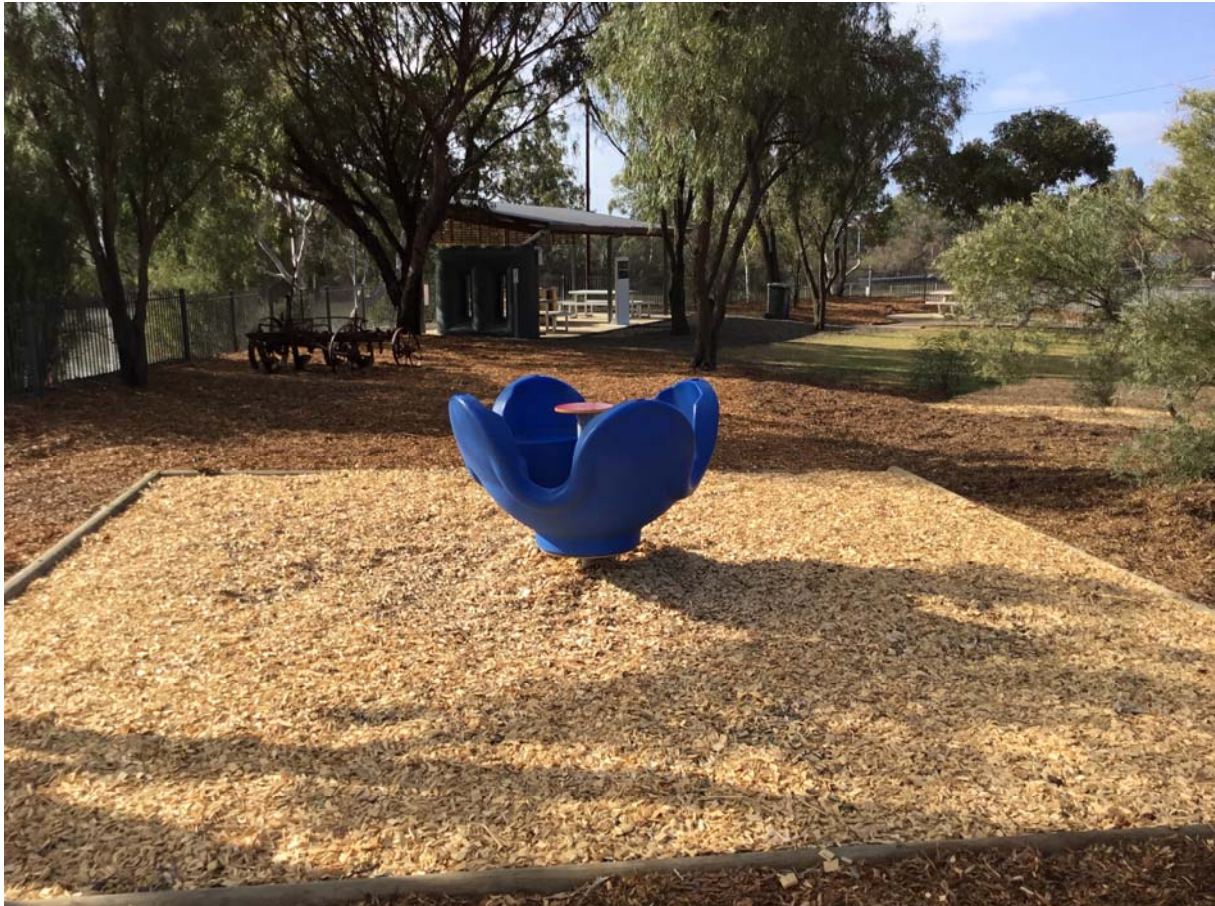
SN: WAB – 007

OPERATIONAL INSPECTION		
Play Equipment	Findings	Rating
Excessive wear of moving parts (including chain links).	This spinner has no play within the use both free spinning or under pressure.	LOW
Any protrusions and sharp edges.	No sharp edges or protrusions were found.	LOW
Are there any entrapments, hang points or catch points on any of the equipment?	No hang points or entrapment was found.	LOW
Excessive corrosion, particularly within structural members.	No excessive corrosion or rust on the item.	LOW
Impact and attenuating edges of swing seats, pommels and other moving equipment that can impact users.	All edges were as designed with no areas of concern.	LOW
Trees for potential hazards. NOTE: This may require the skills and competencies of a professional arborist.	No trees impact this area.	LOW
Sufficient softfall within the fall zone for impact from forced play.	The softfall measure is 50mm and requires a top up of 250mm.	MEDIUM

- Softfall is 50mm deep and needs to be bought up to 300mm deep (**Remedial**)

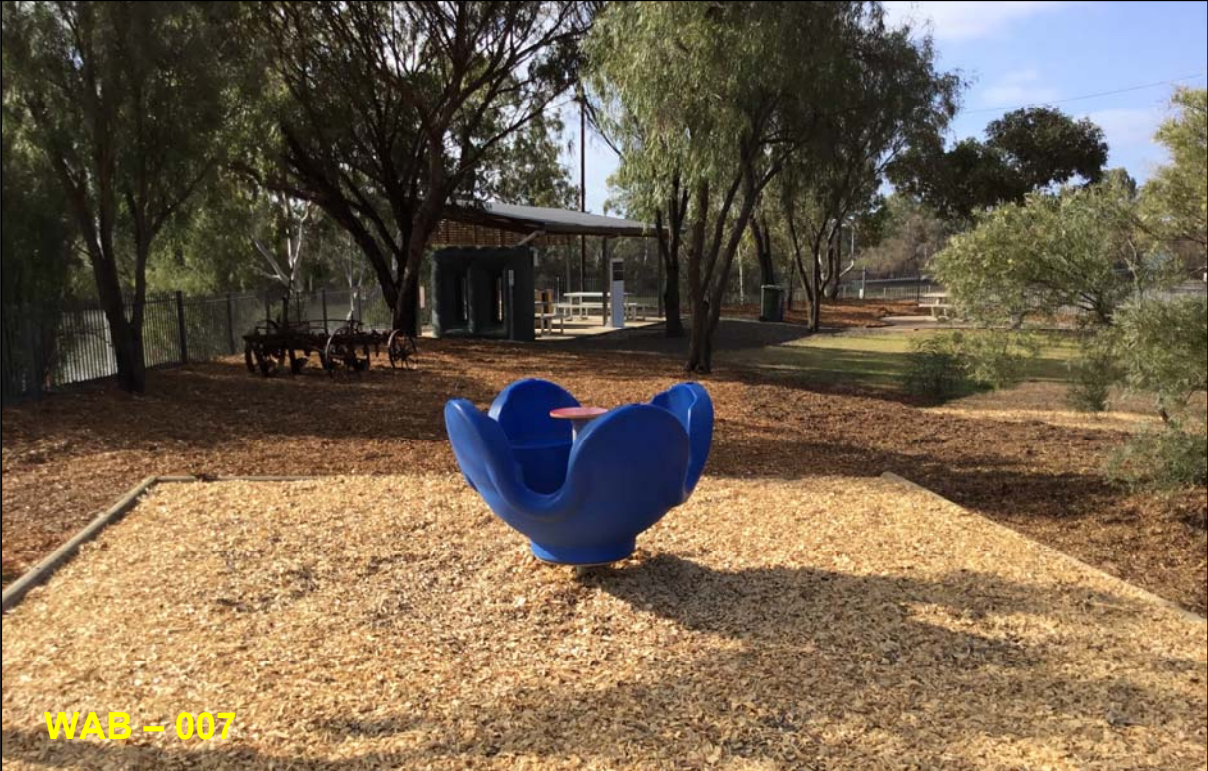
Spinner his plastic and all is intact and no defects or discoloring within the plastic no cracks and no scuffing. The item turns as it supposed to and the bass looks to be good condition and the bearings seem to be in very good condition.

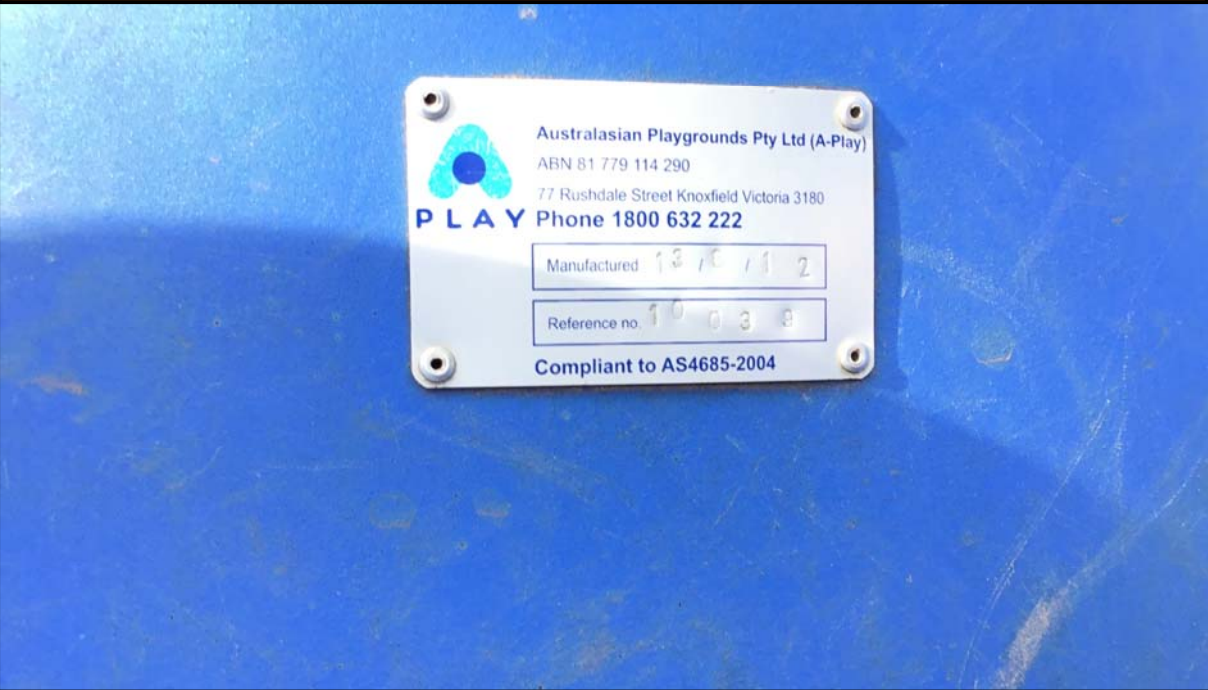
There is a sufficient full space around the edge being a force play item this also requires 300 mm of softfall however this only has around 50 mm and is 250 mm short of the standard requires

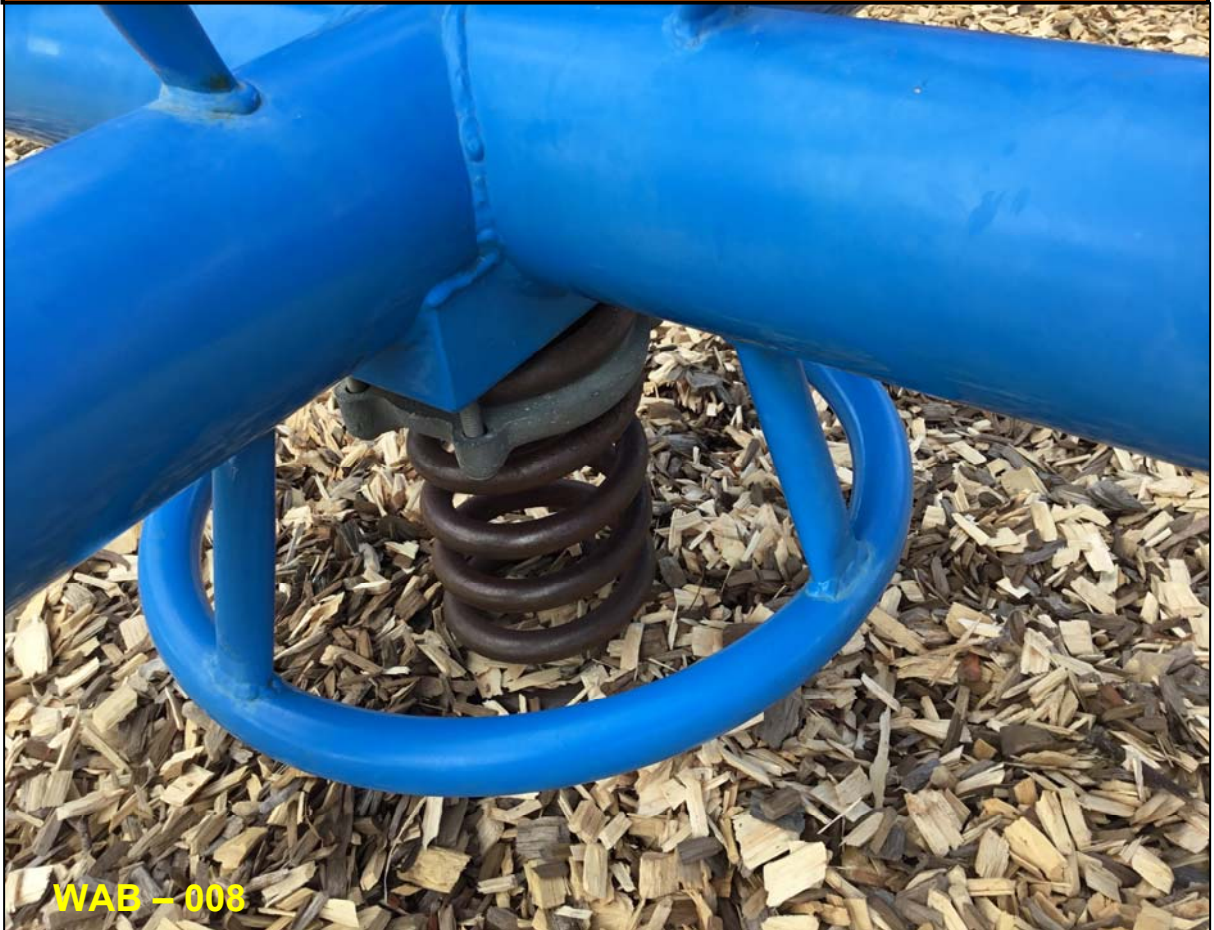
Spring has good solid base plate and does not show any areas of cracking and the top plate also does not show any areas of cracking the spring does have scale rust within the top two coils which indicates that the spring should be changed over the next year. The rest of the swing is in good condition with all plastic components still intact and not showing any signs of cracking or wear. This piece of equipment is only 500mm from ground level the area does not require softfall, the distance of forced play is also minimal within this area to find the area of play.

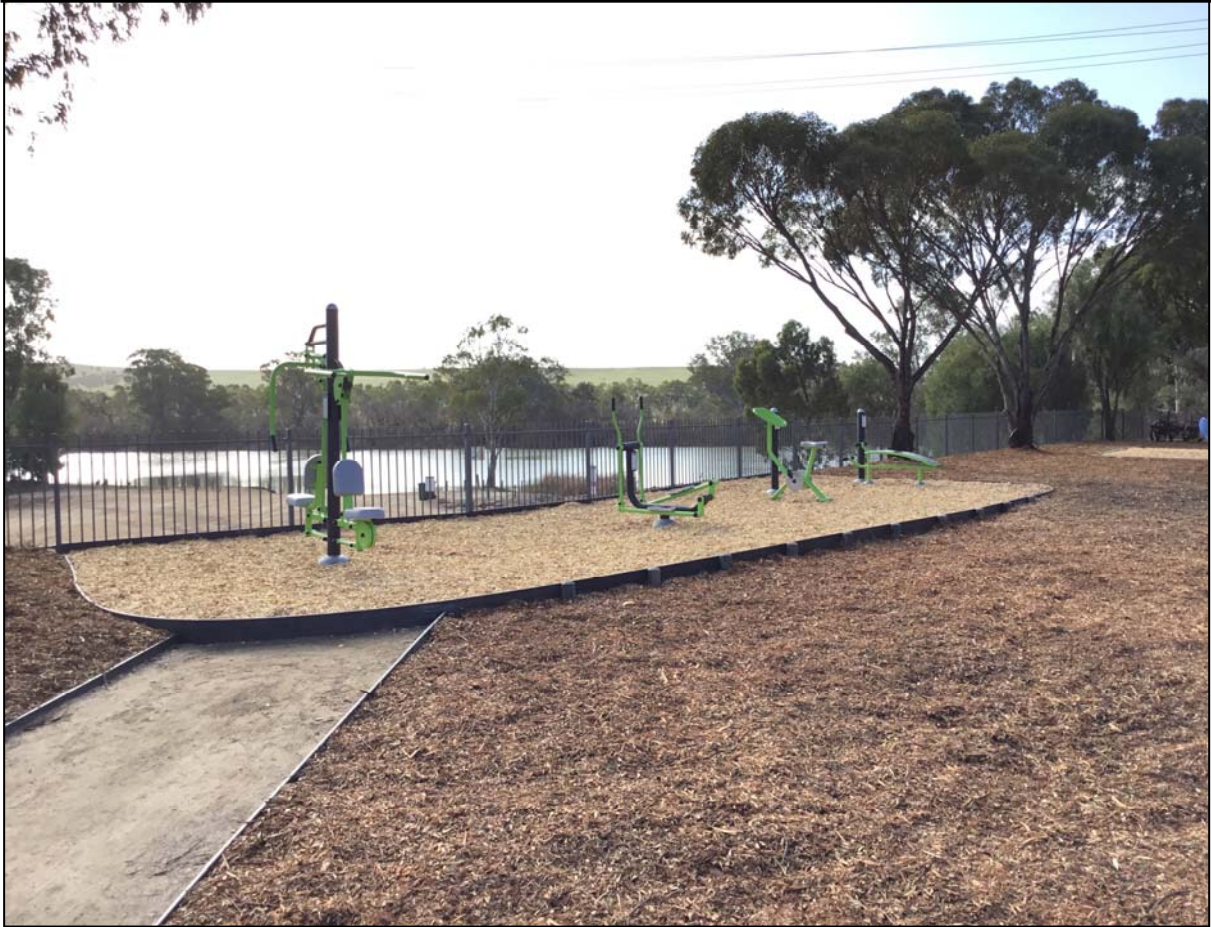
All the fitness equipment in this area is only brand-new and all functions as supposed to all are rigid and are fixed to the bases with no movement whatsoever. all instructions are clearly displayed and all stoppers are brand-new. the softfall is 300 mm deep which is not required for this equipment as it is not intended to be a play item.

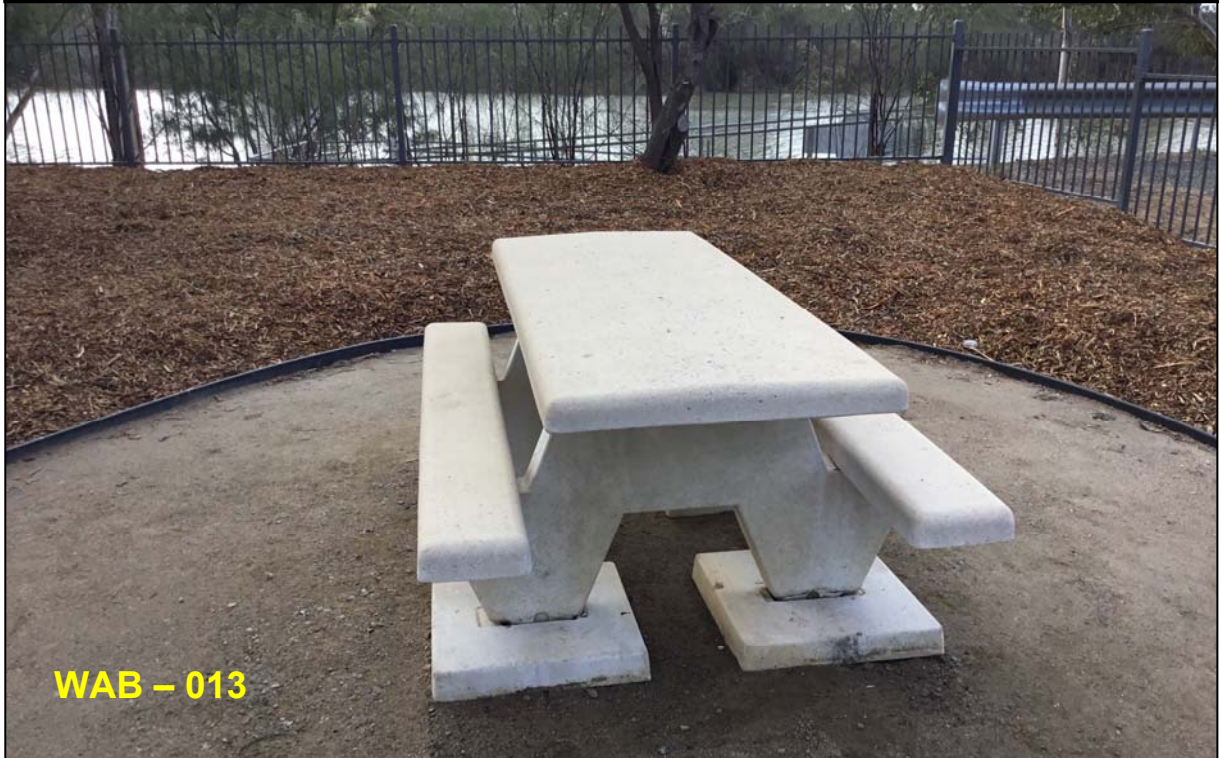
The concrete seat and table is in good condition and looks to be brand-new. None of the seats move and neither does the table and there is no cracking within the concrete structure or panels.

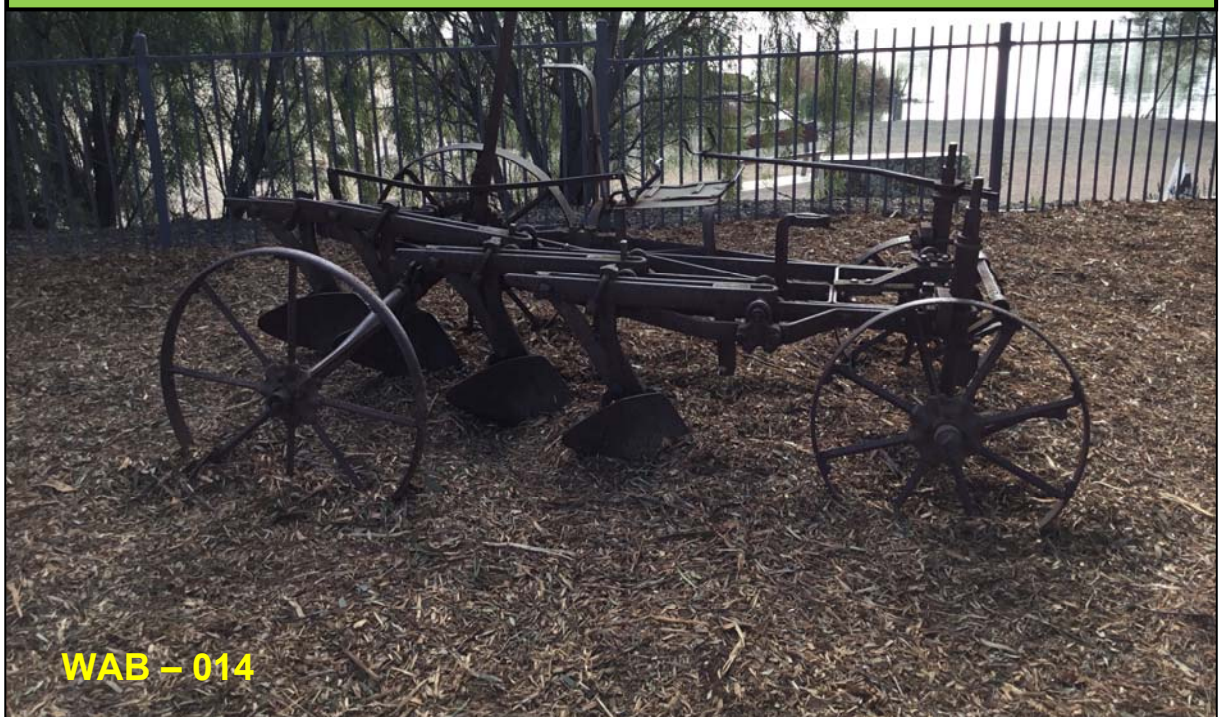
This plow is intended for visual aspect and not intended for play and is regarded as a sculpture and is treated as a sculpture.
