JULY 26, 2020

Playground Audit

TRURO MEMORIAL PARK PLAYGROUND

MID MURRAY COUNCIL

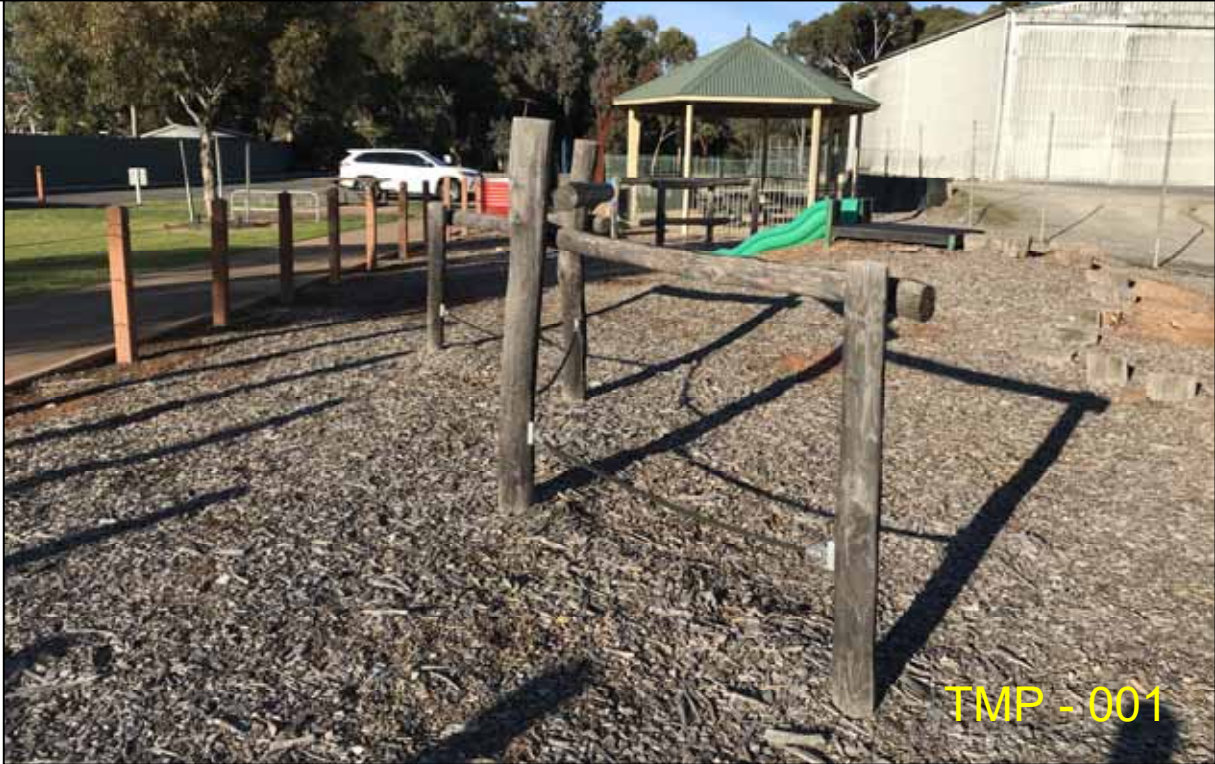
The climbing fence is securely fixed with all the rope connections still connected quite soundly to the post. The posts bases and top rails are all sound with very little areas of movement.

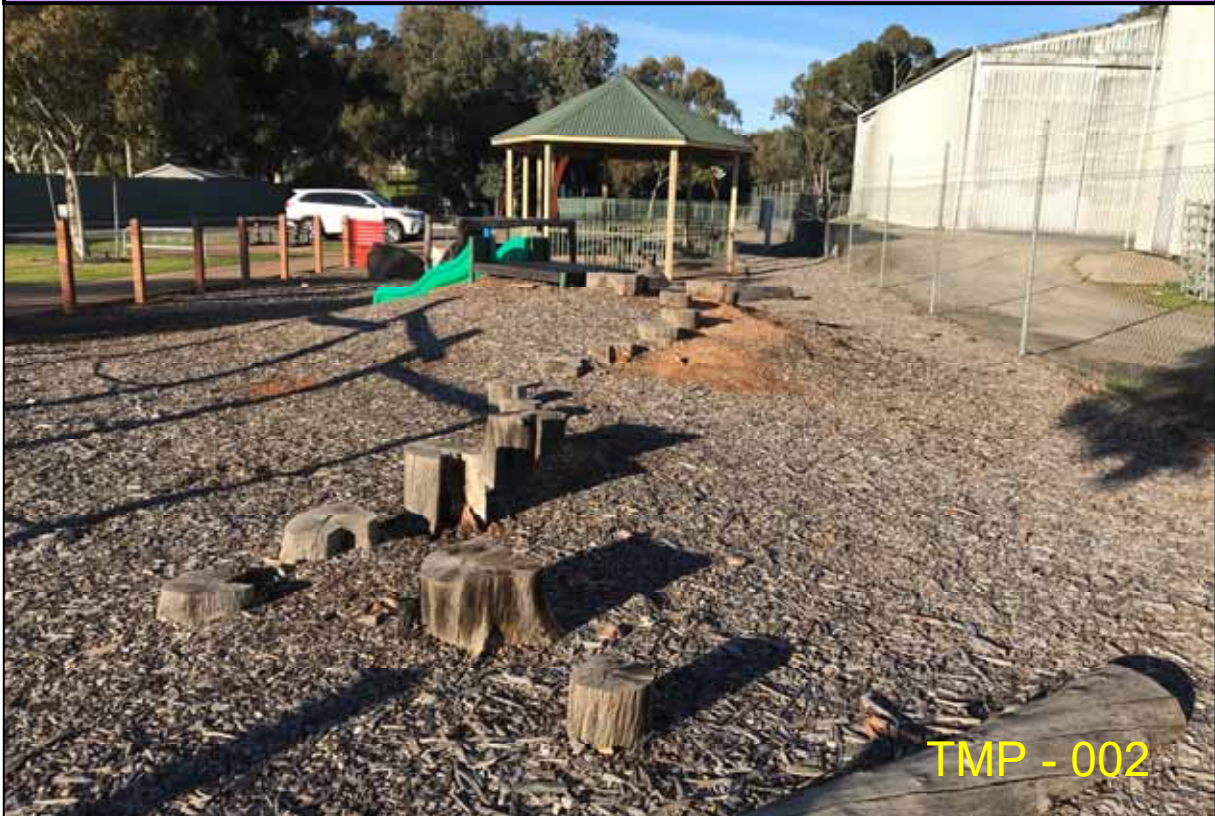
Many of the tree rounds have started to break apart, all will need to be removed and replaced but the rounds should be treated before they are replaced, refer to fact sheet on the process.

- Remove and replace all log rounds. **Defect**

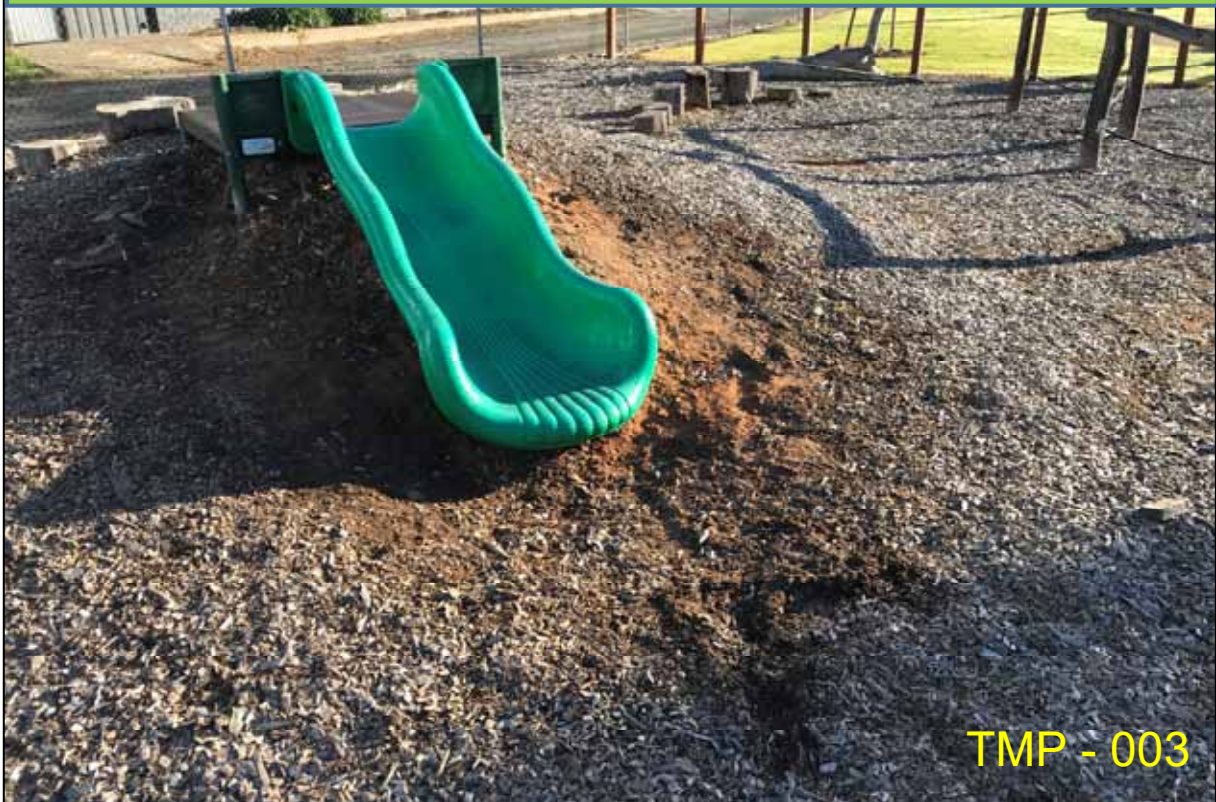
The slide is sound and has very little wear, all fixture points are stable and no movement was detected, the slope and length of the slide does not require softfall

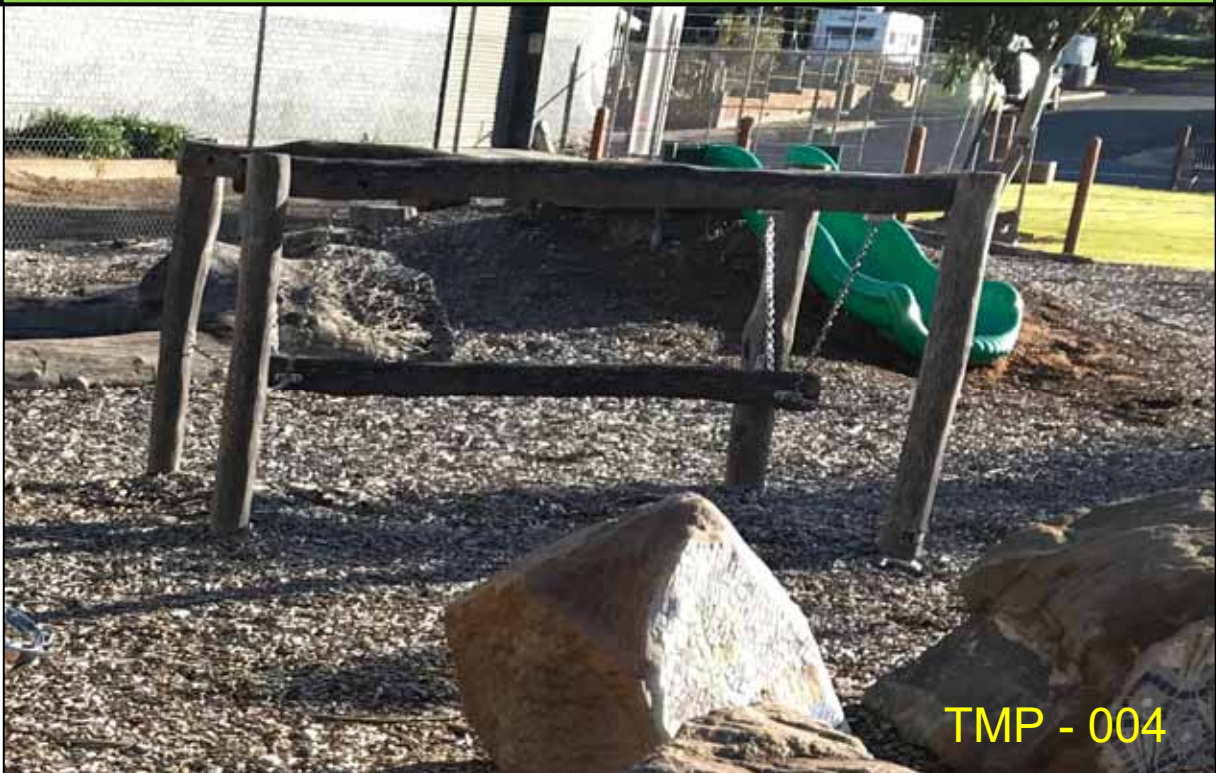
TMP - 003

All fixtures and attachments for this long chain swing are all in good condition and fix security key all the logs within this piece of equipment. The top log what time logs are in good condition and are quite sound and the fixtures.

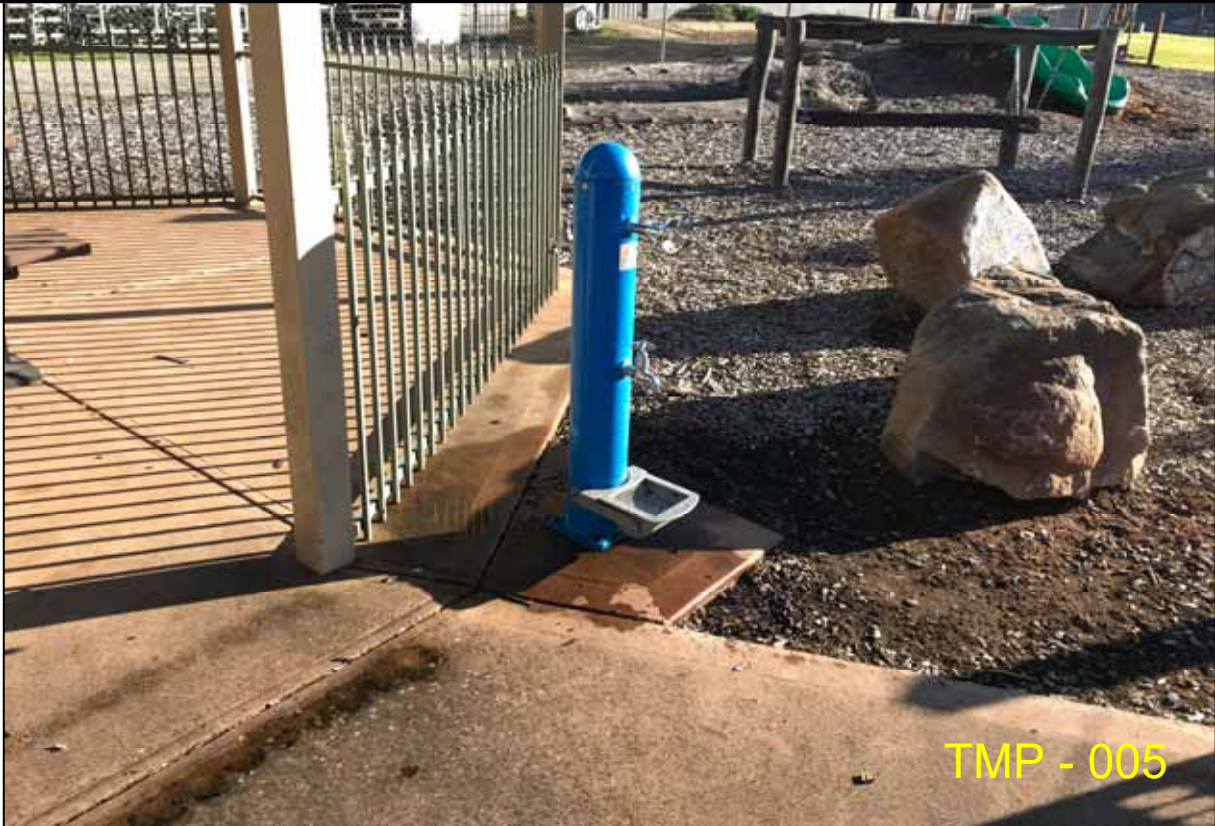
TMP - 004

This fountain is working as manufactured, on the rear of the fountain is the security tap which is dripping continuously and causing the area below to be wet at all times. The tap is either not turned off properly or the washer will need to be replaced.

- The tap on the rear of the fountain needs to be checked and either turned off properly or it may need a new washer. **Remedial**

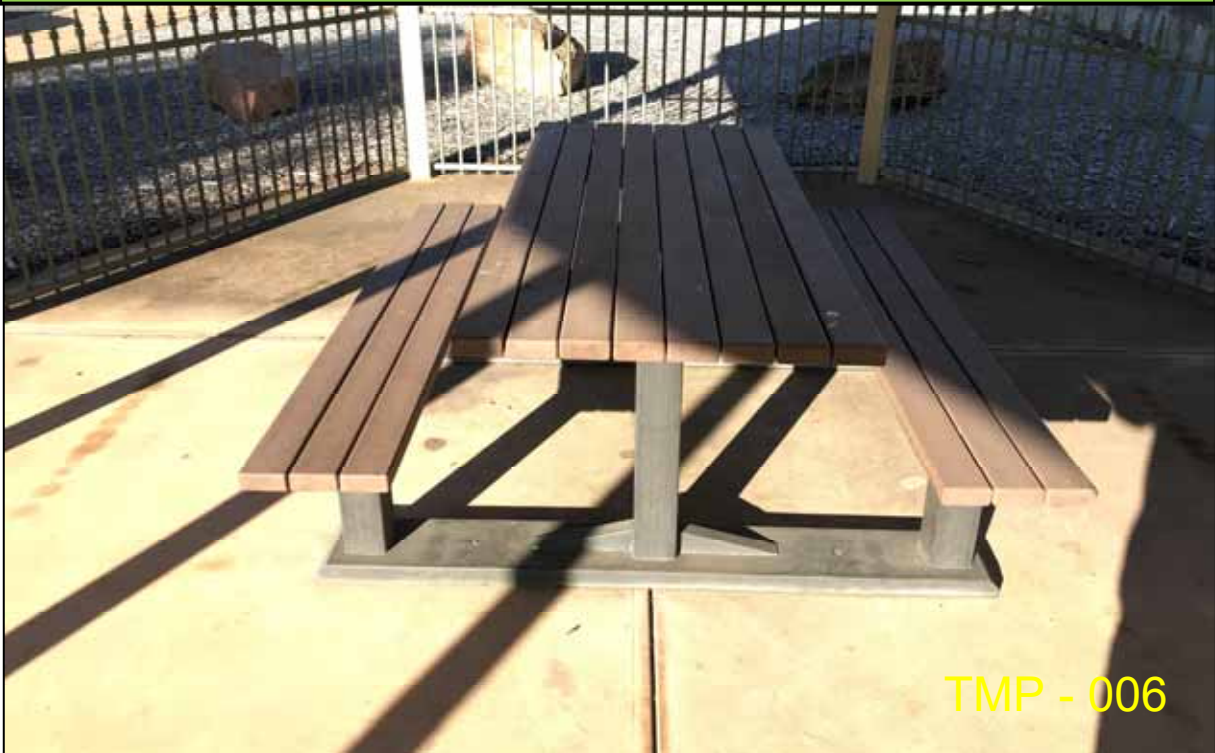
The two lots of seats and tables are both in good condition with no loose boards and both are quite clean with no vandalism or damage apart from some scratched in writing on one board. This does not remove any structural capacity from the table and is not a great problem.

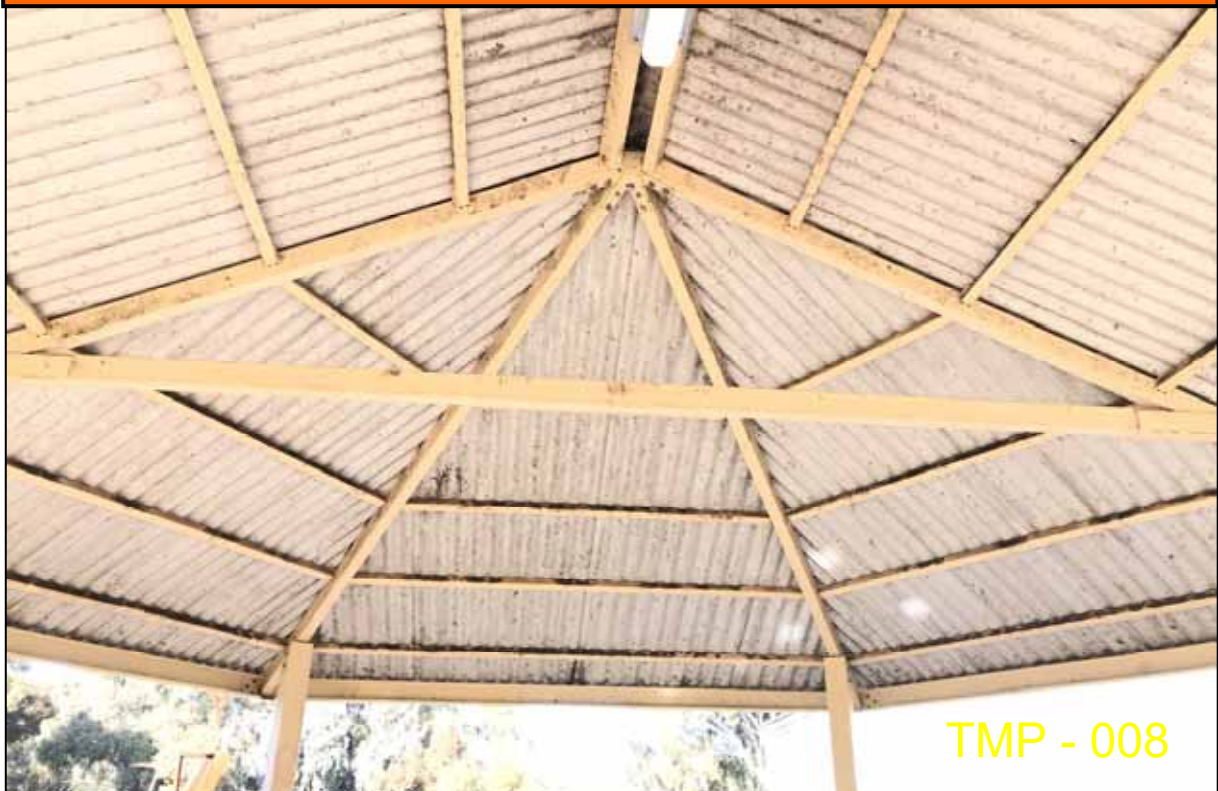
The shelter does have a lot of mold on the underside which looks to be from water or mildew that are settled on the inside of the roof. This may need to be cleaned before it gets too much of a buildup.

- Removal of bacteria build up is recommended, steam cleaner or high-pressure sprayer will remove most of the bacteria. **Remedial**
- Fence panel needs to be refastened on the rear panel. **Remedial**

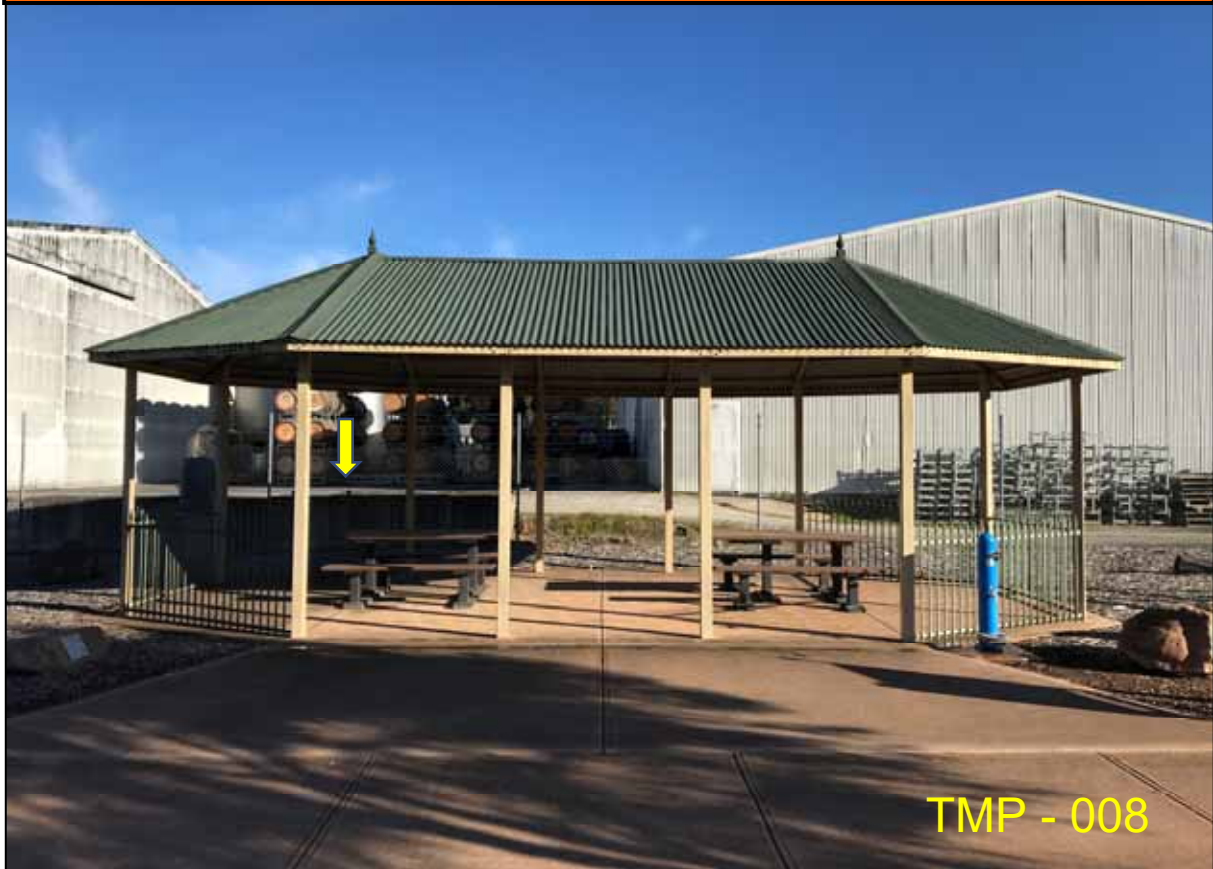
The fence panel on the shelter closest to the power box in the back of the park is loose and will need re-tightening and I would suggest using Loctite to keep them from coming out.

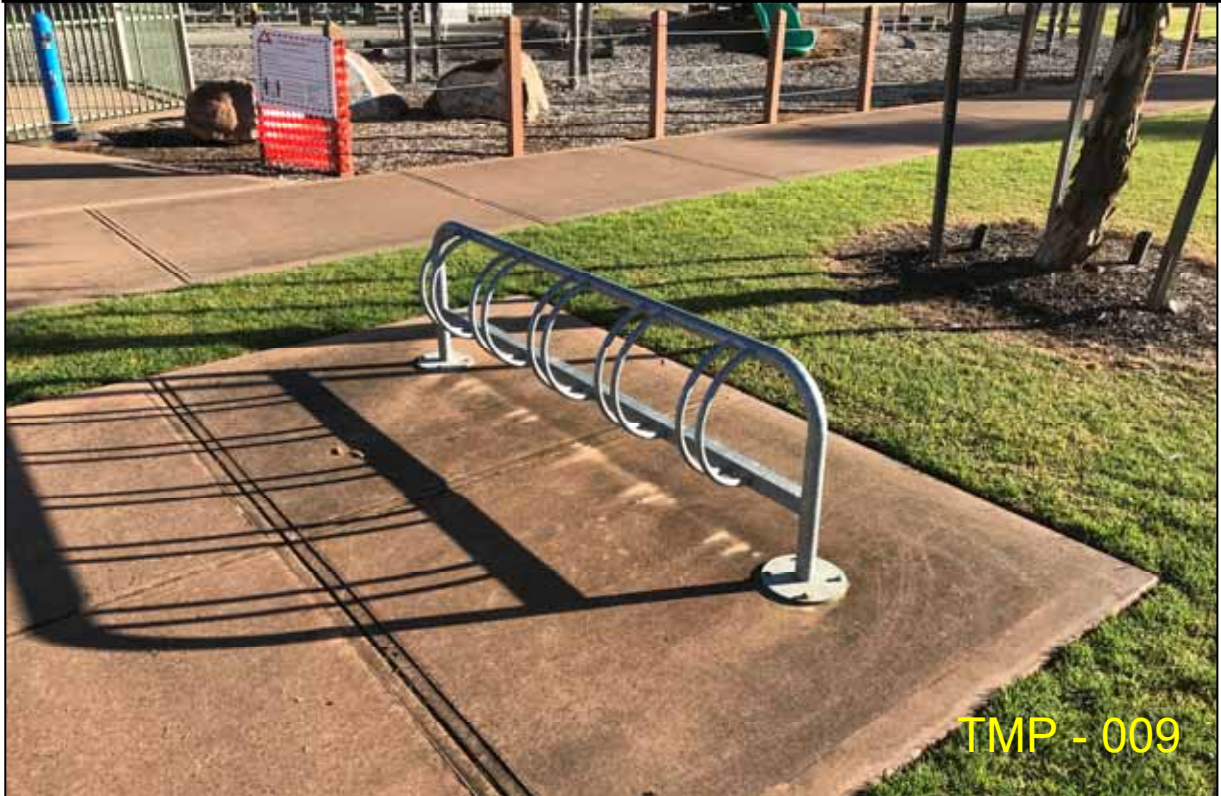
The bike rack is in good condition and doesn't have any signs of deuteriation, all fixtures are sound and no movement within the structure.

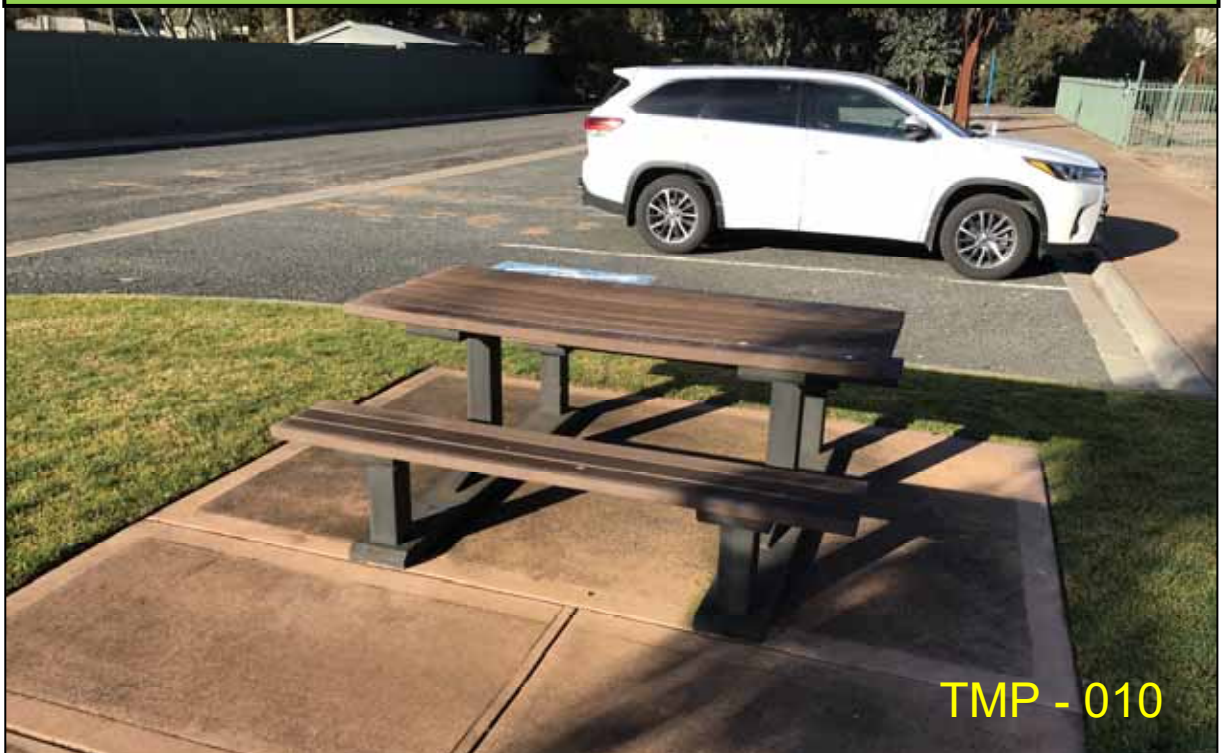
The bench seat and table are securely affixed to the slab and all parts are fastened with no movement.

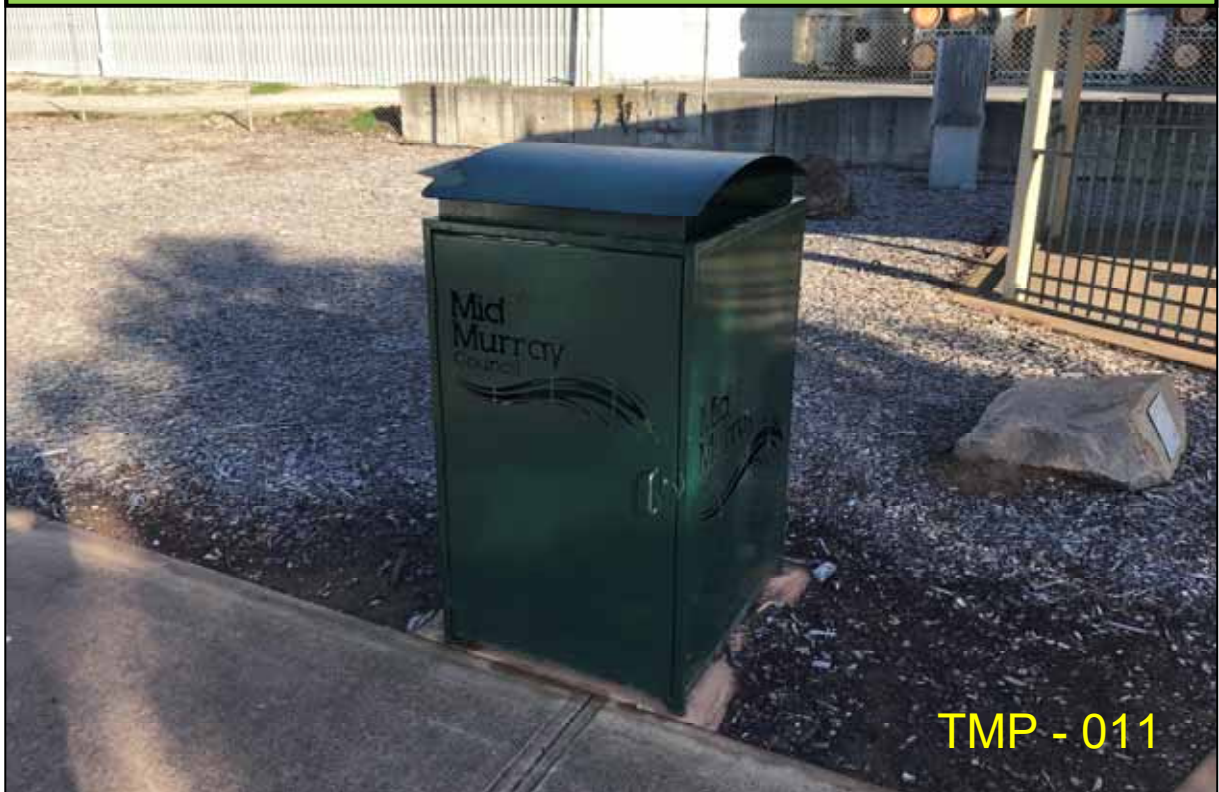
The bin was locked and the structure was sound.

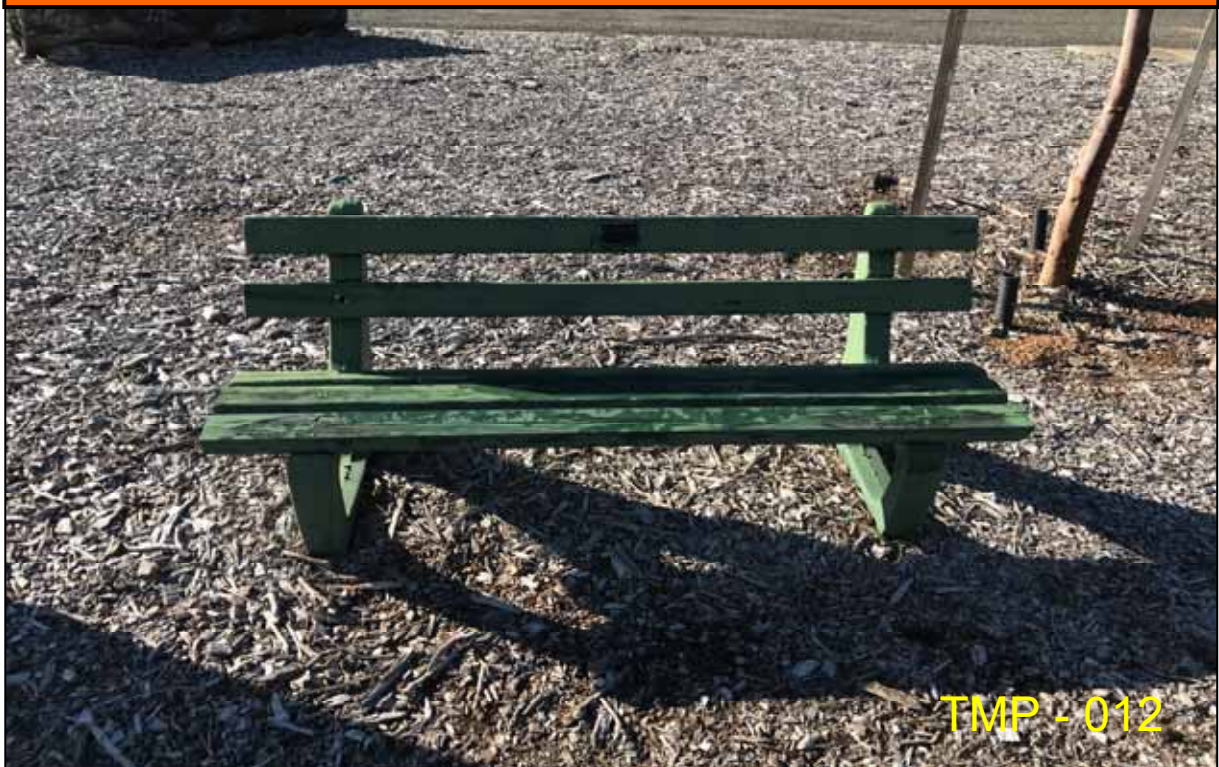
The bench seat has four of the boards securely attached to the seating, the middle board will need to be fixed in place I would suggest the use of silicon for this as the bolt coming out from the concrete will require removal and the new one installed however with the silicon you can attach it to the area as long as all the rust is removed from the old bolt.

- The middle bottom slat will require refastening, the use of silicon such as liquid nails should allow for fixture without having to redrill a hole that may cause weakening in the concrete. **Defect**

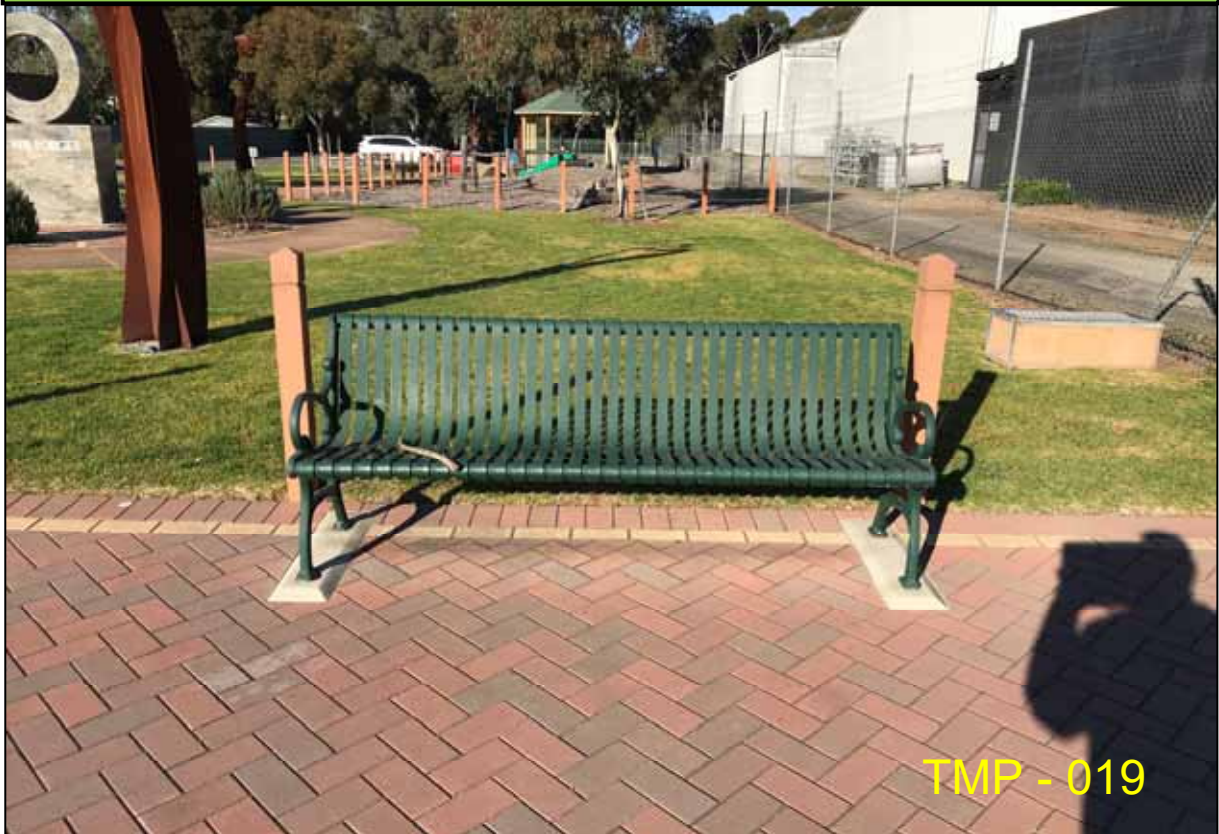
This seat is in good condition and affixed soundly to the footings.

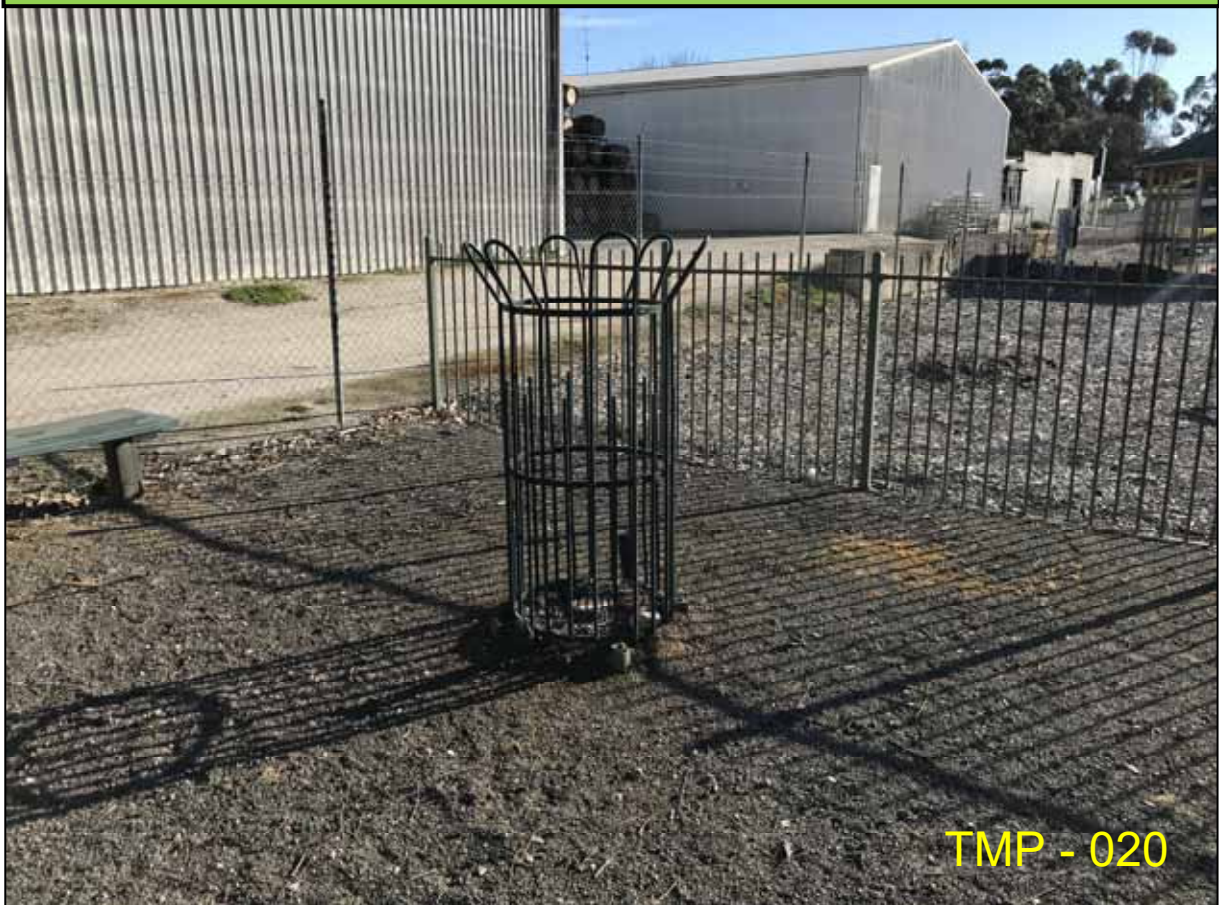
TMP - 019

The tree surround in the dog park is in good condition but doesn't have a tree.

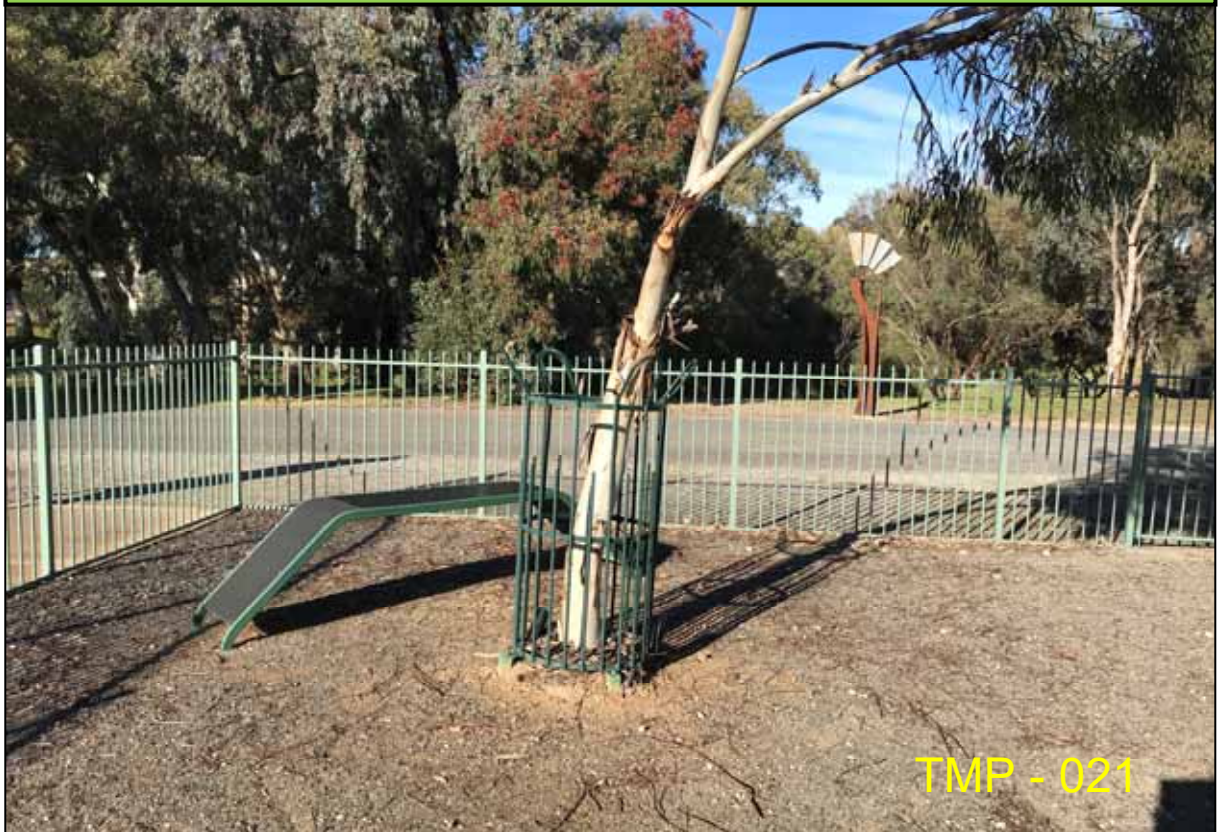
TMP - 020

This tree surround is in good condition, the tree is on a lean and this may impact the surround as it matures.

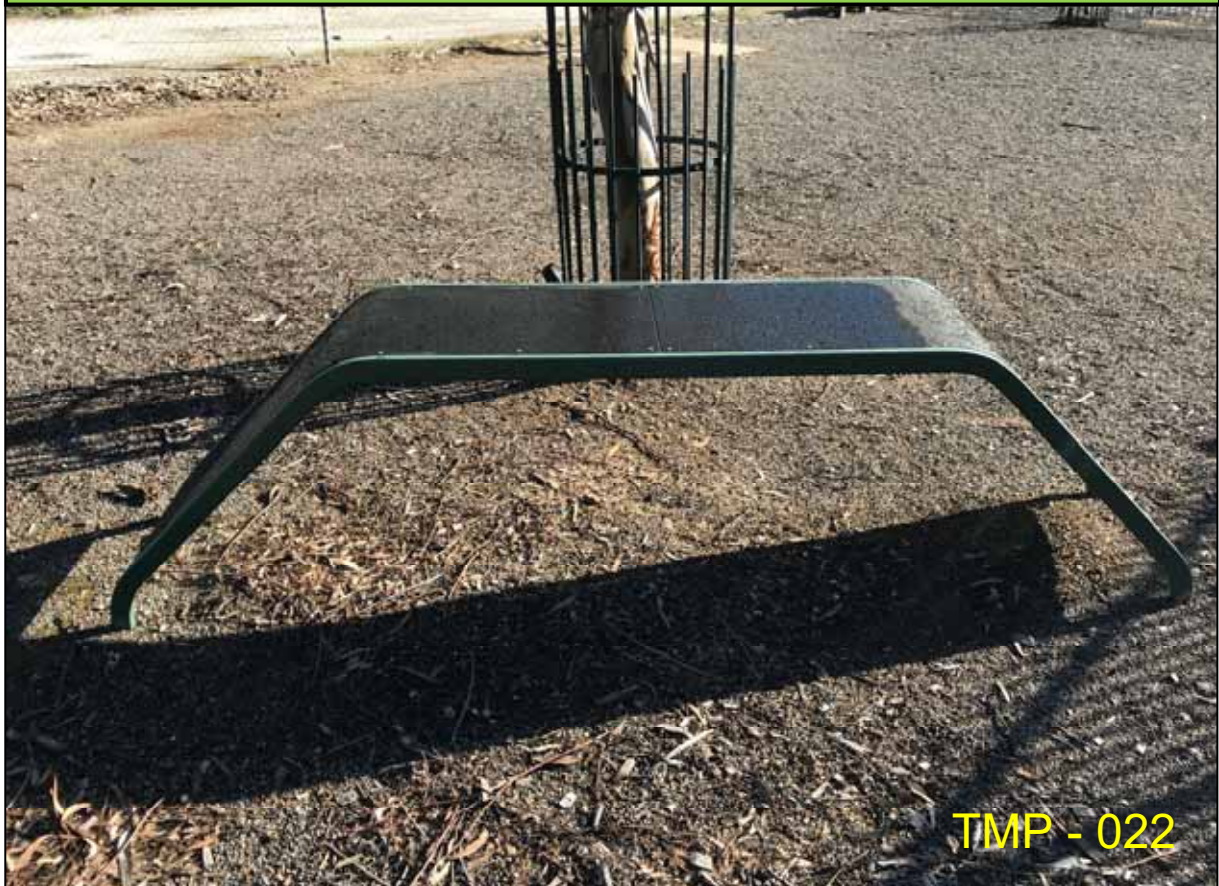
The dog bridge is in good condition and is stable.

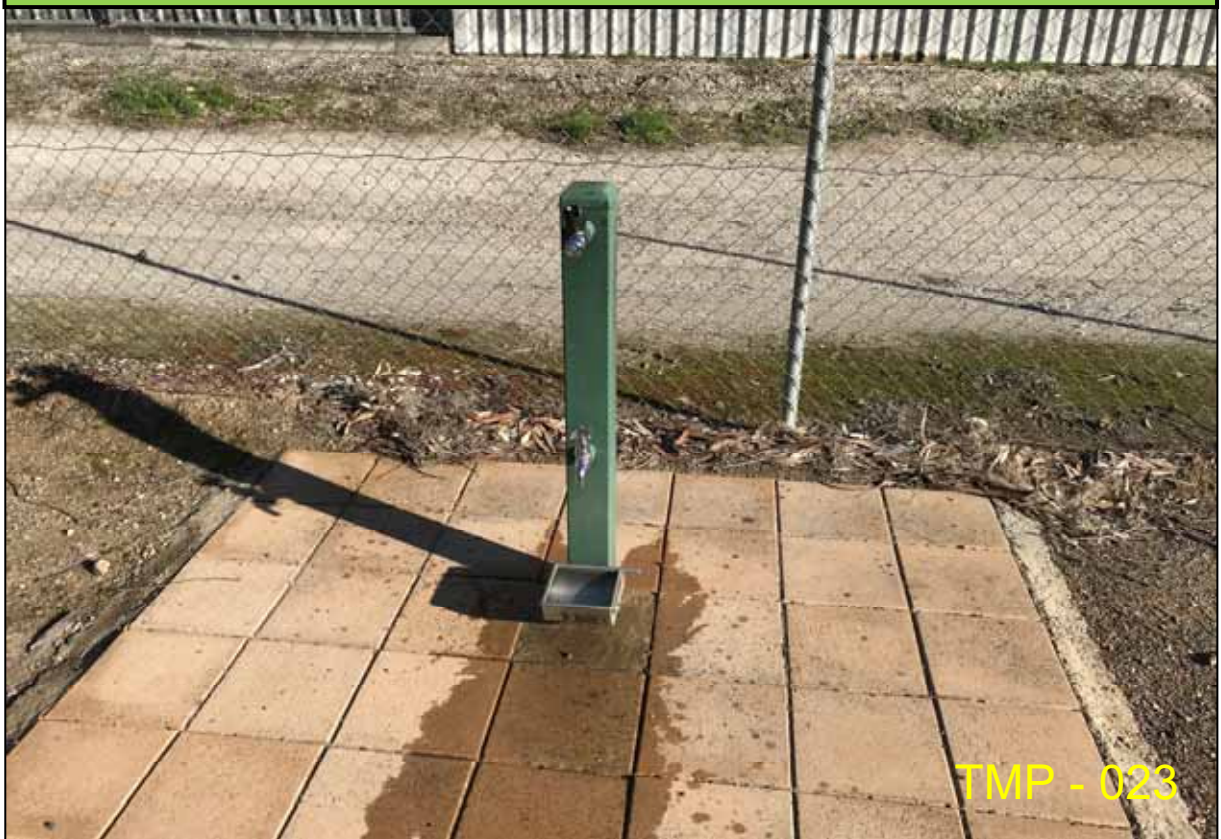
The water fountain is functional and works as required.

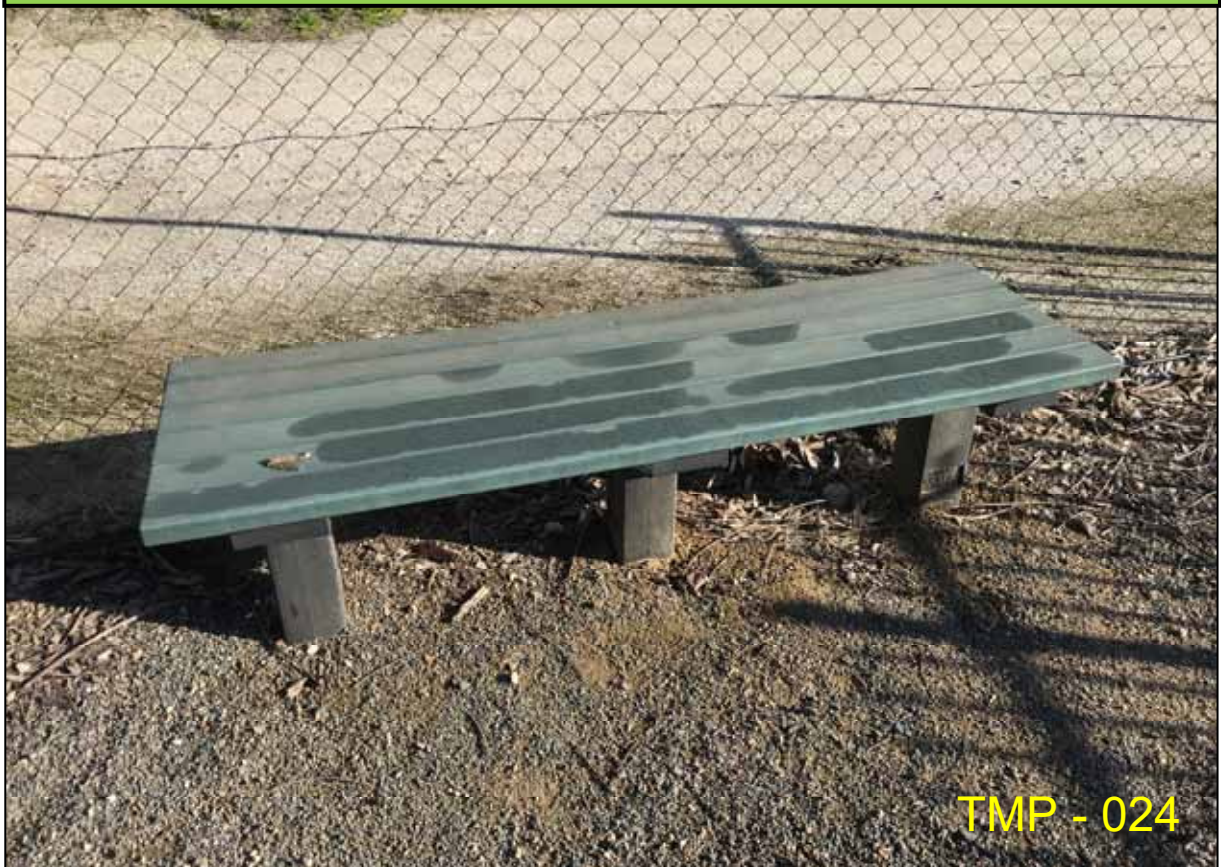
The bench seat is all intact and fixed securely.

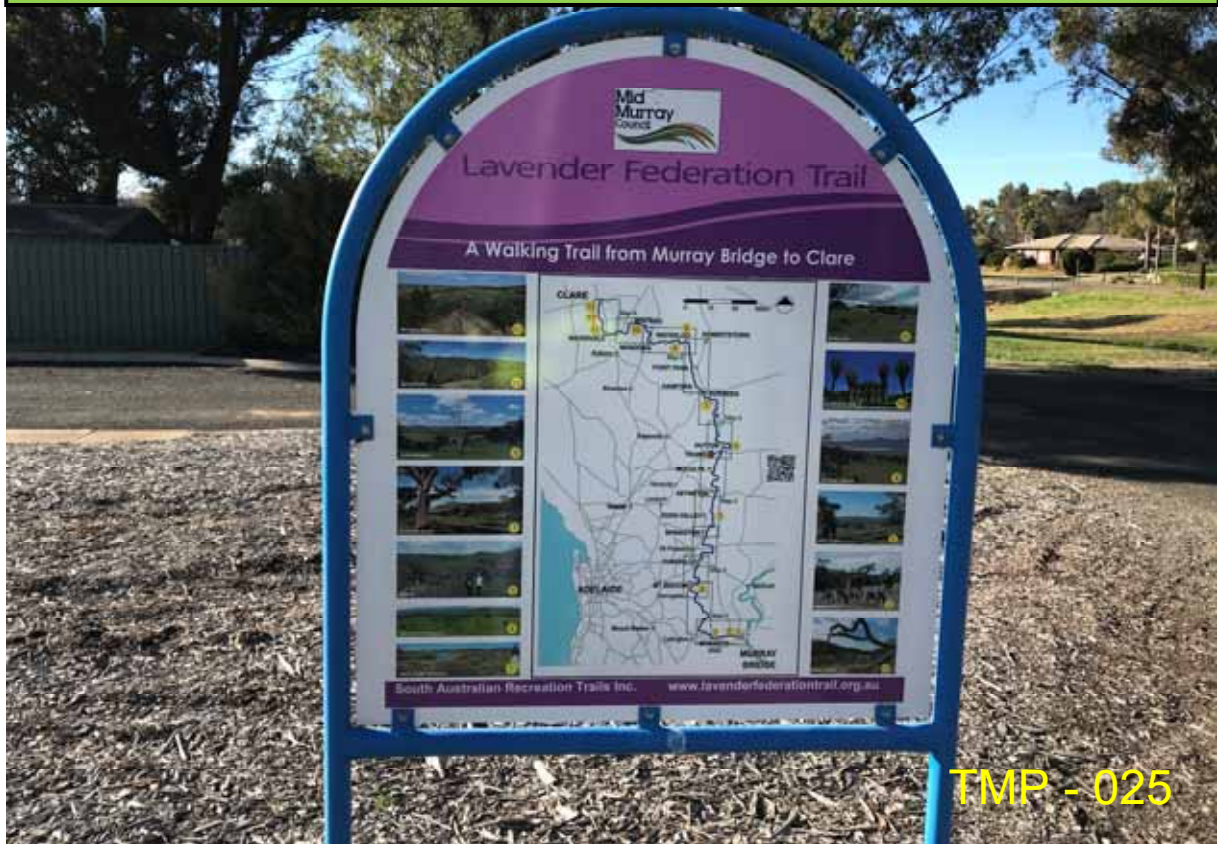
The sign is in good condition, the graphics and text is legible and with no fading, it is mostly as installed condition.
