JULY 25, 2020

## Playground Audit

# MORGAN RIVERFRONT RESERVE

MID MURRAY COUNCIL

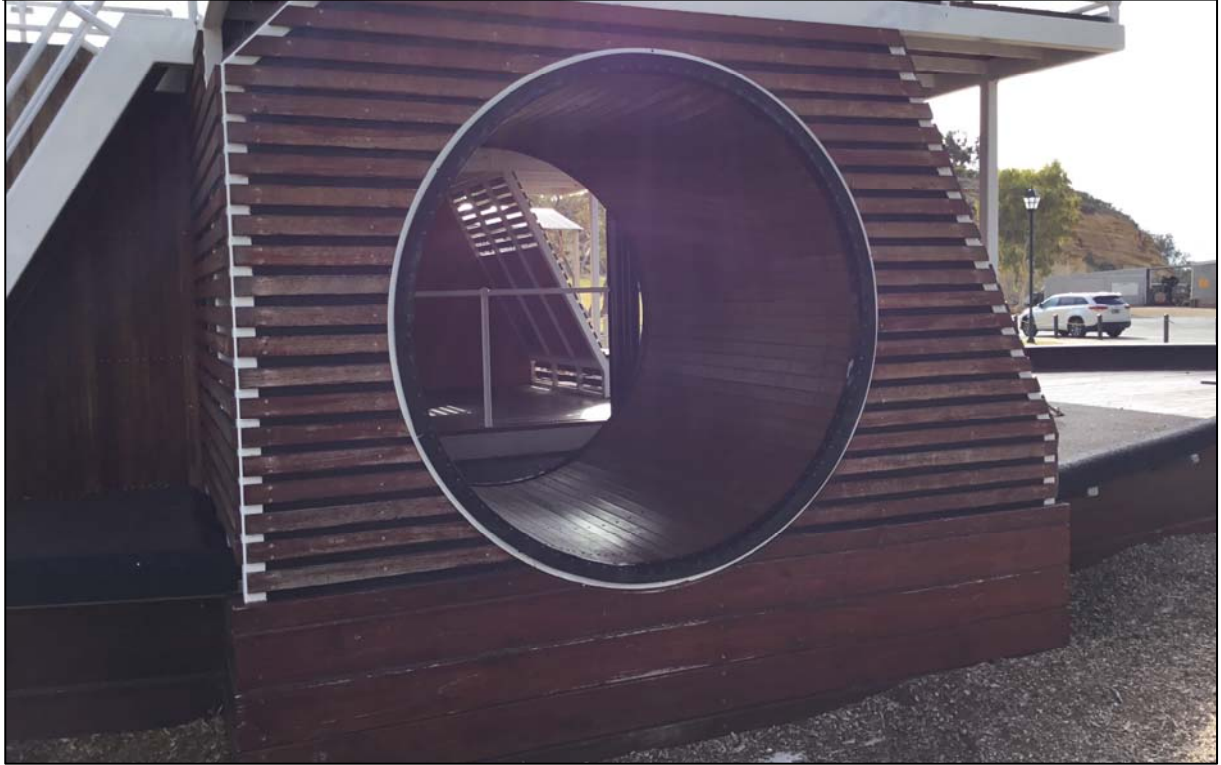
The internal Paddle wheel is very hard to turn it does turn slightly with some effort however it is sticking in parts. Either the rollers need adjusting or new rollers are required, I would recommend keeping this feature as it is unique in a play area and offers a feature that many would see.

- Movable Paddle wheel needs attention, hard to move. **Remedial**
- Softfall inadequate, some areas of exposed concrete and soil. **Remedial**
- Rails needed on the deck around the whole bottom level. **Defect**
- Upper deck flooring needs attention, treatment and fix cracked boards. **Remedial**
- Perspex cracked on two panels on upper deck. **Remedial**
- Step missing on stairs to upper deck. **Defect**

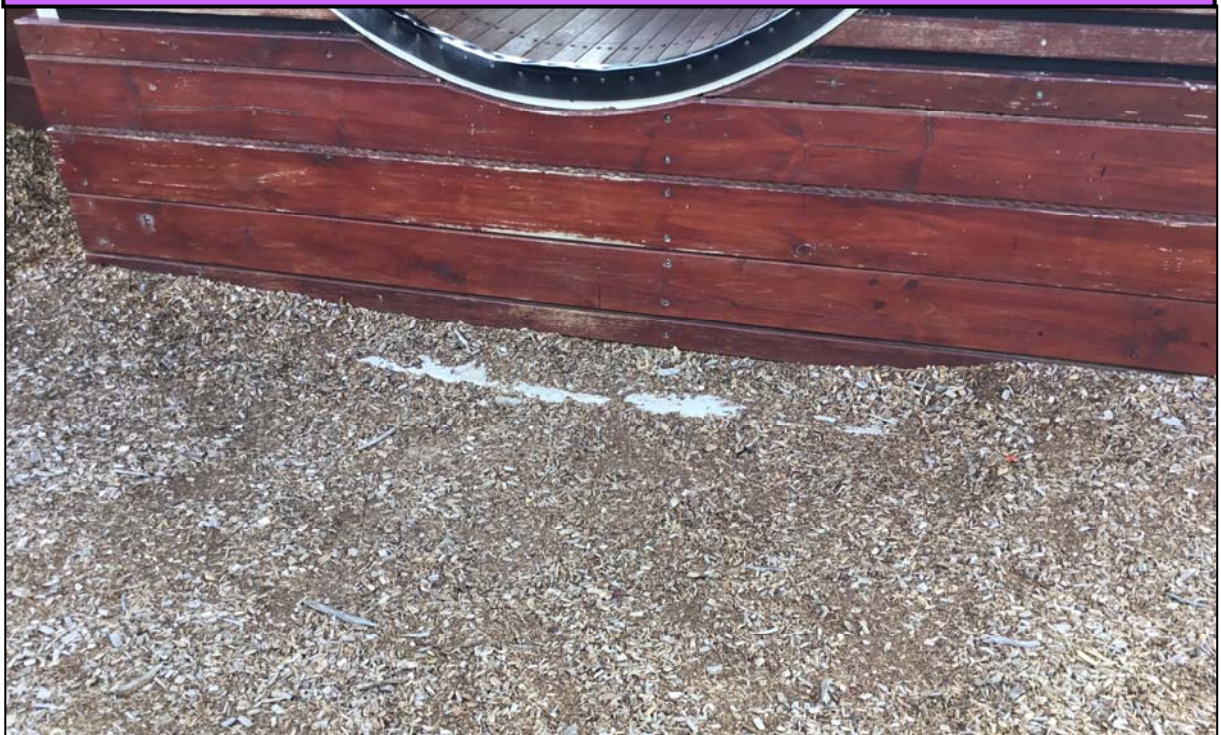
The softfall is thin all around the structure in places is expose concrete and soil is the area of impact. Softfall needs to be to a minimum of 200mm with a 100mm overfill, sustaining the 200mm depth is require for the reduction of blunt force impact to the brain.

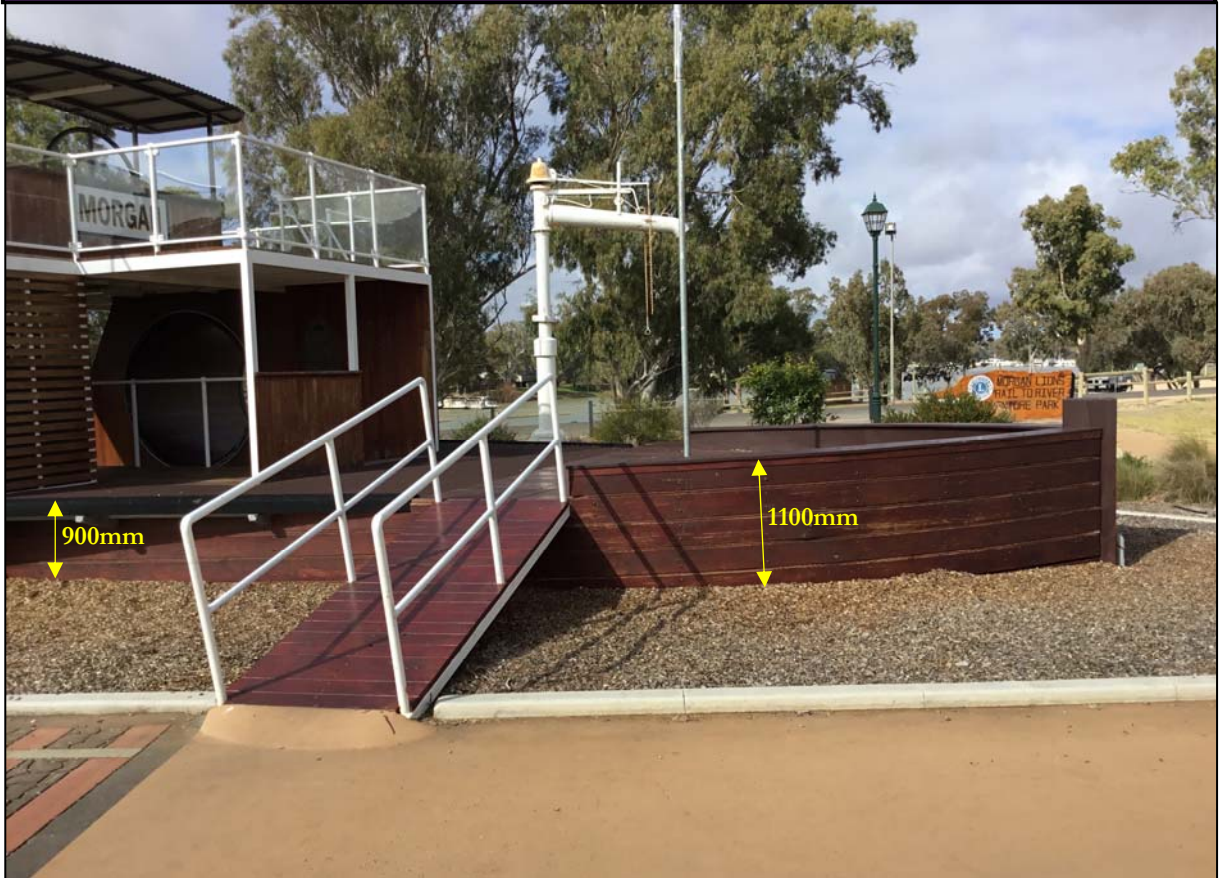
The deck of the boat is 900mm at the lowest point and 1100mm at the highest, as the area is easily accessible the deck of the boat needs a barrier with a minimum height of 700mm above standing height and a

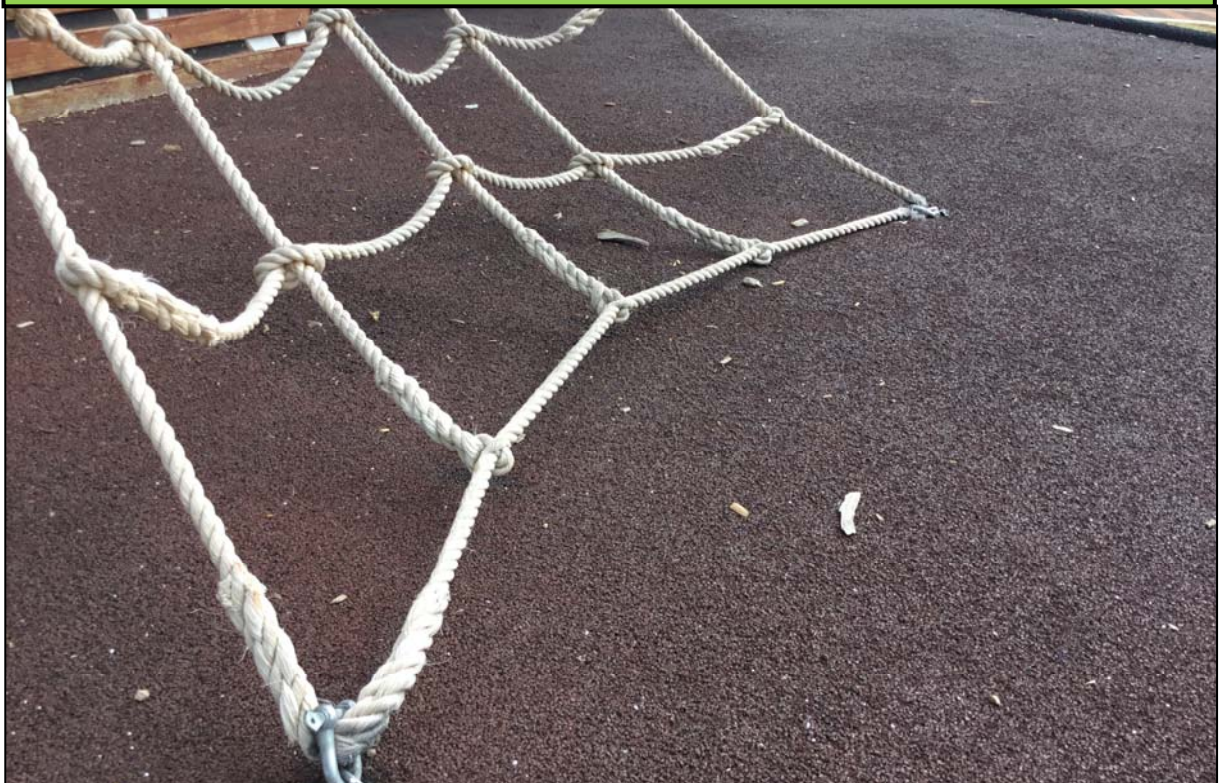
Rope ladder starting to fray but overall is in good condition

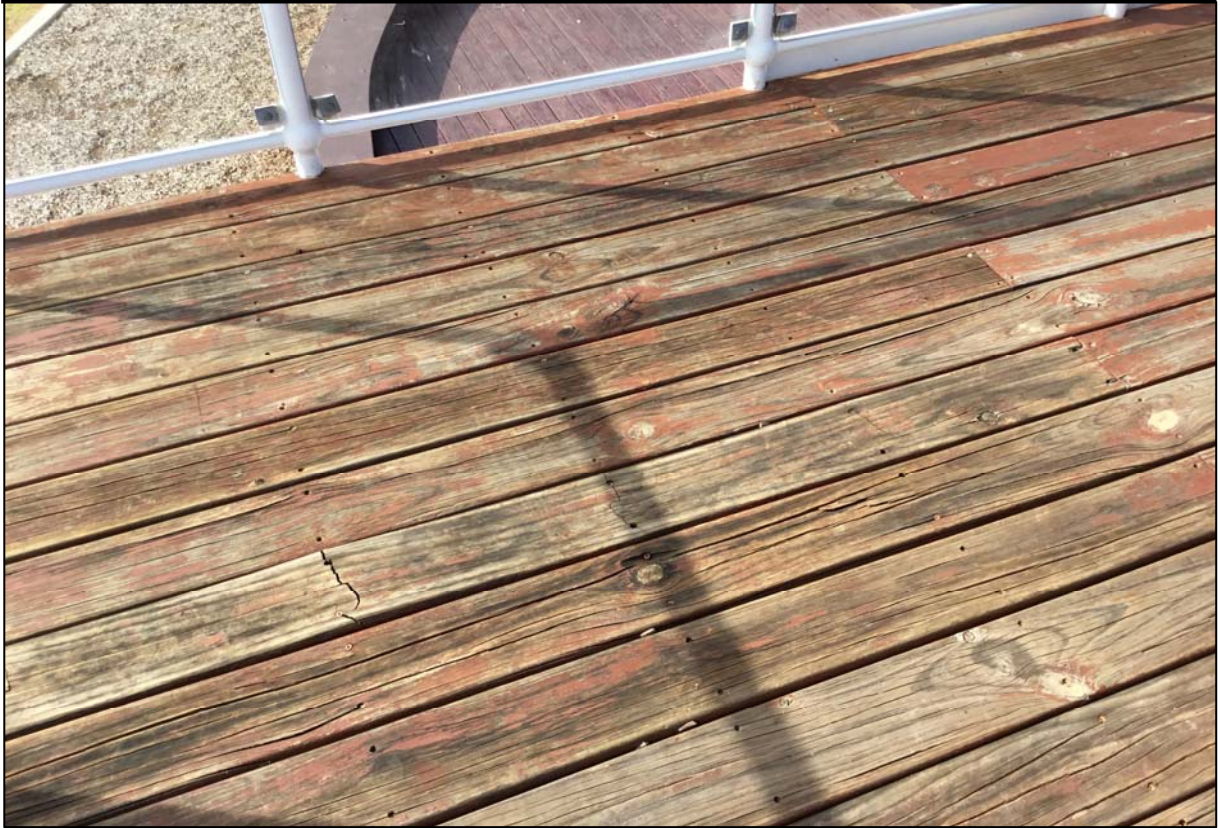
Some of the boards along this area are starting to lift and crack in places, there is some areas of splintering that really needs to be fixed up. Most of the boards are in good condition but should be treated with a decking paint or sealant.

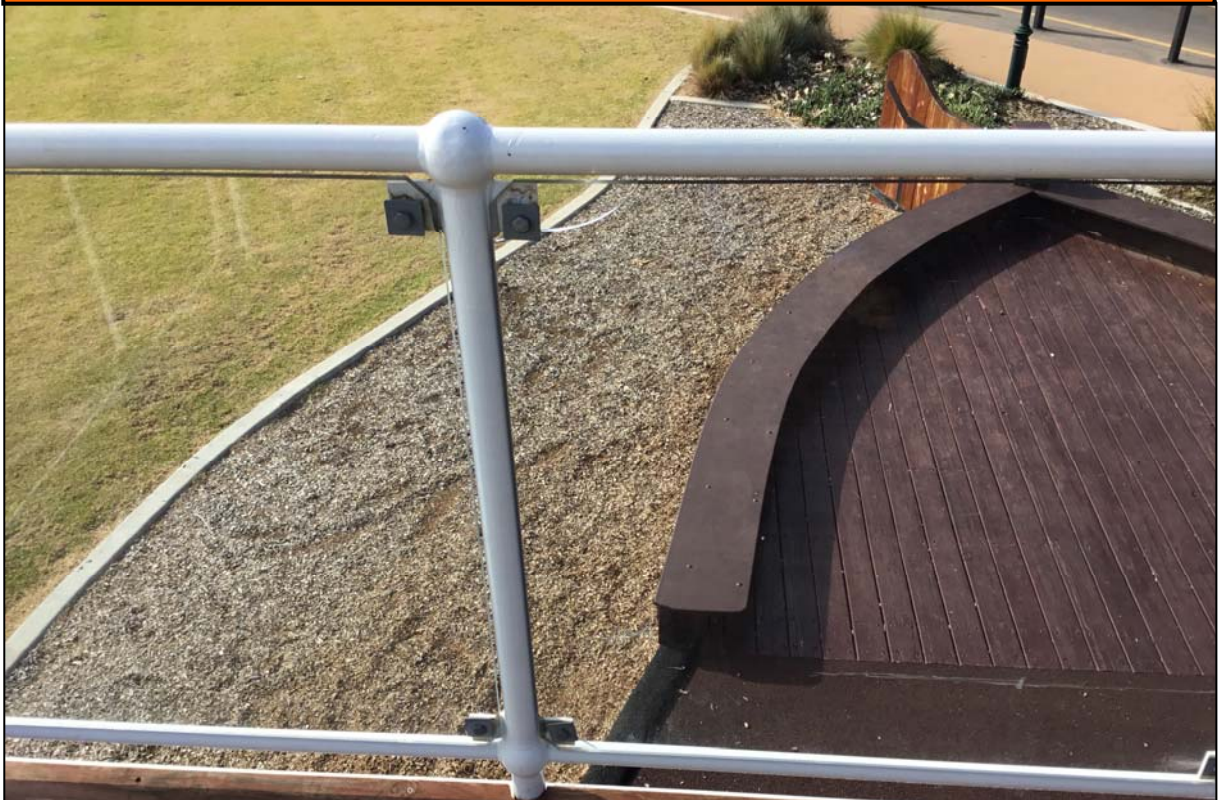
Cracking in two parts of the Perspex barrier.

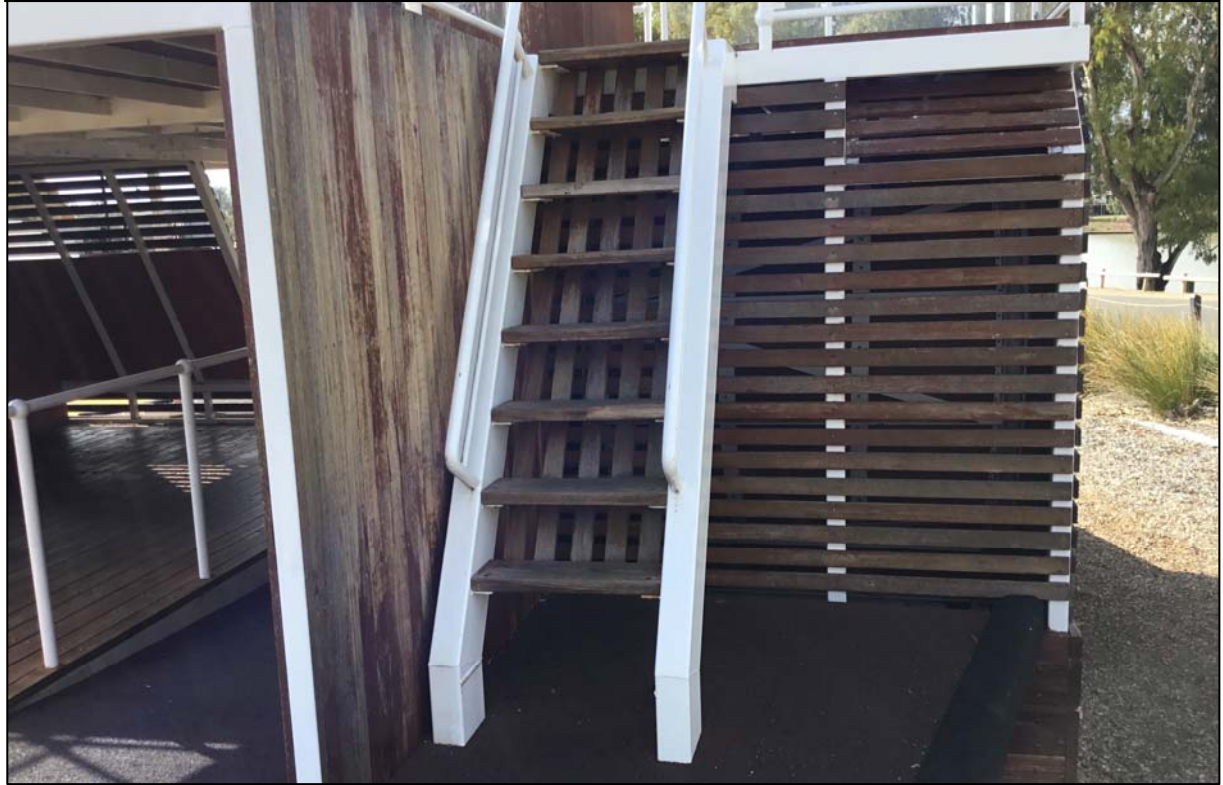
The steps up to the top deck are steep and can be hard to climb, the angle should have come out to the end of the wall with a 600mm hand rail, also the bottom step is missing which makes it hard for younger kids to climb this area and creates an inconsistent foot hold when coming back down the stairs.

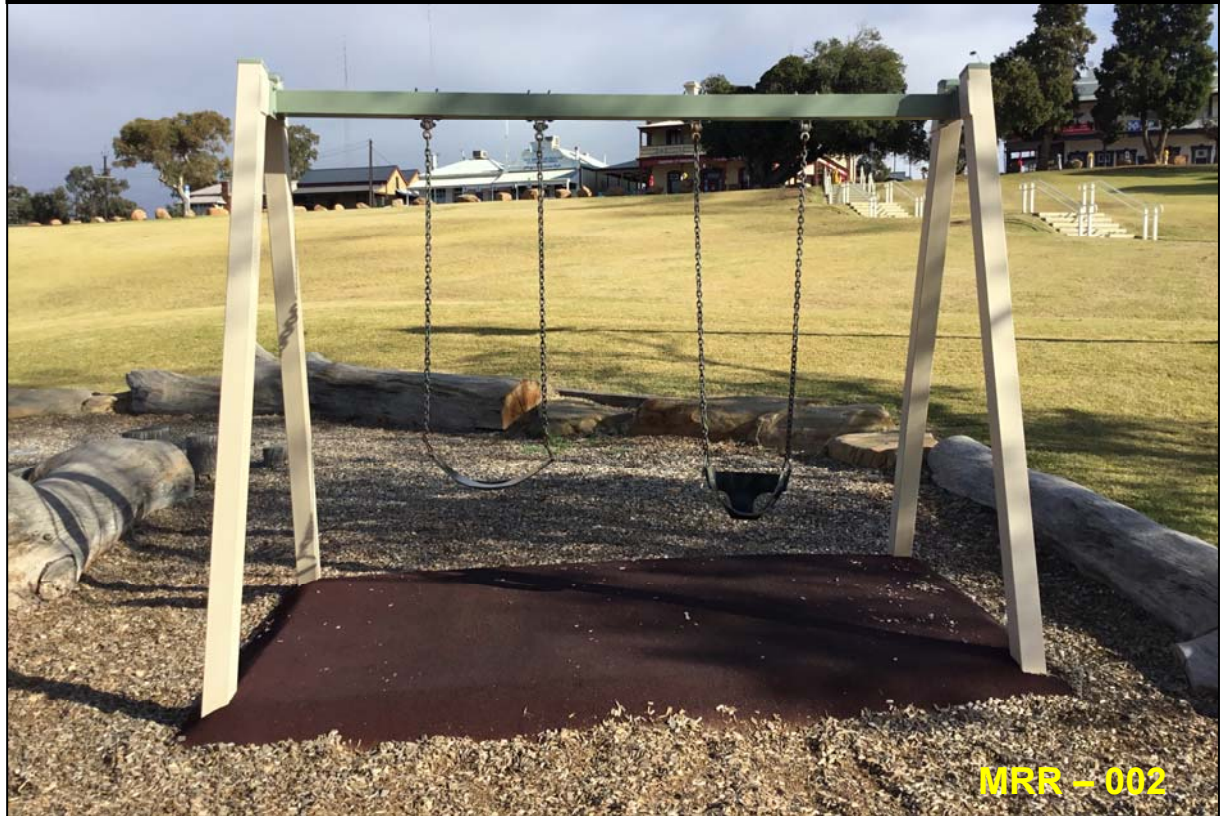
The two swings here are both in good condition the item of equipment doesn't look to be that old. There is bonded rubber softfall for the base which does not allow for inspection of the upright however the uprights do not have any signs of rust in the area and being of a young age should not have developed rust at this time. Both of the swing seats are in good condition and all S hooks swivels and chains are also in good condition they comply with standard.

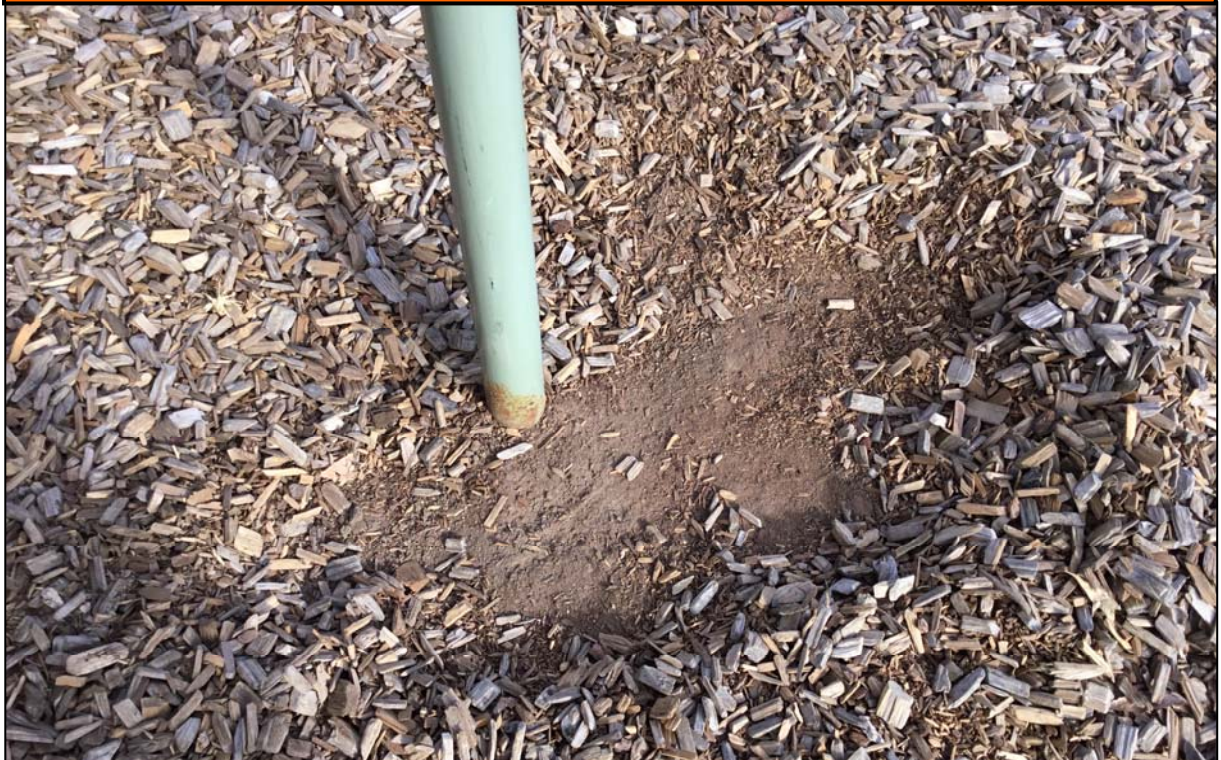
Bubble rust starting to arise from the ground up on the fire pole.

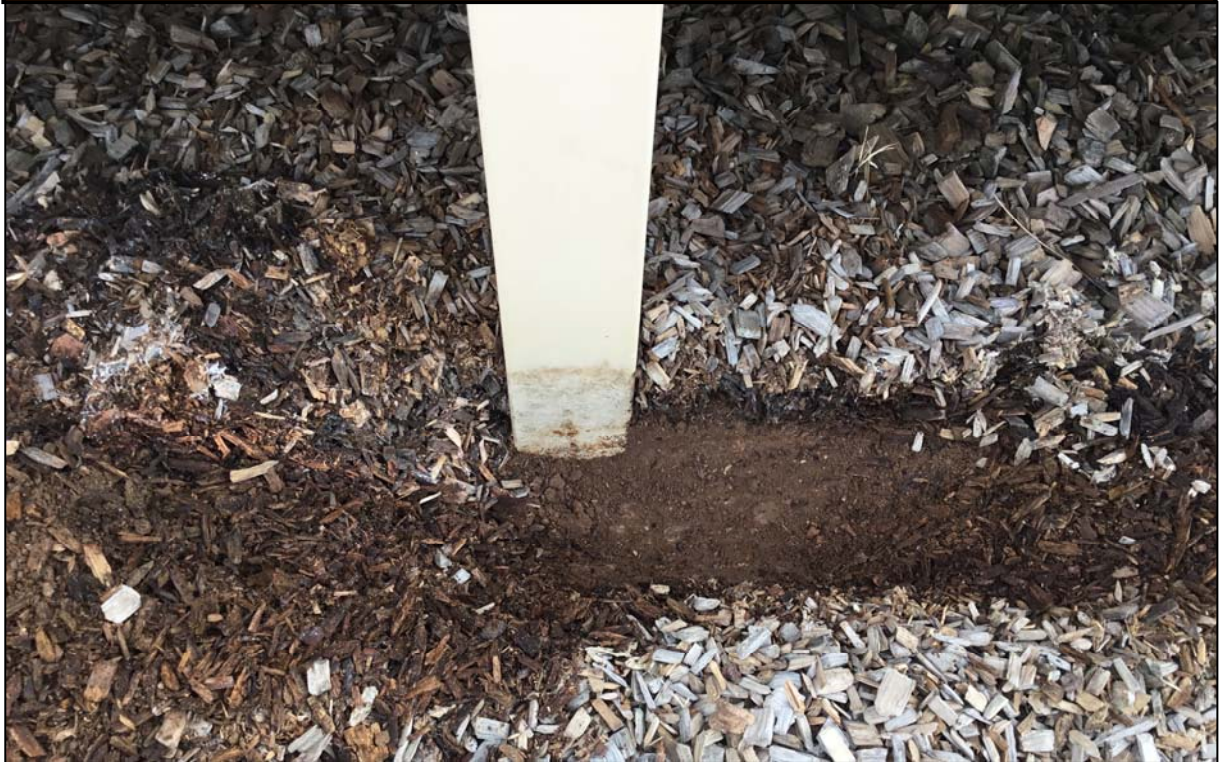
Bubble rust starting to arise from the ground up.

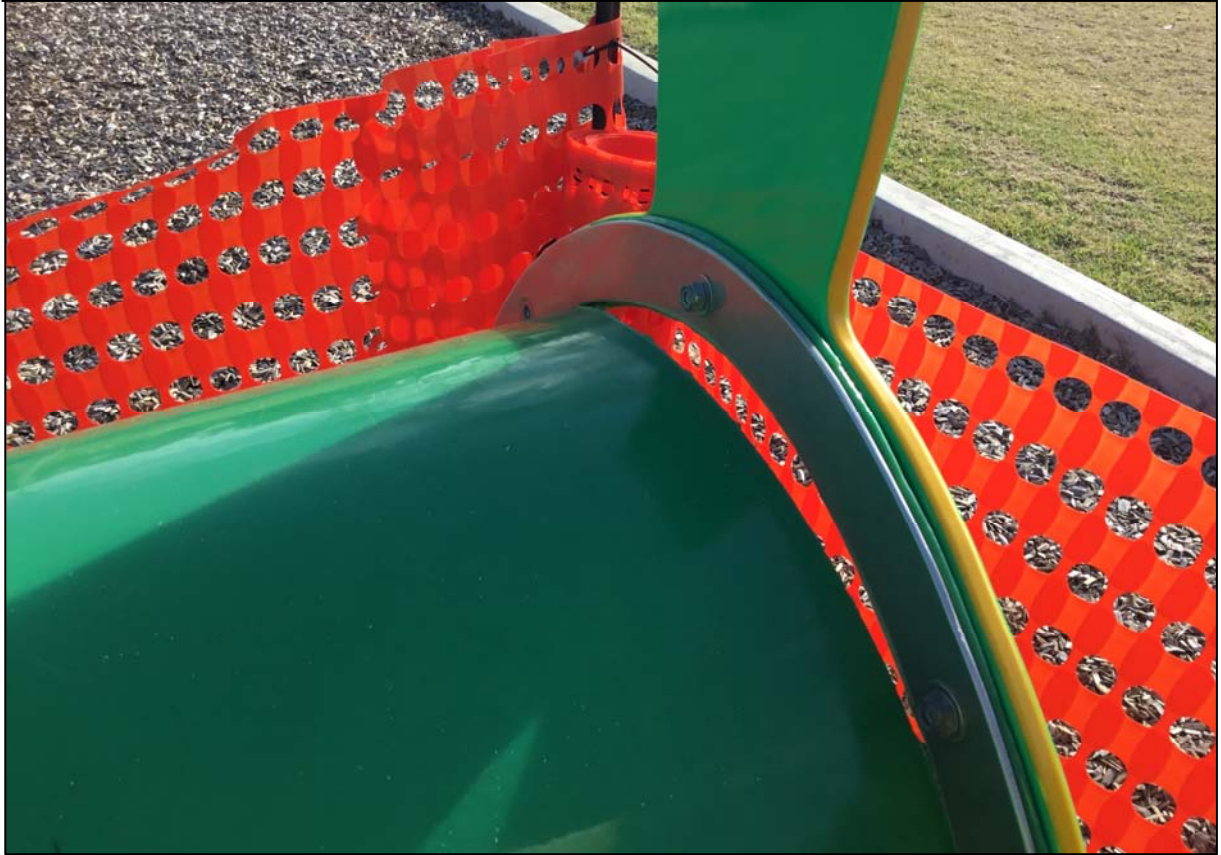
The train had been bunted off at the time of inspection as one of the springs and holders have been removed for repair, all the rest of the springs look intact with no areas of breakage or cracking, the floor plates are sound and all the fixtures to the springs also look to be sound. The trains front panel has been busted out from the main cylindrical front end; this is caused the plastic to be broken off the top of the stainless-steel plate. This may require a stainless-steel plate to be welded around in a format creating an "L" channel type temperature which can be bolted onto the cylinder engine compartment.

- Spring and holder currently being replaced. **Remedial**
- **Front of train needs attention. Defect**

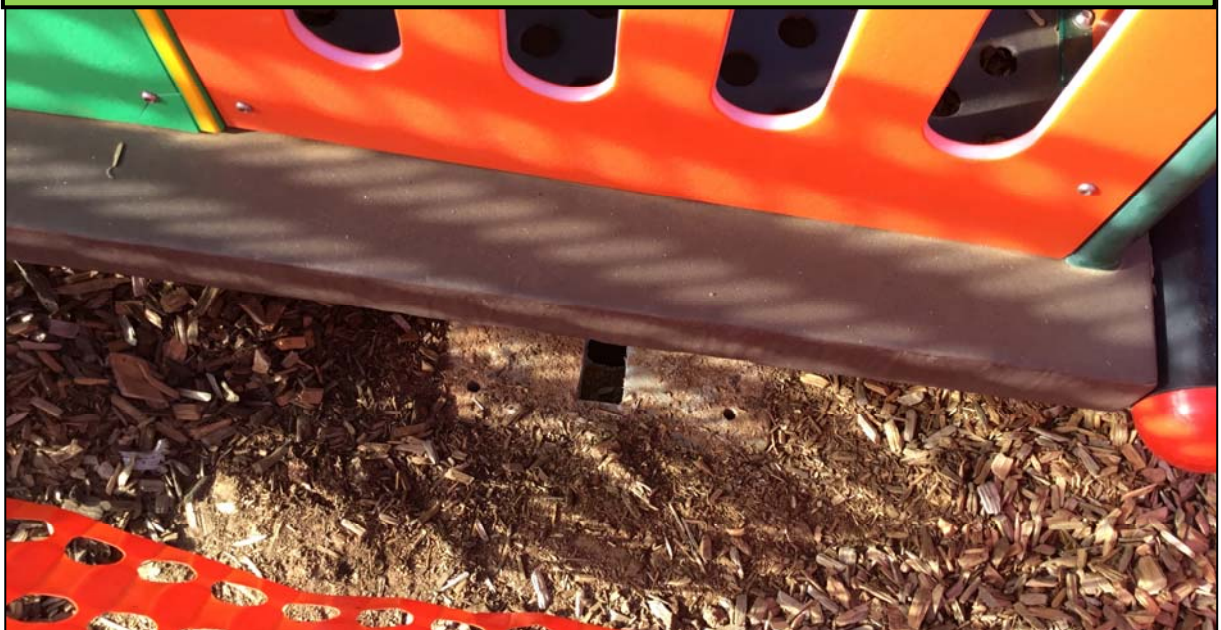
Removed spring foundation

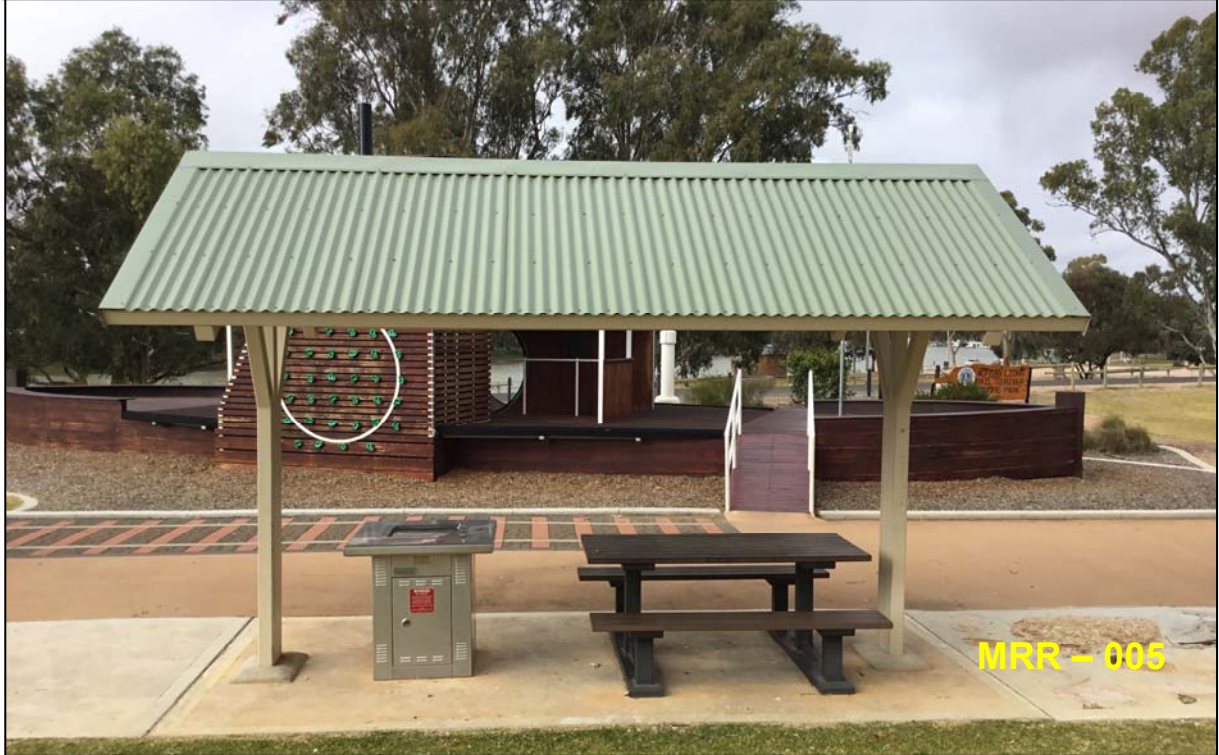
The bench table and seats are fixed securely to the concrete, the barbecue works however the barbecue is loose and is quite unstable

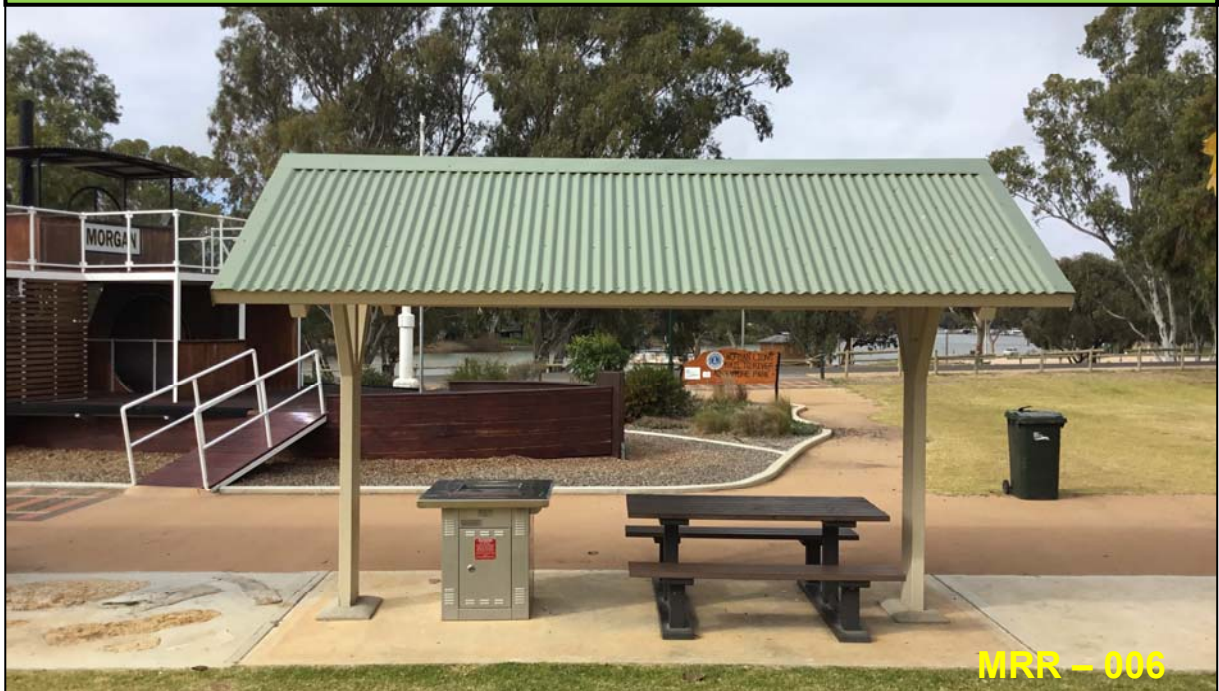
Number two area has its bench table and seat affixed to the concrete, the barbecue works but like the other one it is partly wobbly and even though it is a fixed to the concrete it I think the stainless steel is flimsy and moves within the stainless steel.

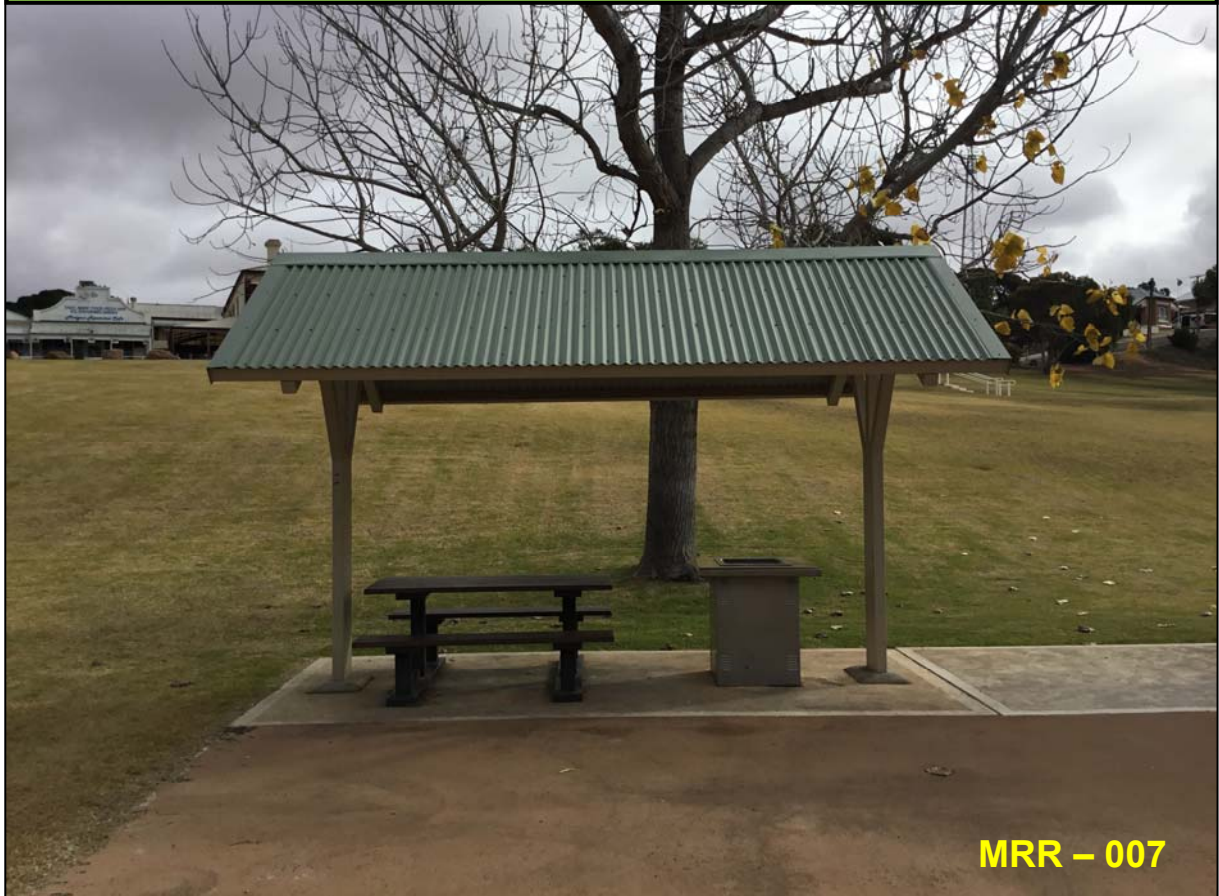
The same with number three, the bench seats and table are affixed securely but the barbecue is somewhat wobbly but it does work correctly.

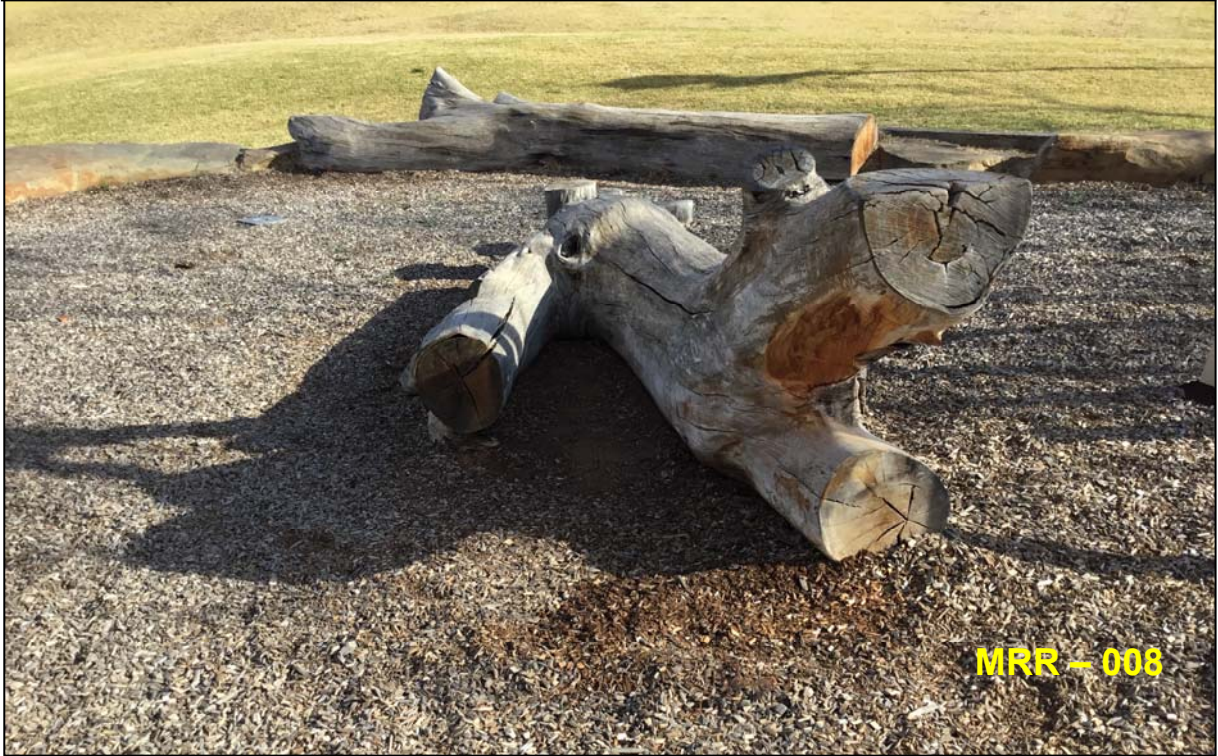
Belongings and the rocks within this area are considered a nature play item where they can easily be accessible to children playing hear anything above 600 mm will require a 300mm softfall beneath it out to 1500mm. The main log in the middle only has areas of exposed soil this will need to be covered with a minimum of 300mm of softfall.

- **Softfall needs topping up as the log is above 600mm. Remedial**

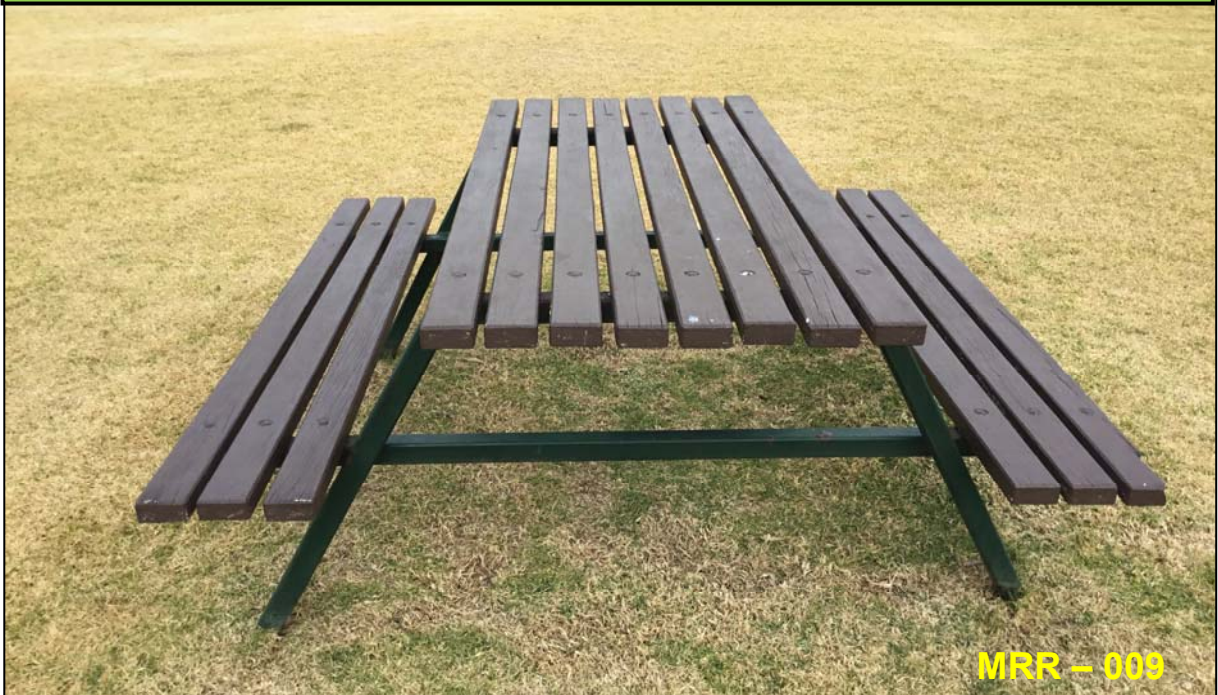
The bench seats and table are all sound with no areas of splintering and all boards are securely attached to the frame, the seat has no movement.

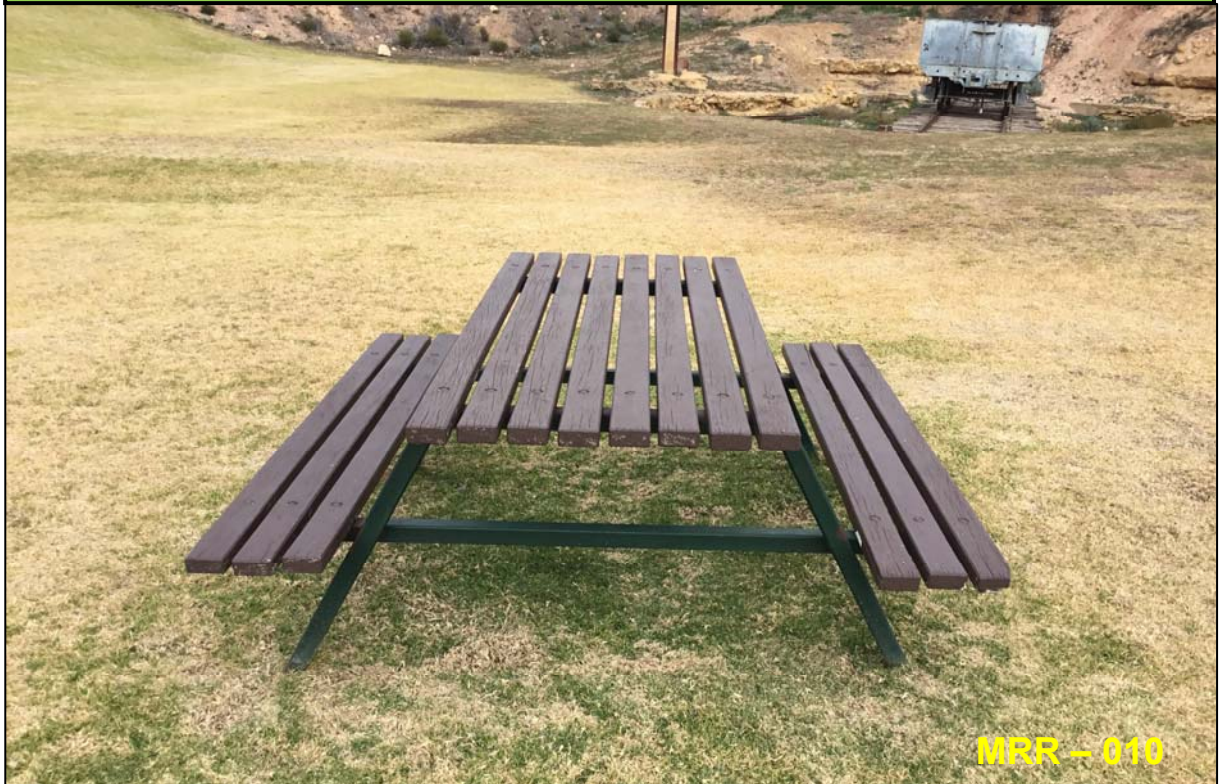
The bench seats and table are all sound with no areas of splintering and all boards are securely attached to the frame, the seat has no movement.

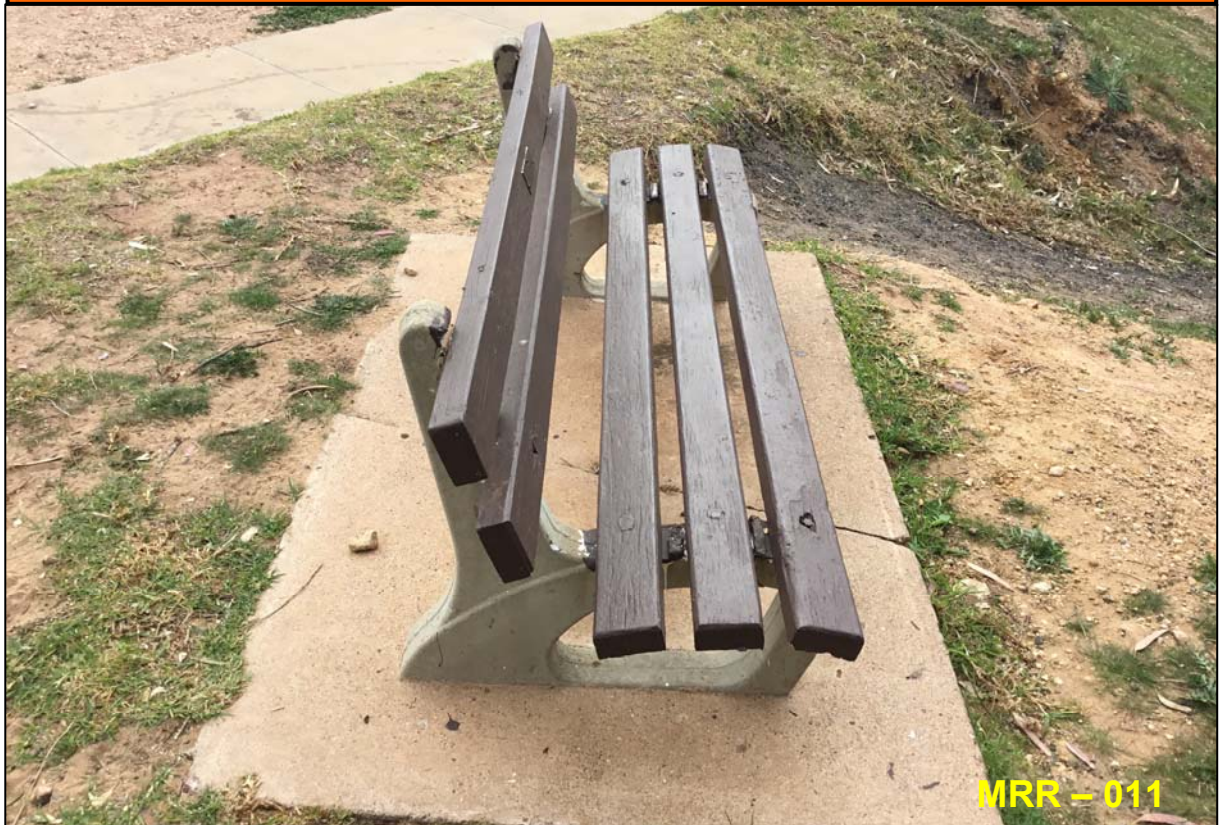
The planks on the seat are loose and will require a medium such as liquid nails to affix the planks back in their place.

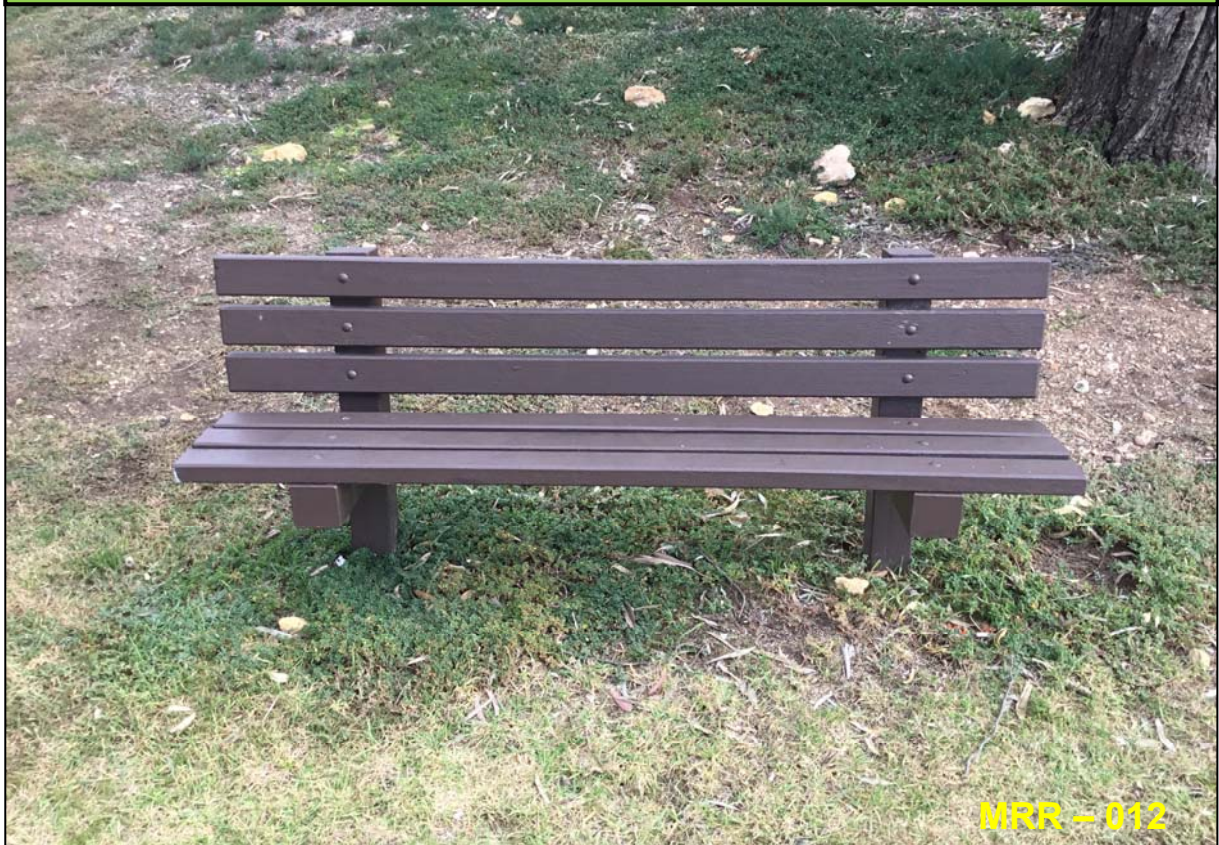
This park seat is in good condition, it has securely fixed seat and back boards with no movement

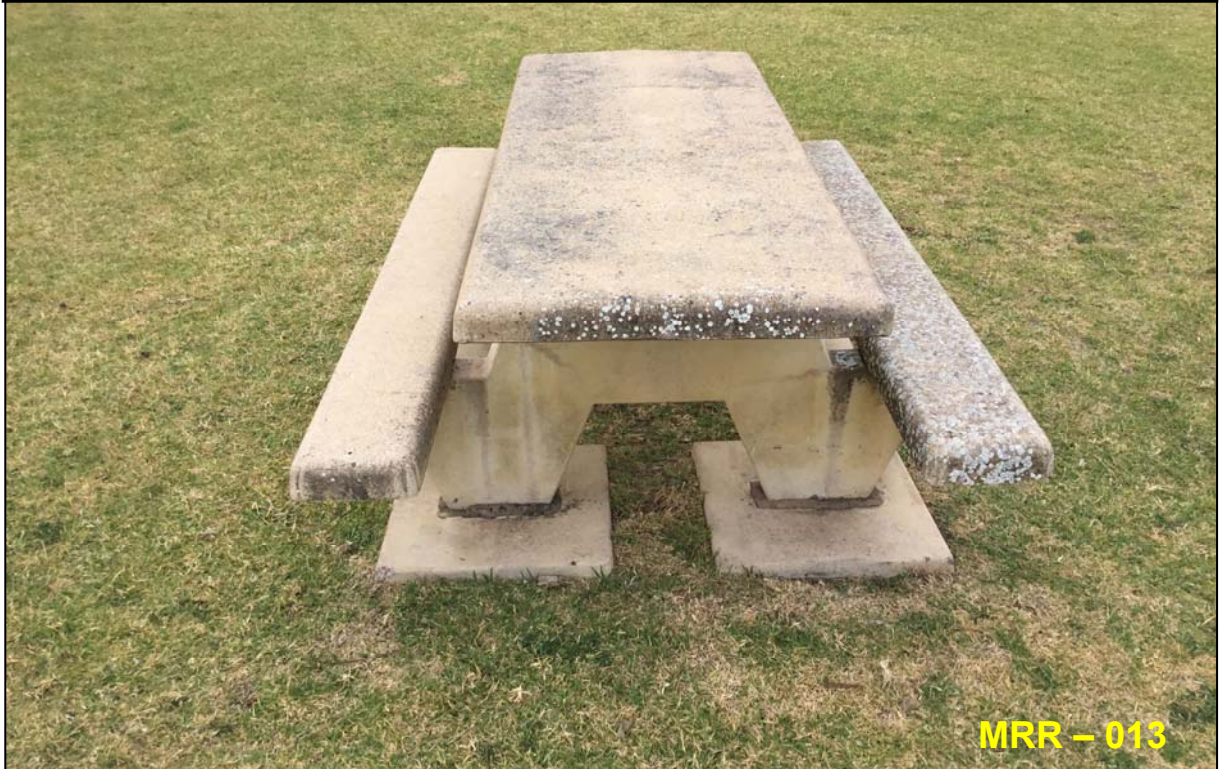
The seat on the town side is loose and will need to be re-fixed by liquid nails or silicon. The rest of the table and chairs are sound with no other movement within it.

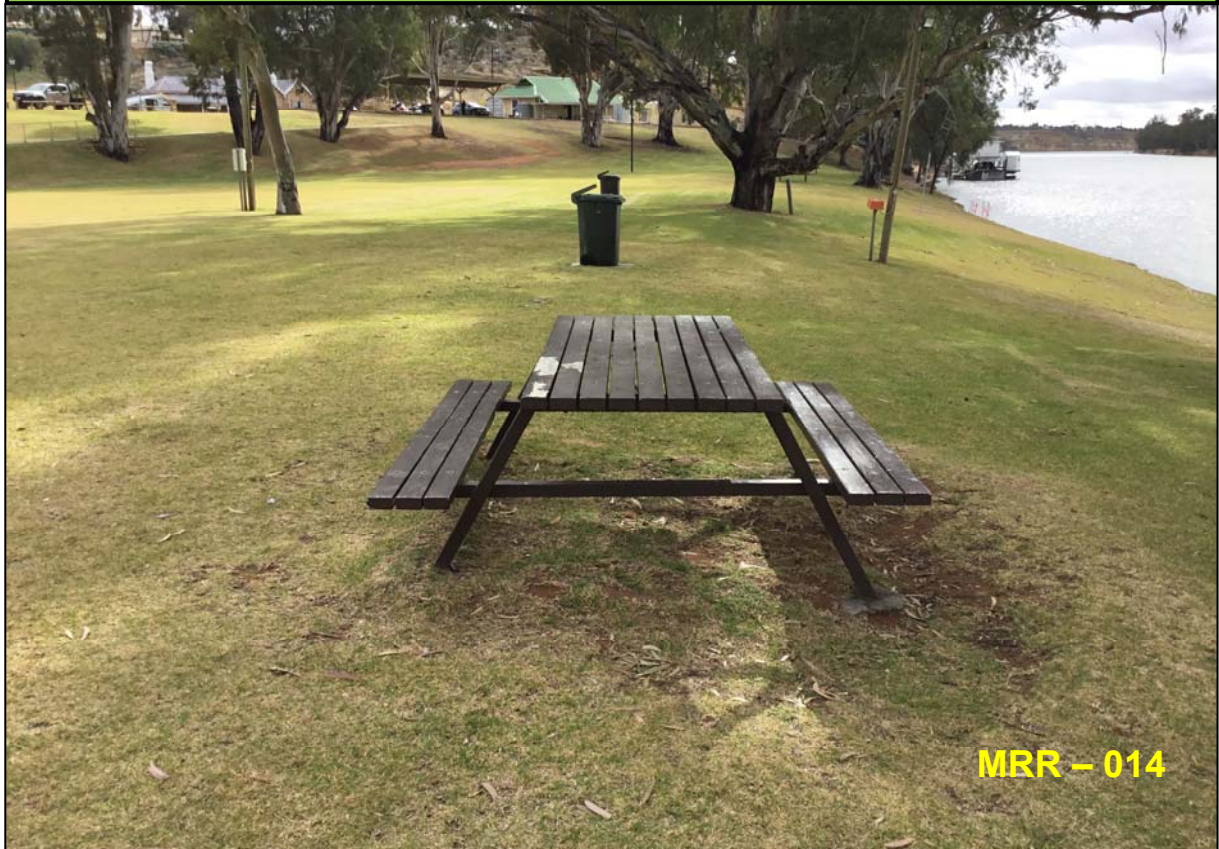
The bench seats and table are all sound with no areas of splintering and all boards are securely attached to the frame, the seat has no movement.
