JULY 25, 2020

## Playground Audit

# MORGAN RIVERFRONT RESERVE

MID MURRAY COUNCIL

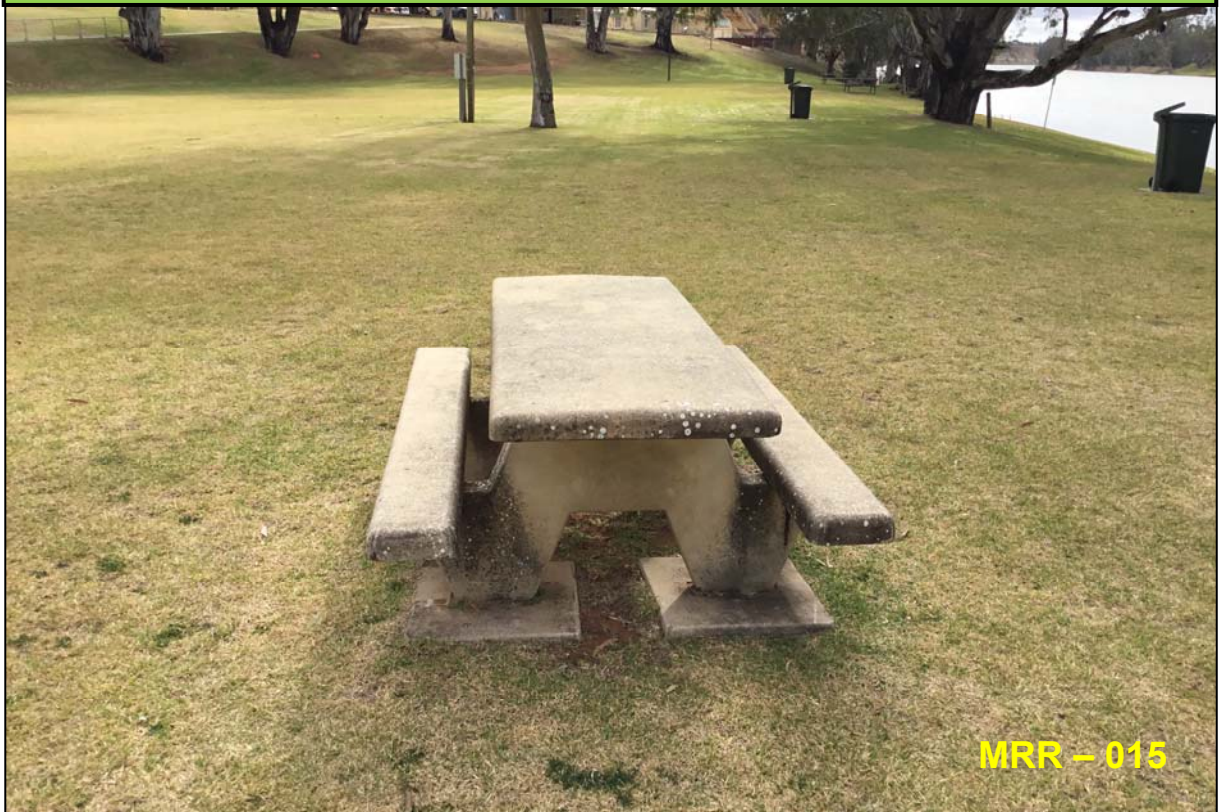
This seat is in good condition, it has no loose items and the concrete is in good condition

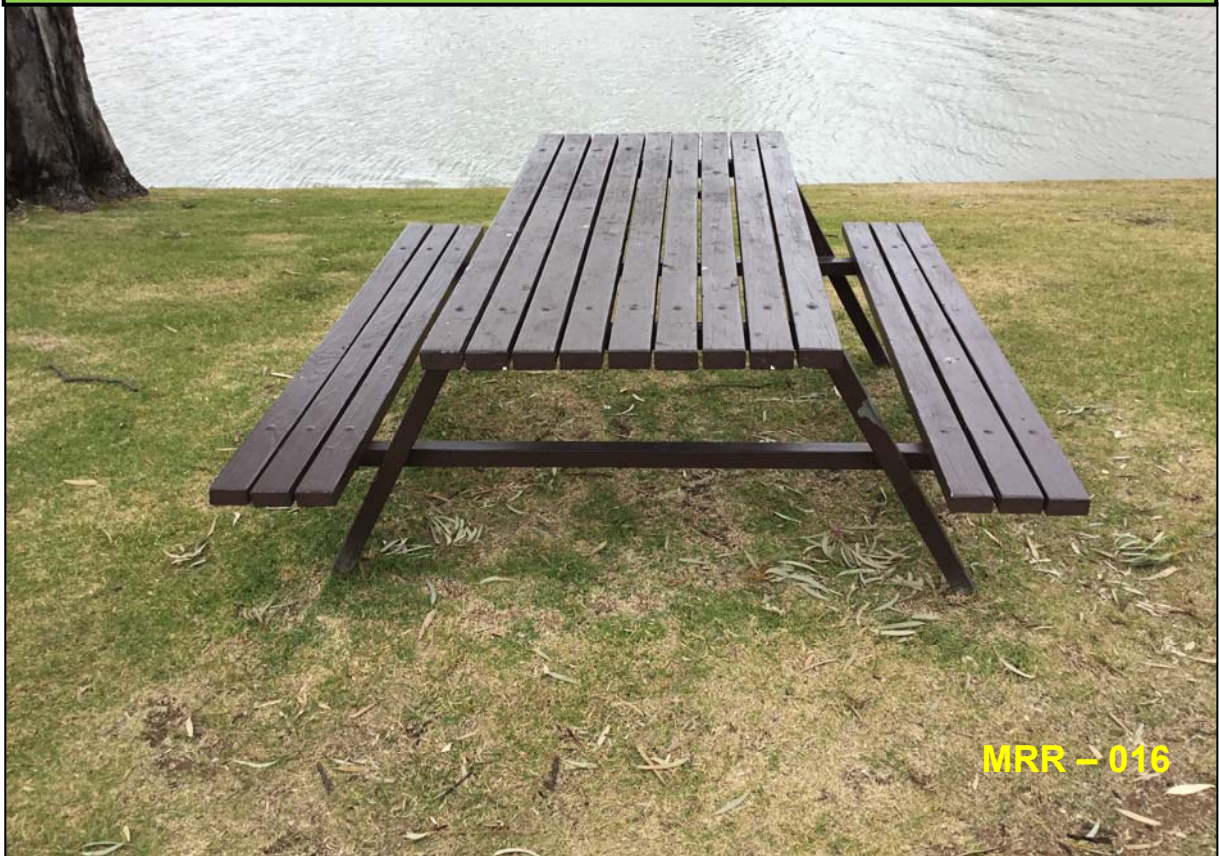
The bench seats and table are all sound with no areas of splintering and all boards are securely attached to the frame, the seat has no movement.

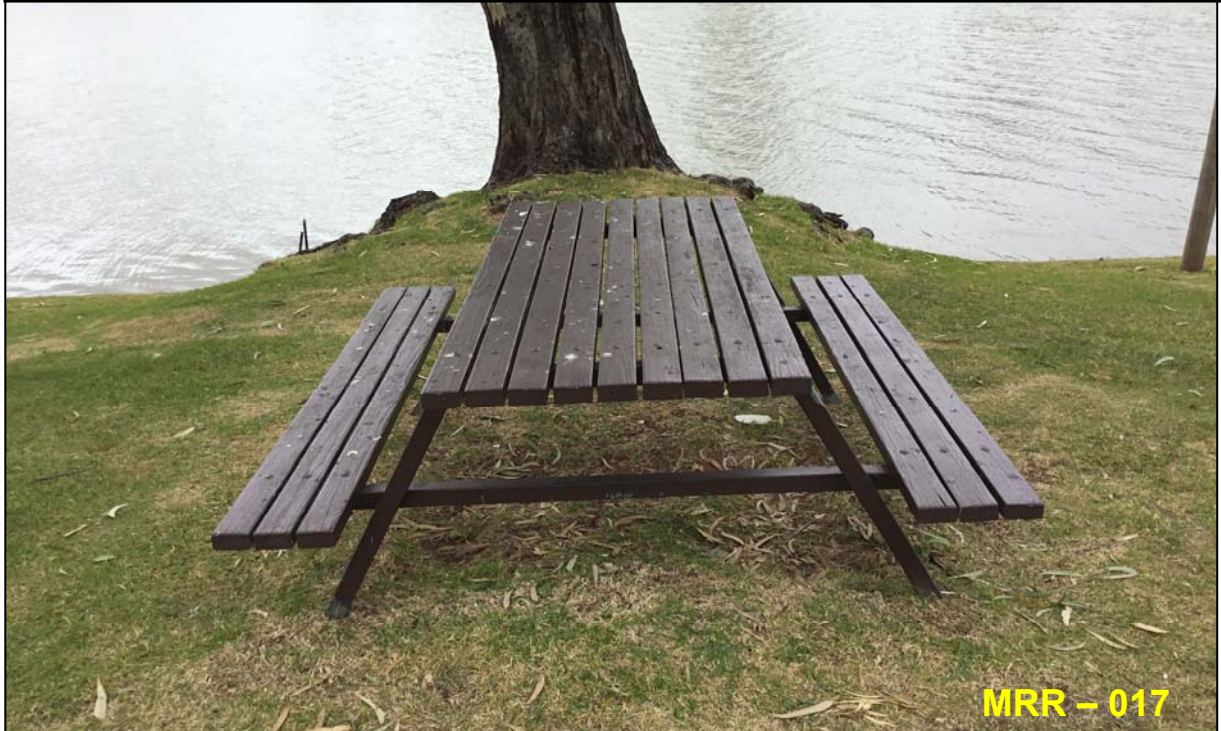
The bench seats and table are all sound with no areas of splintering and all boards are securely attached to the frame, the seat has no movement.
