OPEN SPACE SERVICES

JULY 25, 2020

Playground Audit CADELL TENNIS COURT PLAYGROUND

MID MURRAY COUNCIL

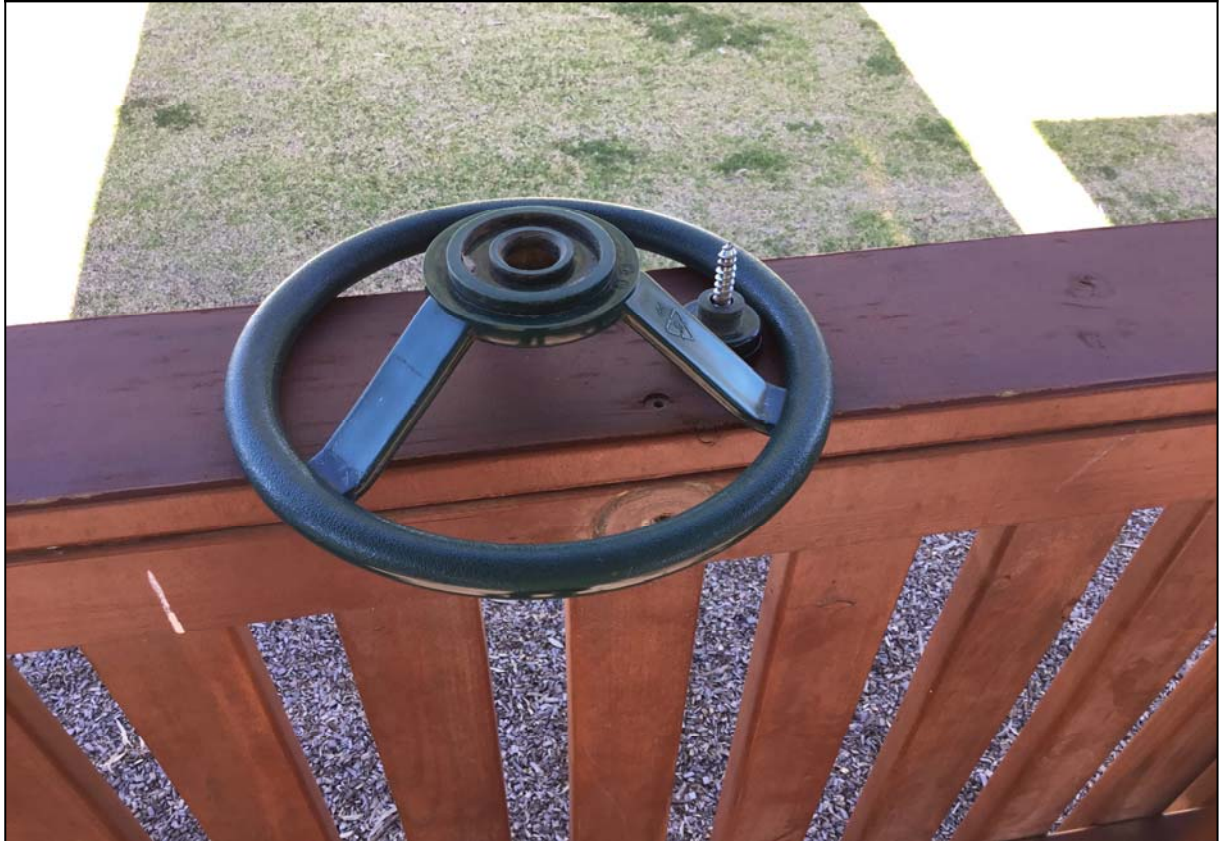
The searing wheel has come off and, the spacer is not the right size which has allowed the bolt come undone. This bolt should have been a bolt with a nut that went completely through and Loctite or nyloc nut to stop the nut from coming undone.

- Reinstall the steering wheel and use a bolt and nyloc nut **(Defect)**
- Reinstall Chain climb lower eye bolt with Nyloc nut and check top nut **(Defect)**
- Grind off all protruding threads under the swing bridge **(Defect)**

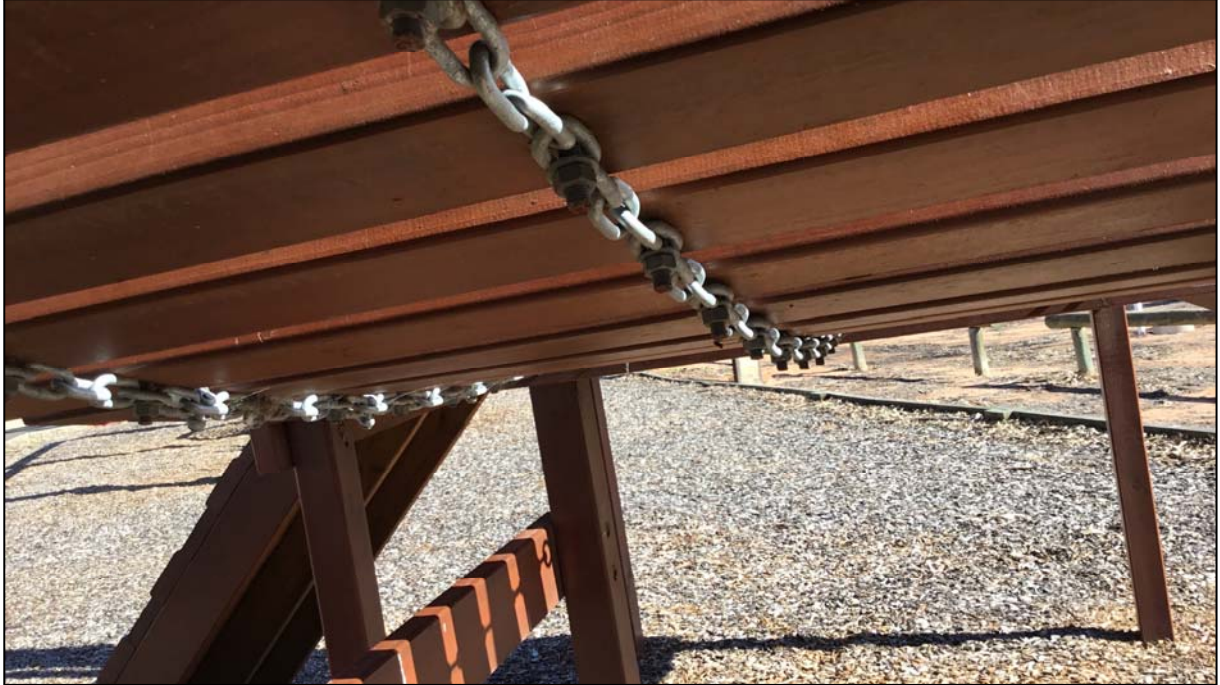
Any protrusions and sharp edges.	The bolt threads under the swing bridge will need to be ground back to the bolts.

Under the swing bridge the area is accessible especially for young kids of the same height of the under bridge. Under the bridge the bolts that are protruding through the planks and through the links of the chain have many areas of expose thread in these areas no thread is allowed to be exposed as they are sharp protrusions and will need to be ground back to the level of the bolt itself.

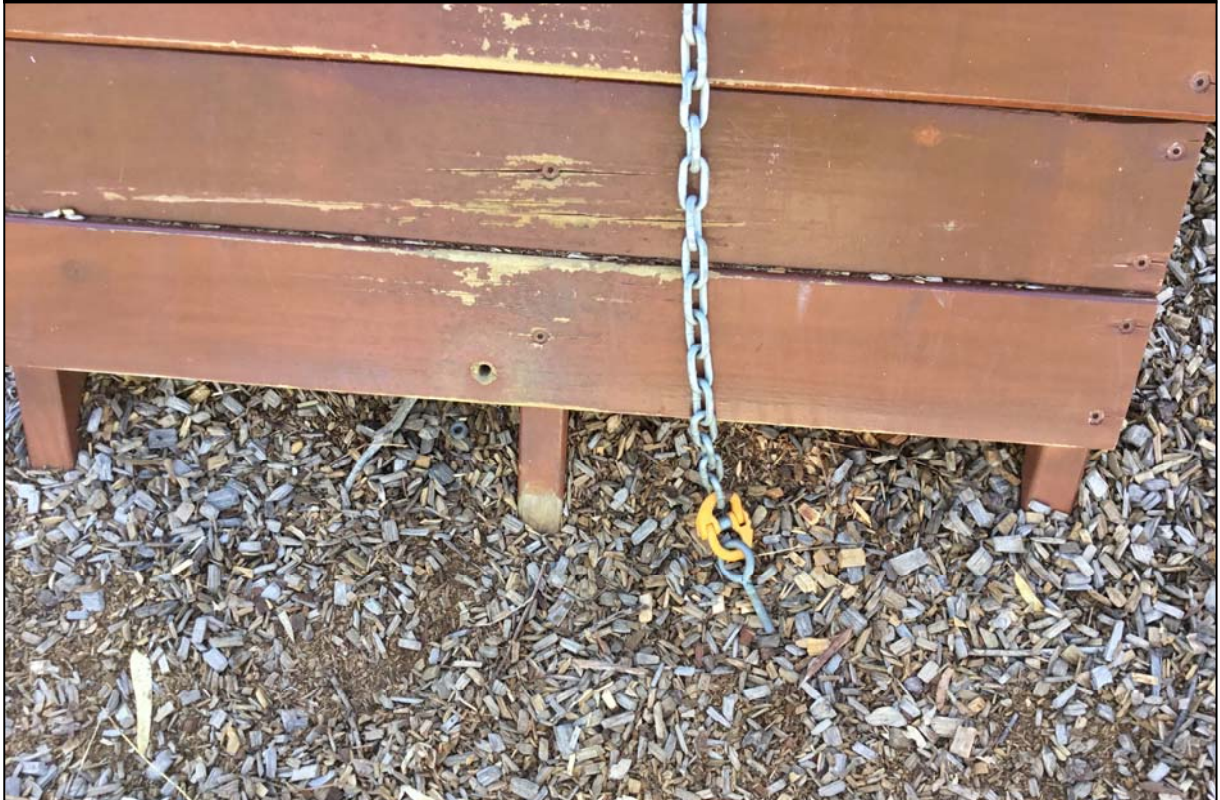
The chain climb has the lower eye bolt removed due to the nut coming off. This will require Loctite or a nyloc nut to keep it from loosening in the future.

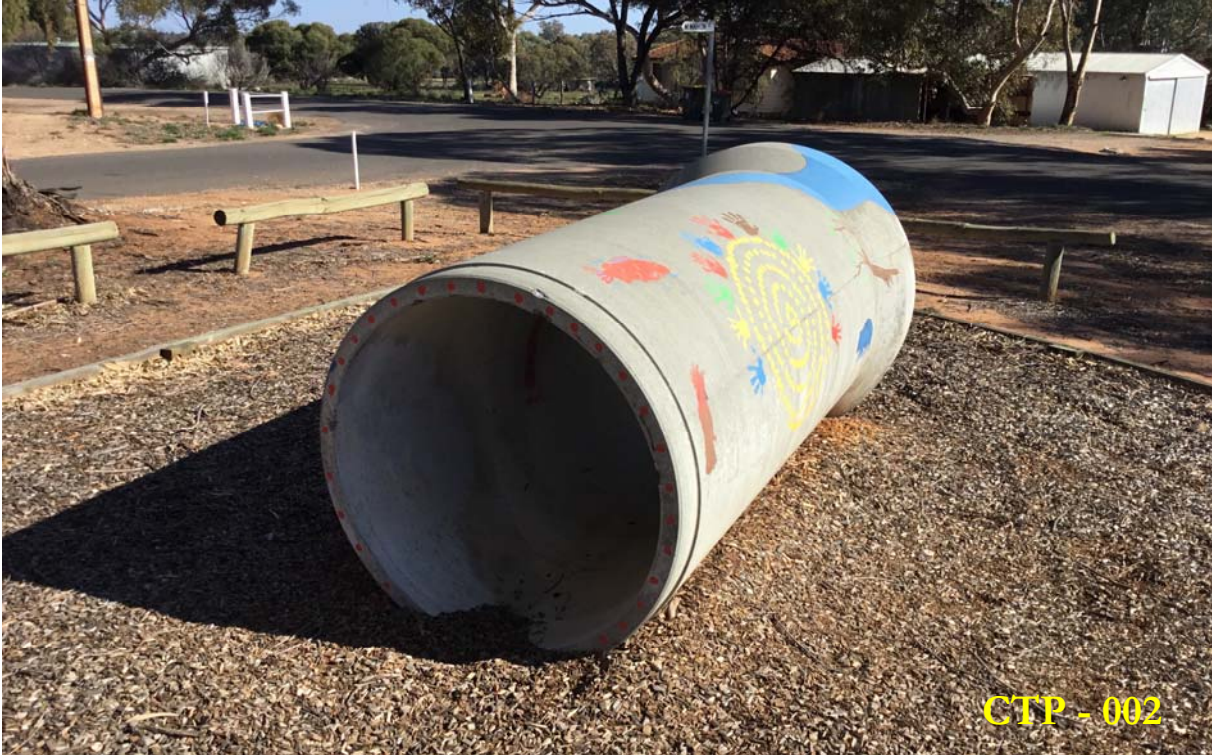
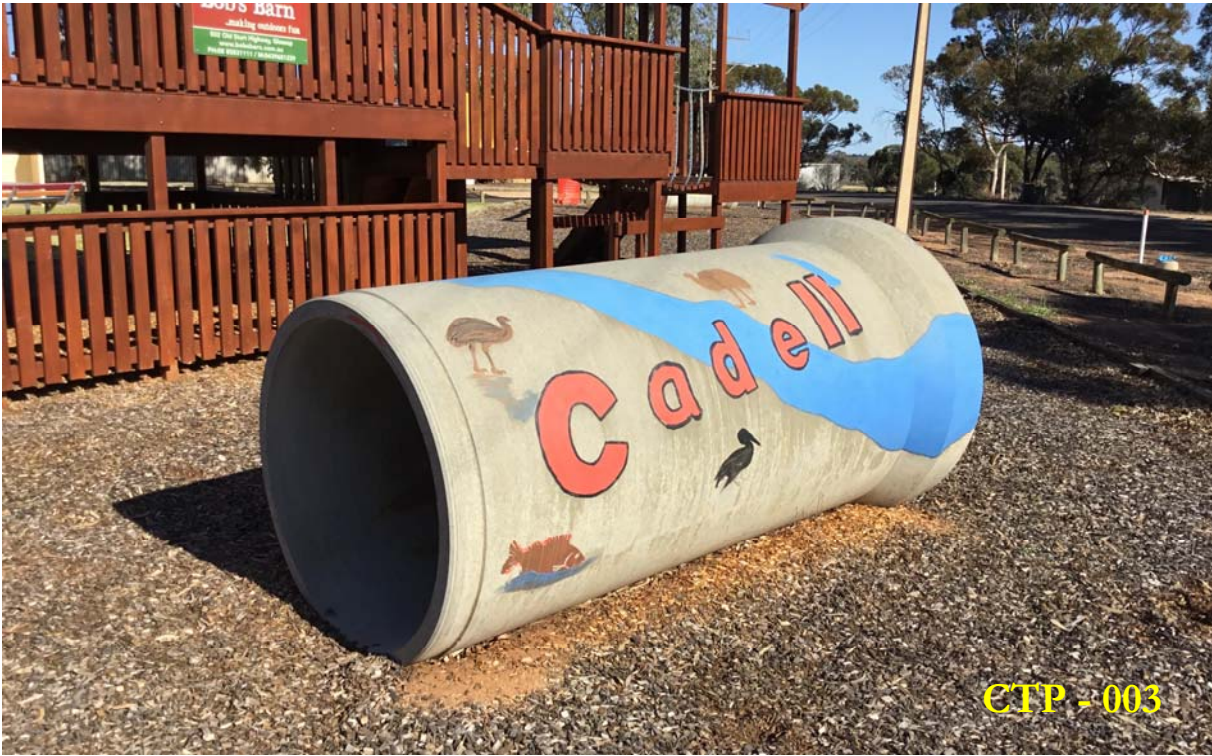
OPERATIONAL INSPECTION		
Play Equipment	Findings	Rating
Any protrusions and sharp edges.	Both ends of the pipe have sharp edges which will require rounding over.

Comments		
<p>These pipes are only quite new and its intended use was not as a play structure but as a stormwater movement facility item. The bell end has sharp edges which should be beveled, the female and has beveling on the larger bill however the in a still quite sharp and should Be beveled also. The structure is a sound within its area and its intended use is for walking through as there is no access to the top.</p>

- Bevel both sharp ends of the pipes **(Remedial)**

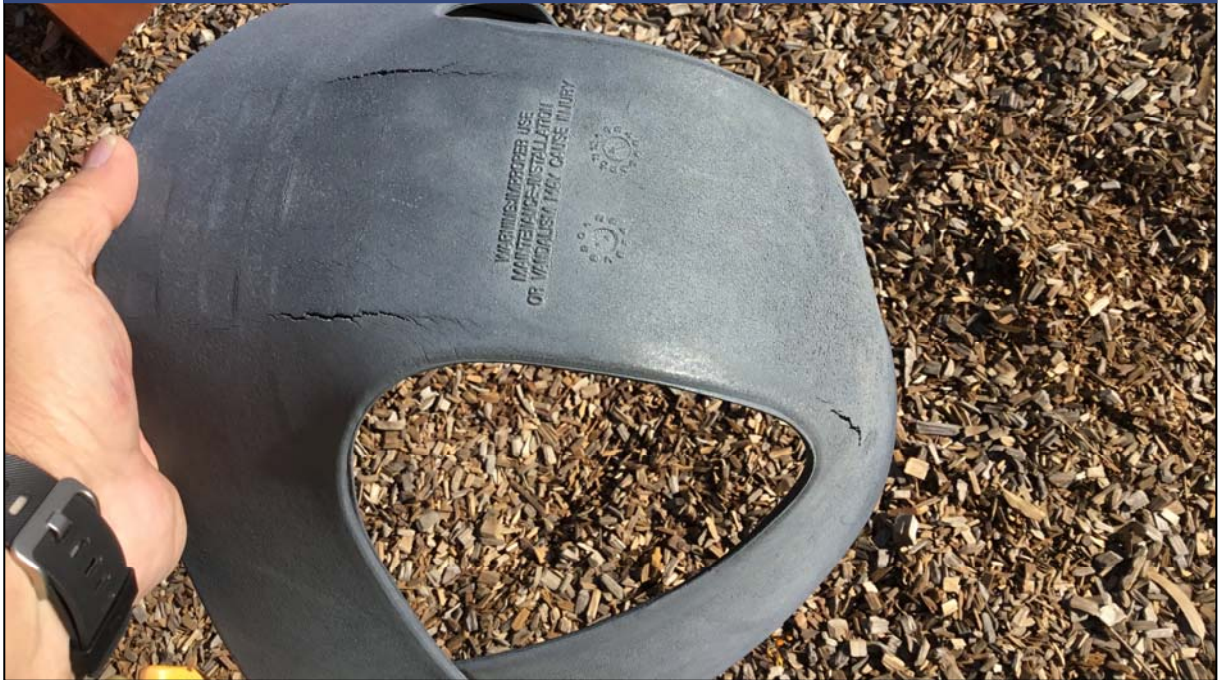
The net swing and the flat swing are in good condition and are only quite new. The baby seat which has cracking along the area of steel inserts will not last that long as once the cracking begins it will eventually tear out within this area, this will require replacement in a few month time.

- Replace baby seat within the next year. **(Remedial)**
- Works needed on exposed ends of uprights silicon and cap. **(Remedial)**

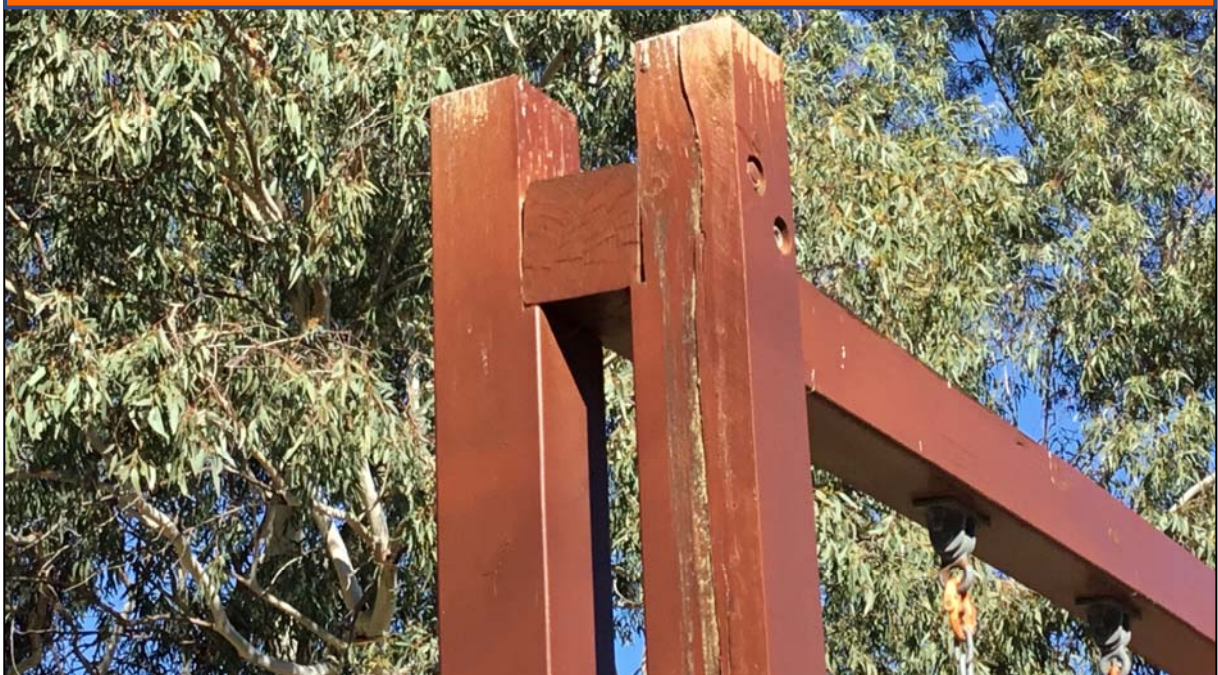
Foundations for exposed concrete, rot and corrosion.	The top of the uprights of the swing has deuteriation due to water infiltration and constant movement through wet and dry periods.	MEDIUM
Trees for potential hazards. NOTE: This may require the skills and competencies of a professional arborist.	No trees impact this item.	LOW
Are chain links or gap areas greater than 12mm or less than 8.6mm	All chains are within specification	LOW
Are all structural attachments affixed tightly to their respective anchor points and attachment points sound with no wear or pull out from fixture points?	All structural attachments are sound with no lose fasteners	LOW
Comments

At the top of the upright poles the ends have been left exposed to the weather this has started to cause the top of the polls to part within the grains and opening up causing rot and further splitting through constant wetting and drying expanding the cracks and allowing more water moisture and debris to infiltrate the woodgrain. In many cases this can be alleviated by ceiling the top usually with the silicon waterproof layer and then capping on top of that.

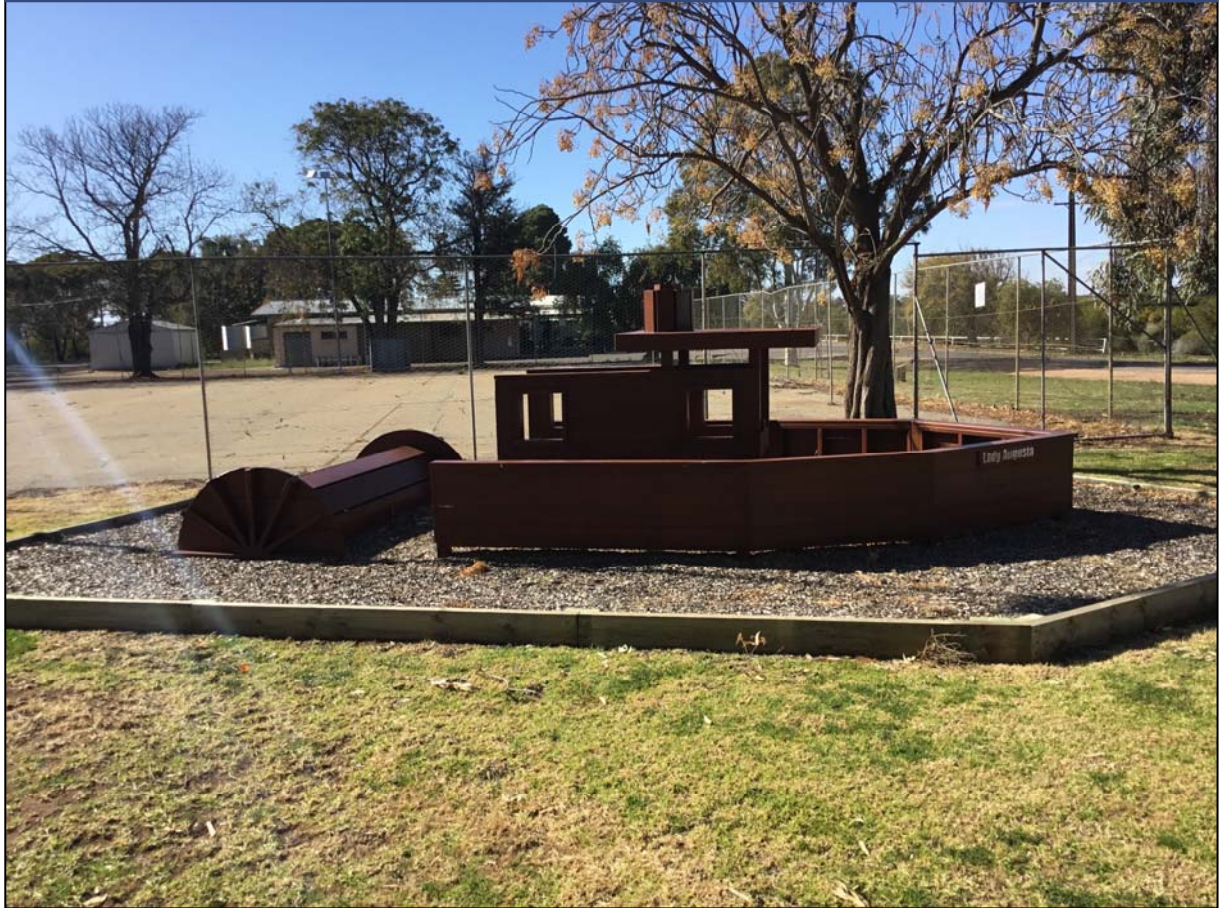
The structure is basically a non-climbing structure with the emphasis of being a role-play item. Being a non-climb item, it is in a current state of not being risk, the rear paddle wheel which can be easily climbed on is only 600 mm high and does not require softfall. None of this area requires softfall as it is not intended as a climbing structure.

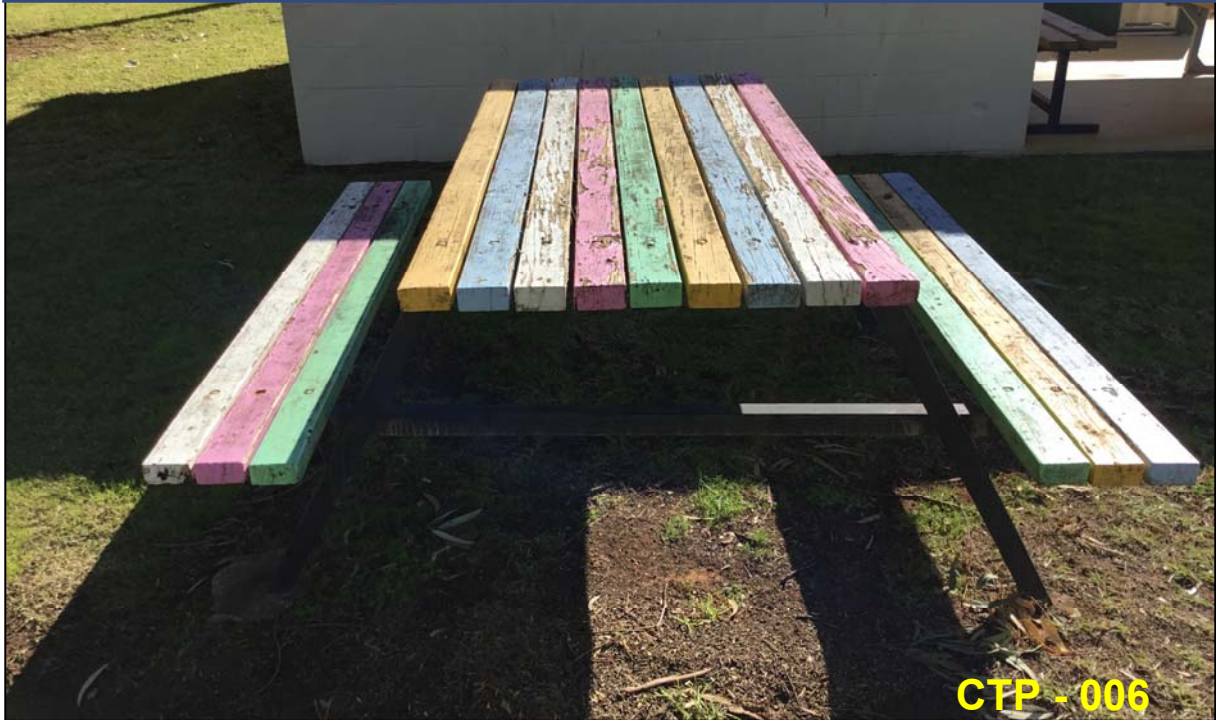
This bench table and seat have all slats securely fixed to the metal frame in the middle frame is securely concrete into the soil. The surface of the table is starting to peel and will require re-painting and if future.

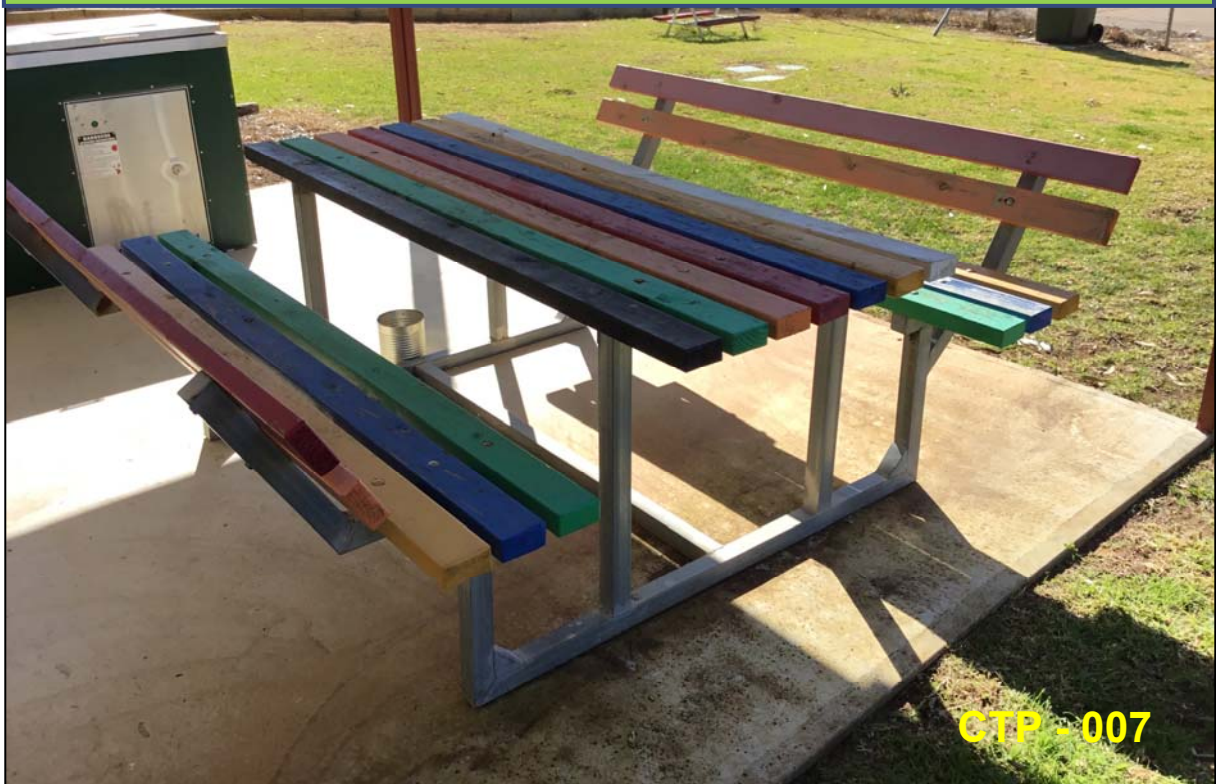
This table is not fixed to the concrete but all planks are fixed securely to the steel frame. This may be a movable item as it is light enough to move.

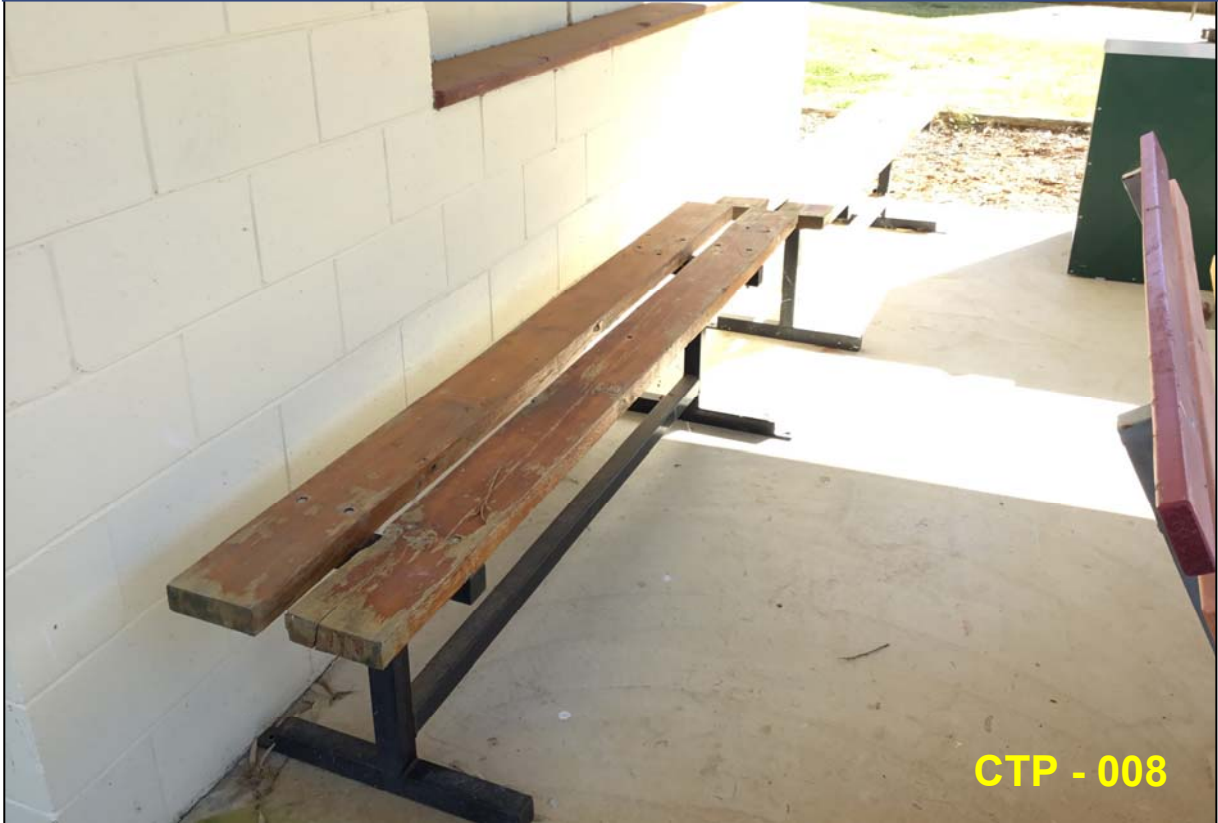
The two bench seats also look to be movable and may actually be part of the tennis court area. The planks are securely fixed to the steel frames and the wood is in fair condition

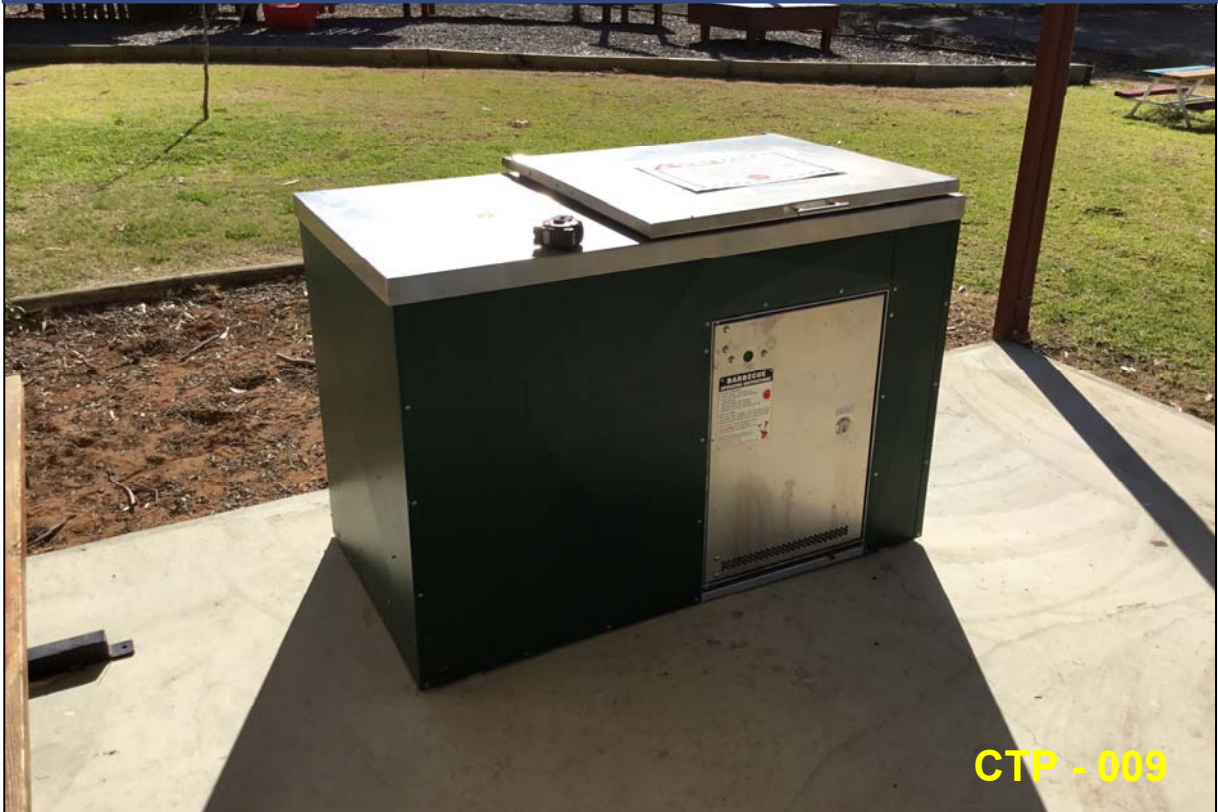
CTP - 008

The barbecue is currently non-functional due to COVID-19. However, the barbecue does look brand-new and does not have any protrusions or problems with the lid.

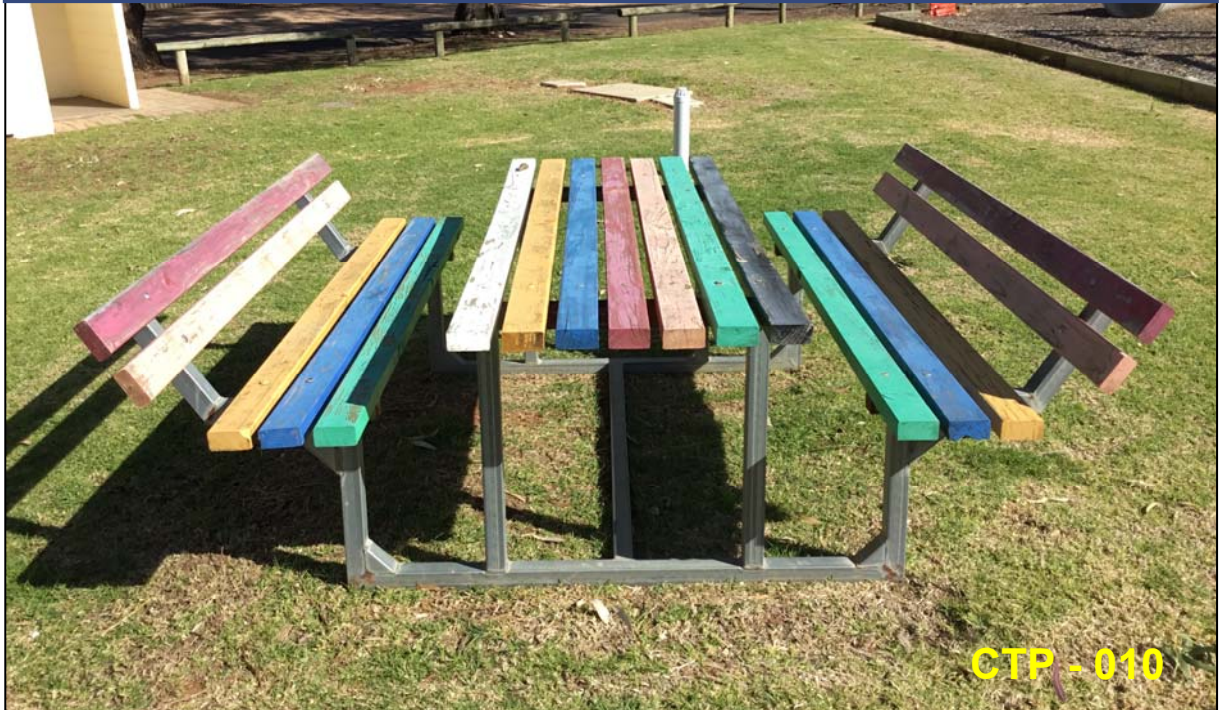
CTP - 009

This is another of the bench seats and tables, the slats are securely fixed to the steel frame, the item is movable and is not a fixed to the ground. The wood is in fair condition and in a few years' time will need to be repainted

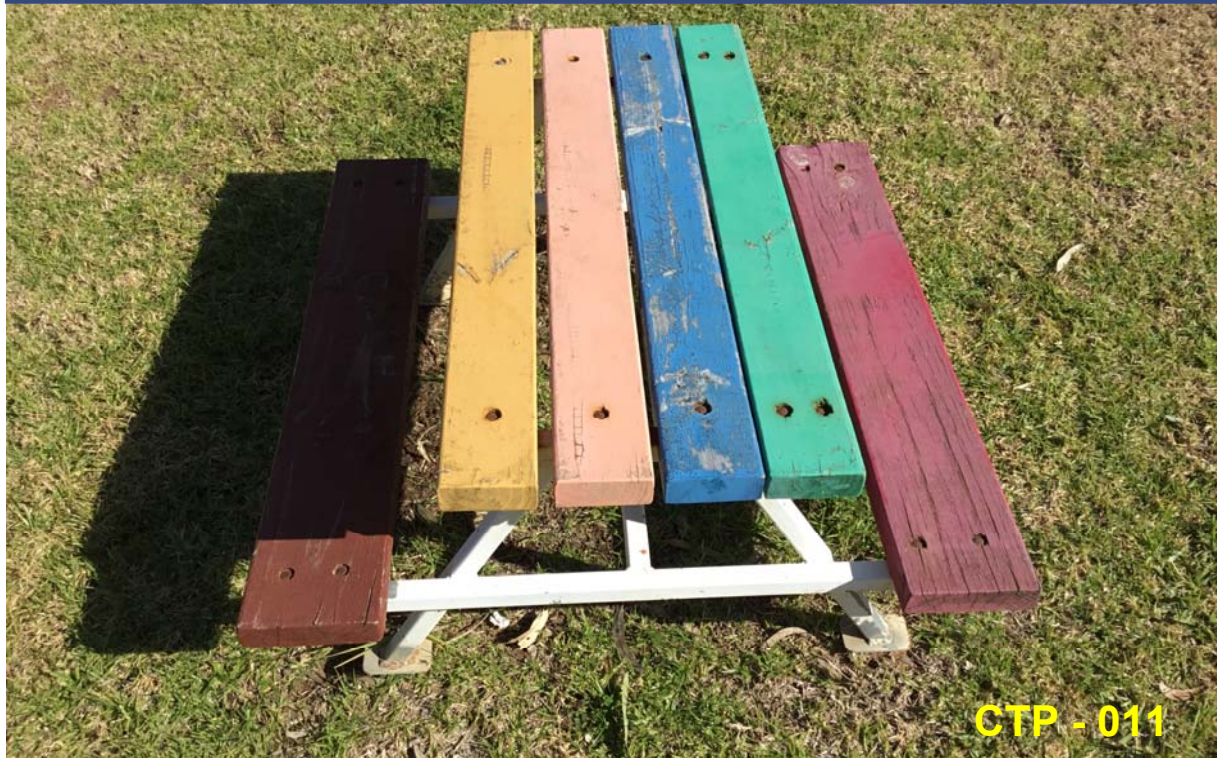
These movable kids bench seat is also movable and it's not securely fixed to the ground. The boards are securely affixed to the steel frame with no movement within the boards

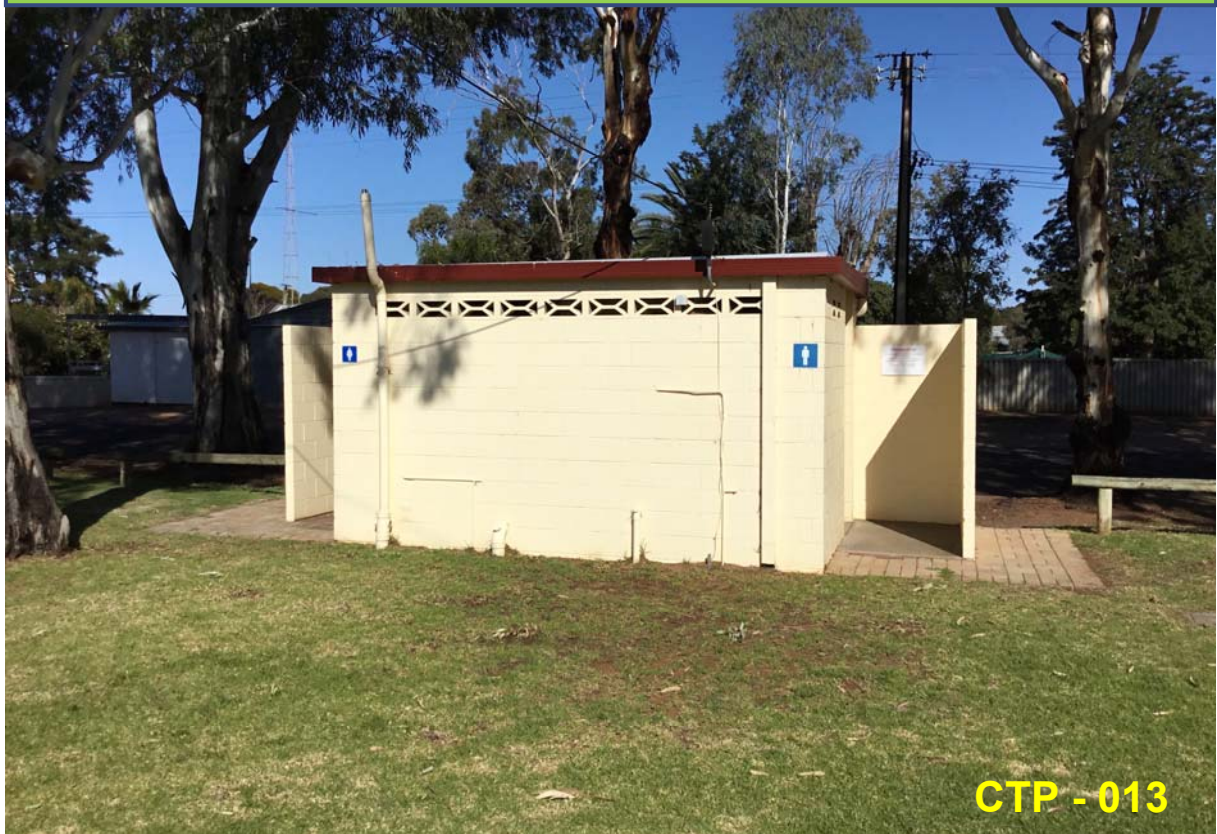
The toilets are all functioning properly and are in a safe so serviceable manner. The toilet roll holders and toilet paper all intact all toilets of flushable hand cleaner present and working taps.
