AUGUST 1, 2020

Playground Audit

GREENWAYS SPORTING GROUND

MID MURRAY COUNCIL

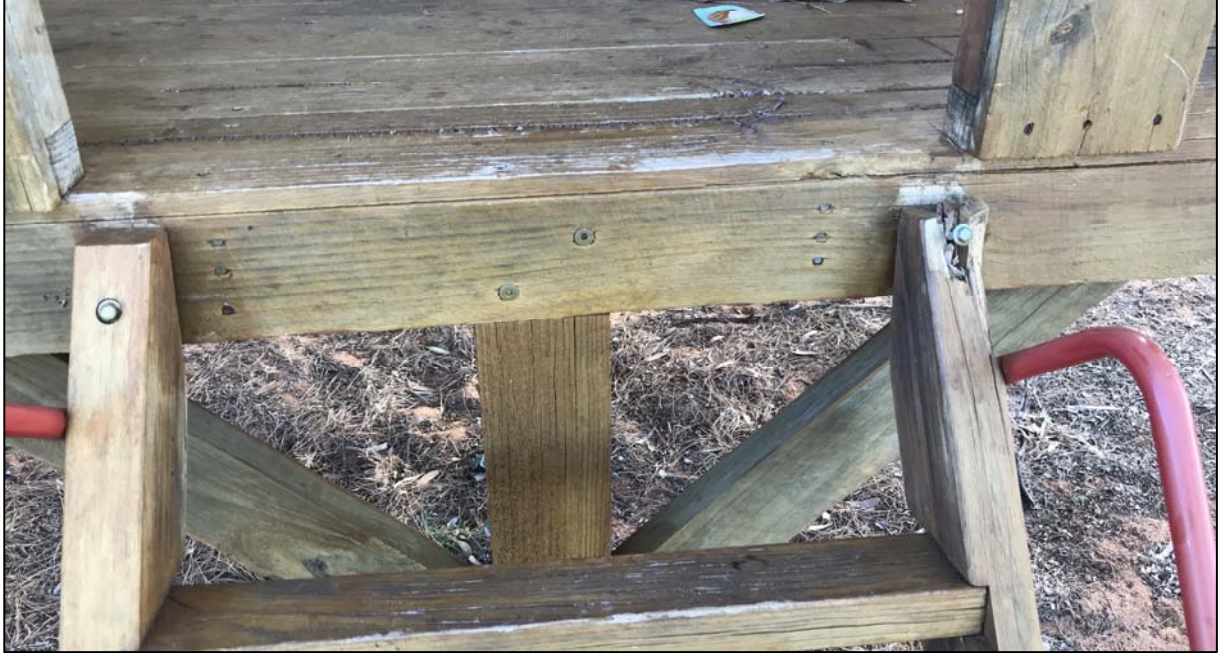
The interior is carpeted but there were no spiders and insects, the outer area is also still in good condition however the stairs have broken out at the top with one side being smashed up which will require fixing. The whole structure is bolted down onto concrete pads and no movement can be identified within the structure. The structure is greater than 600mm and will require 300mm of softfall, also as the stairs are greater than 600mm high, they will require hand rails that are compliant.

- Stair fixture need replacing (**Remedial**)
- Softfall required (**Remedial**)
- No hand rails on the stairs (**Defect**)
- Hang point in step gaps (**Defect**)

note I would recommend lowering the cubby house to 500mm, no softfall will be required and no railing will be required, once at 500mm the hang point

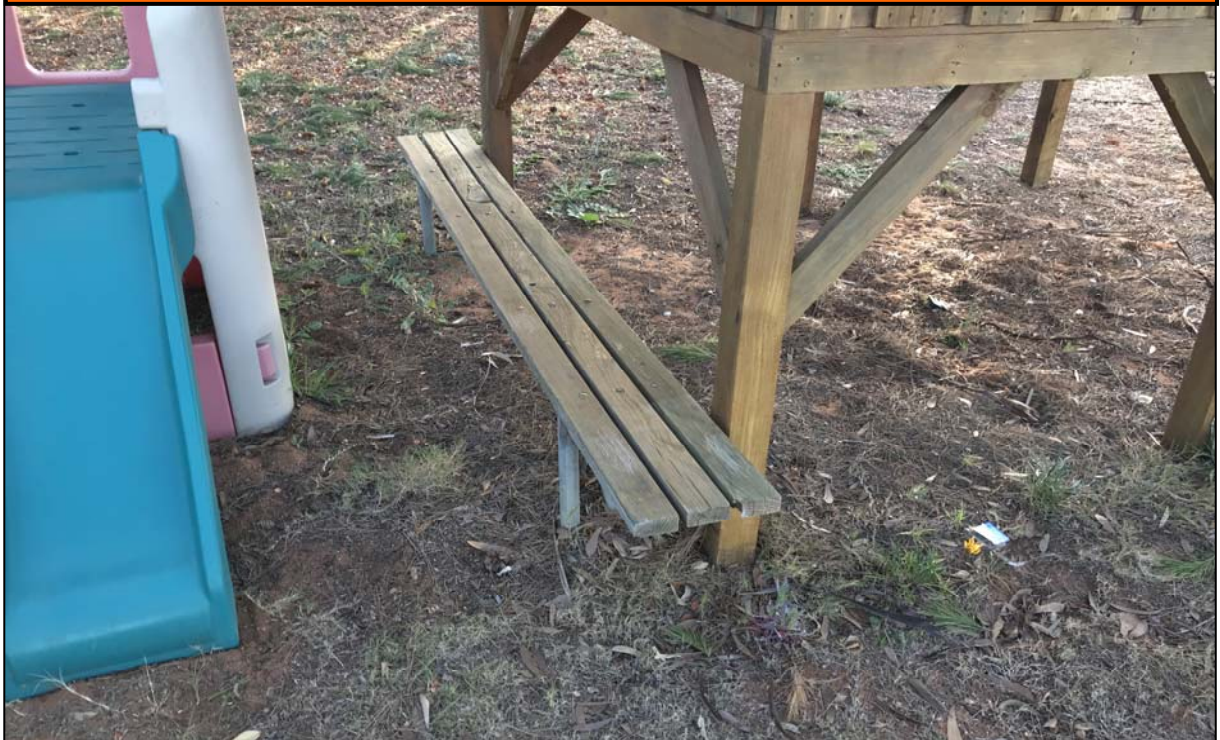
The bench seat along the side is not a permanent fixture. Not sure whether this is for kids or if it is just stored here. The seat is too close to the small activity play item.

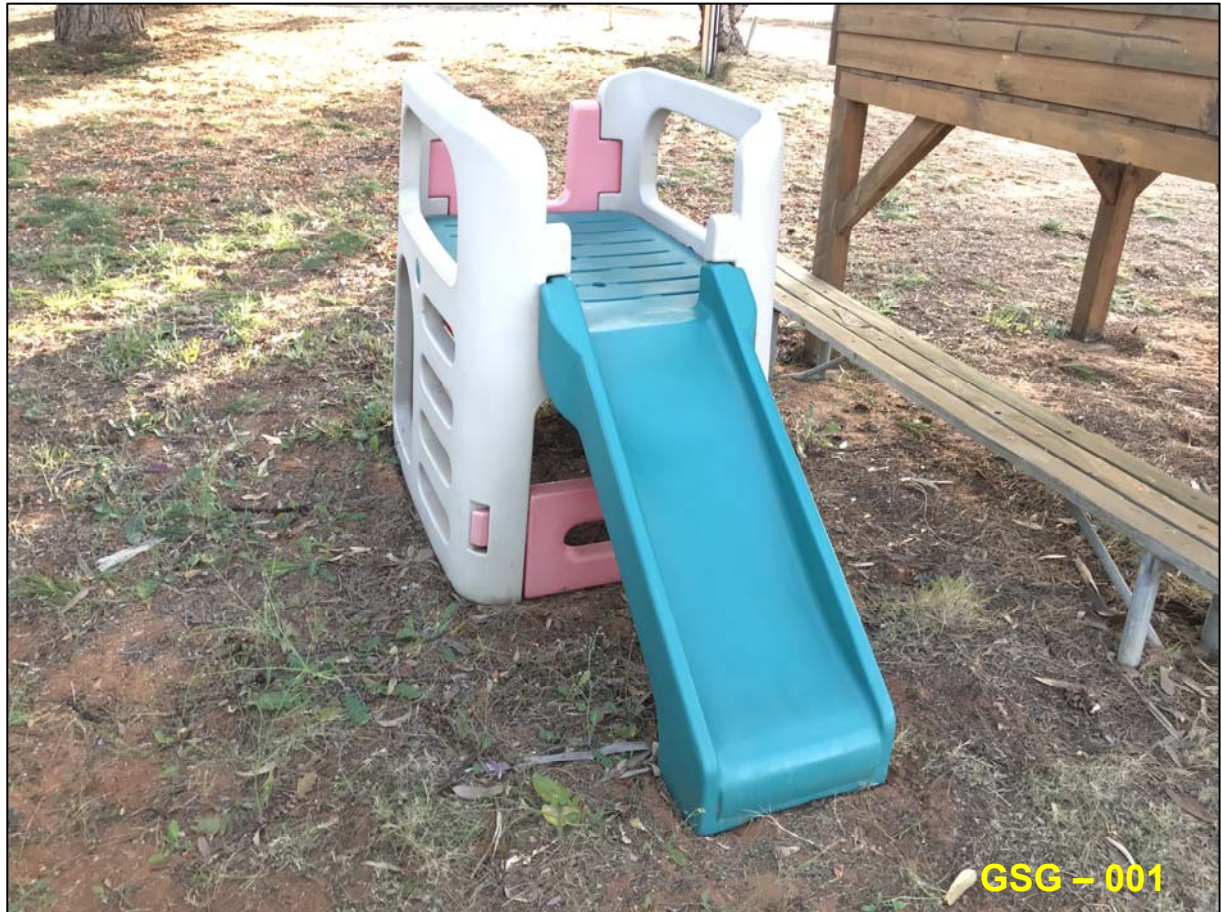
This small play item is a portable module but is over 600 mm in height which also requires softfall to a depth of 300 mm and the seat is too close, it will need to have 1.5 m clearance.

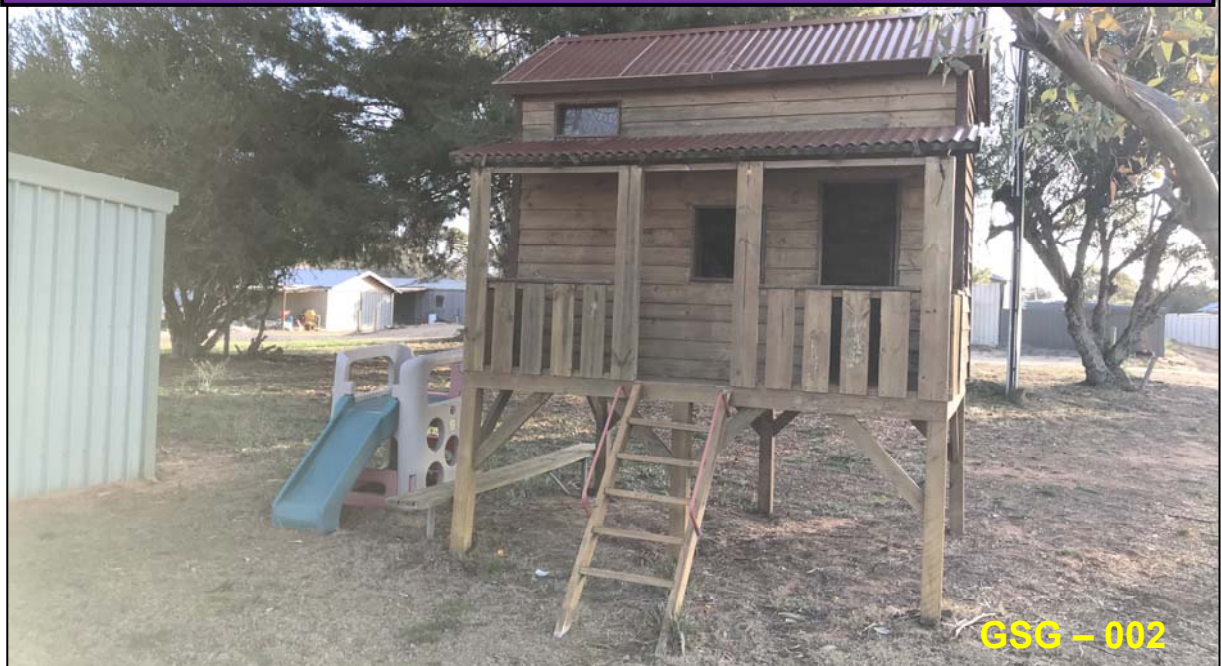
Both pieces of equipment have no sofffall, both are greater than 600mm from ground level and will require 300mm of sofffall and a free fall area of 1.5 metres all around, I am going to recommend that the uprights on the cubby be cut and the whole cubby gets lowered to 500mm from ground level

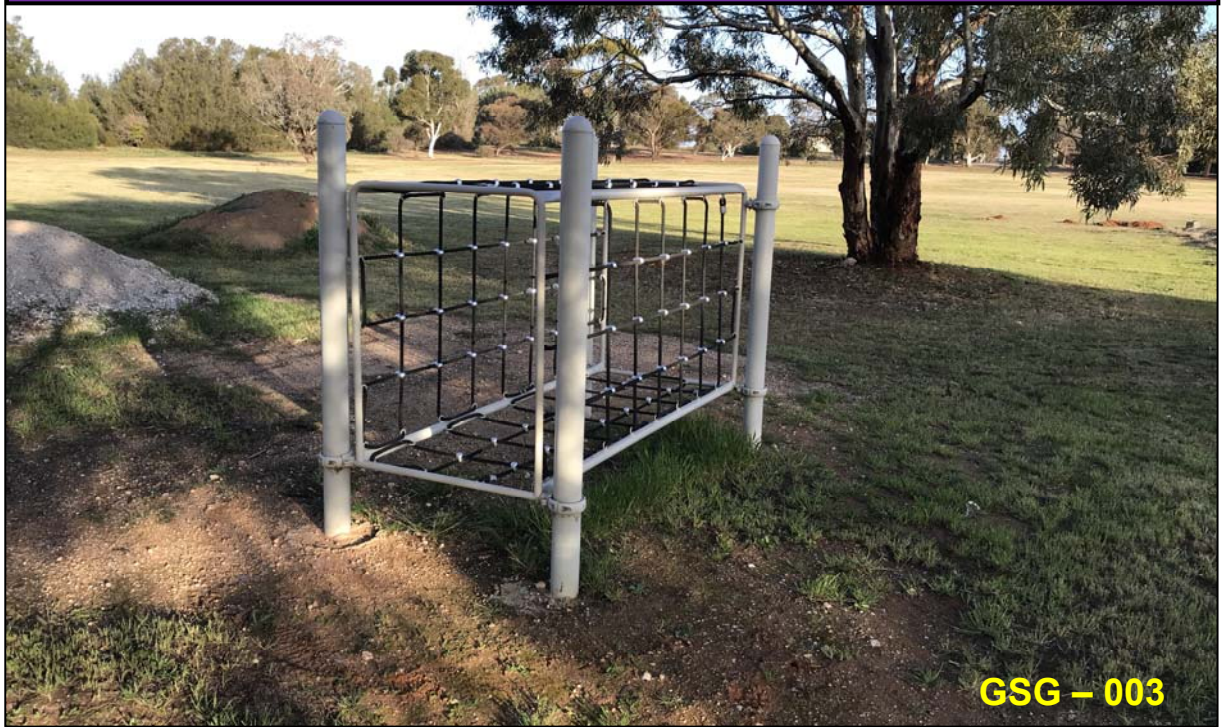
This piece of equipment is like new and has no wear has no softfall, its 1550mm from ground level and will require 300mm of softfall and a free fall area of 1.5 metres all around.

- Softfall required (**Remedial**)

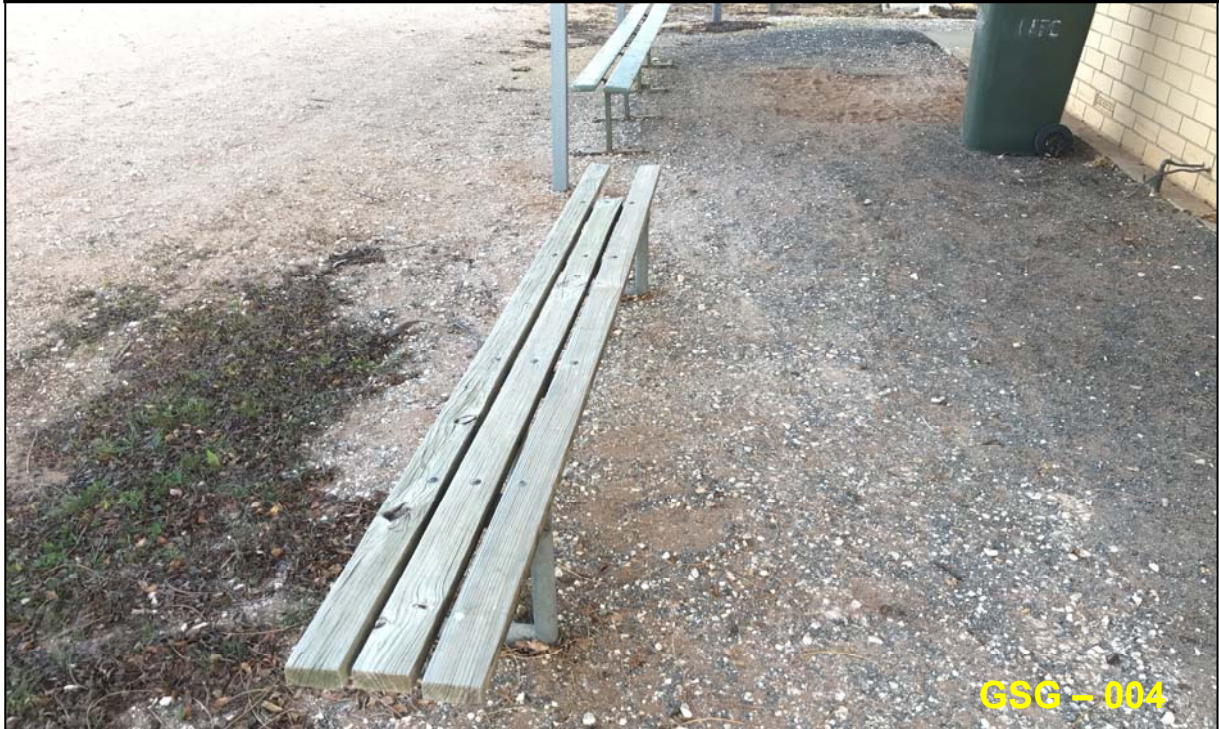
The two bench seats in front of the club rooms are free standing with solid frame and wooden plank top, one of the seats has a broken middle plank on one end, the plank will need replacing.

- Middle broken plank needs replacing (**Remedial**)
