JULY 26, 2020

CAMBRAI OS & P PARK

MID MURRAY COUNCIL

Playground Audit

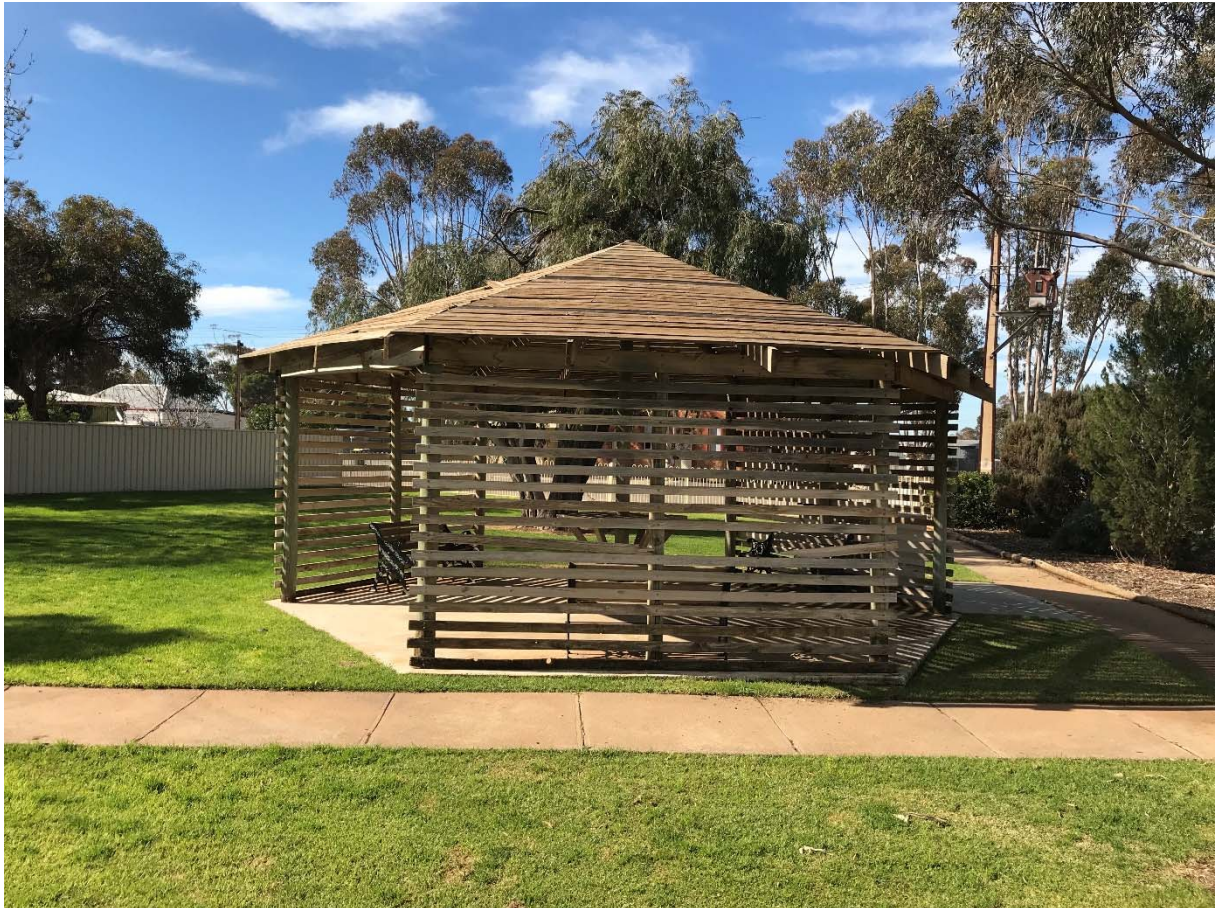
Equipment Number: CPP-1

OPERATIONAL INSPECTION		
Play Equipment	Findings	Rating
Excessive wear of moving parts (including chain links).	No moving parts	LOW
Any protrusions and sharp edges.	No sharp edges or protrusions were found.	LOW
Are all bolts and fasteners secure?	The lid of the BBQ has been bent and will require new rivets.	MEDIUM
Are there any entrapments, hang points or catch points on any of the equipment?	No hang points or entrapment was found.	LOW
The structural adequacy and/or stability of all playground equipment including ancillary items. NOTE: Equipment that relies on a single anchor or attachment point should be carefully inspected.	The structural stability is acceptable on the item.	LOW
Excessive corrosion, particularly within structural members.	No corrosion was found on the equipment.	LOW
Impact and attenuating edges of swing seats, pommels and other moving equipment that can impact users.	All edges were as designed with no areas of concern.	LOW

Trees for potential hazards. NOTE: This may require the skills and competencies of a professional arborist.	No trees impact this area.	LOW
Are chain links or gap areas greater than 12mm or less than 8.6mm	No chains on this piece of equipment.	LOW
Are all structural attachments affixed tightly to their respective anchor points and attachment points sound with no wear or pull out from fixture points?	One board is broken and will require replacement.	MEDIUM
Comments

The three bench seats located inside the gazebo are all sound with no loose boards and are securely affixed to the concrete. There's not a lot of corrosion a little bit of surface rust but nothing that requires attention at this time. The central table is secured with no areas of movement within the planks. The planks around the walls of the gazebo all look to be secured soundly except one board facing the main road that has been broken and has a section missing. Overall, the gazebo is in good condition and does not pose a risk within this playground area.

- Replace one broken plank facing the road **Remedial**

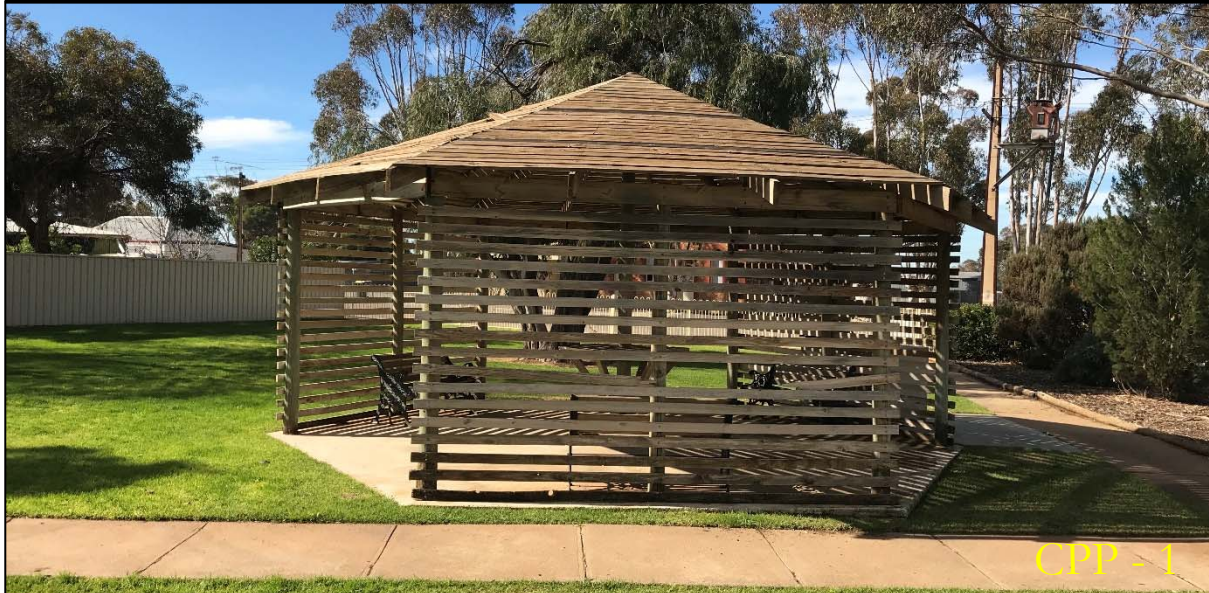
The barbecue looks quite new and does not have any damage within the hour to cover, the holder for the lid has been damaged where it looks like it's been pulled down without being released properly and the pop rivet has almost been pulled out. This is only a minor problem and has most likely been picked up in audits before me anyway. The Barbecue is functional and starts and heat up straight away.

- Lid hinge on the BBQ has been damaged and needs riveting. **Remedial**

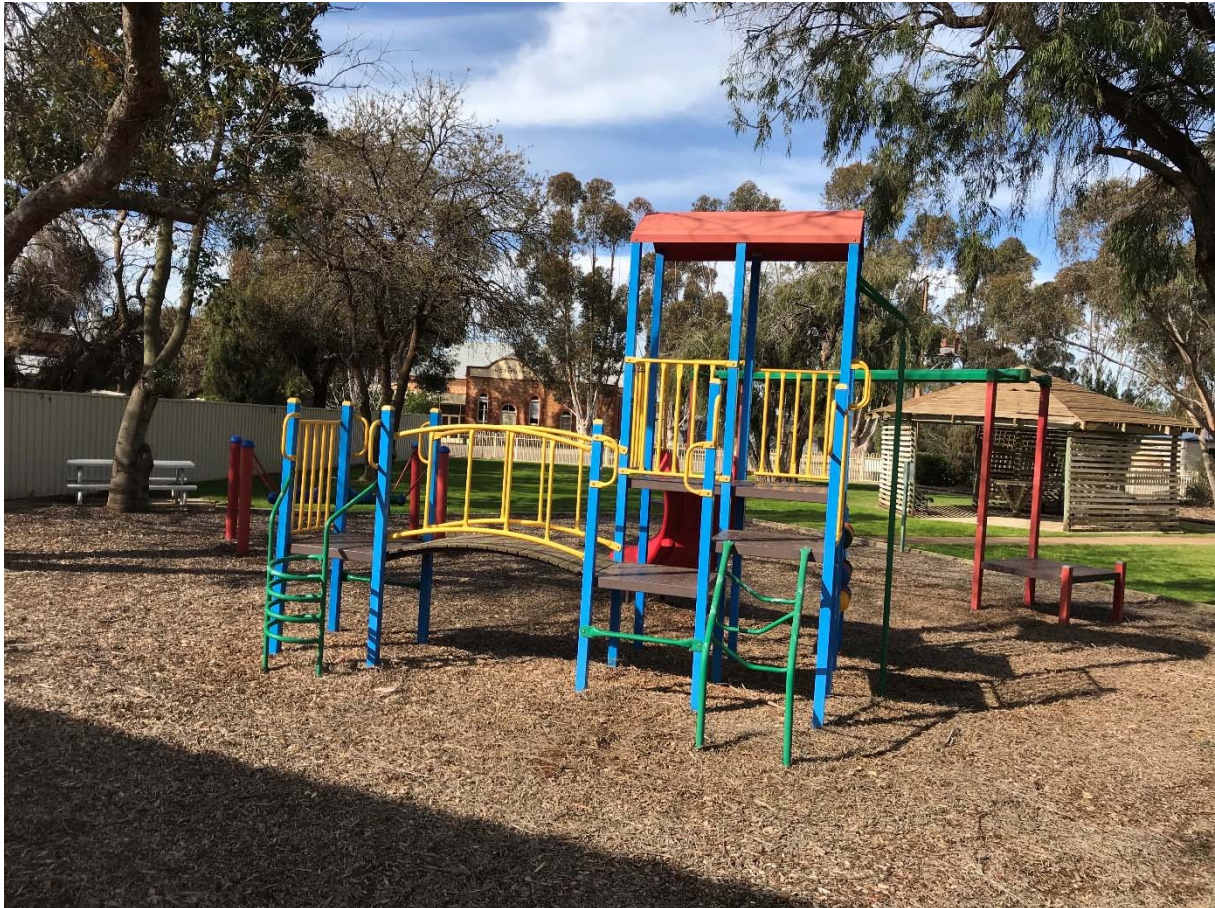
Equipment Number: GPP-3

OPERATIONAL INSPECTION		
Play Equipment	Findings	Rating
Excessive wear of moving parts (including chain links).	Minor wear on the platforms with some surface rust	MEDIUM
Any protrusions and sharp edges.	No sharp edges or protrusions were found.	LOW
Are there any entrapments, hang points or catch points on any of the equipment?	Hang points were found due to the main play structure being of the old standard, replacement will be required when needed.	LOW
The structural adequacy and/or stability of all playground equipment including ancillary items. NOTE: Equipment that relies on a single anchor or attachment point should be carefully inspected.	All uprights were sound and had no movements.	LOW
Excessive corrosion, particularly within structural members.	There are several areas of rust which will need attention, the flying fox will require treatment to slow the progression of rust.	MEDIUM
Impact and attenuating edges of swing seats, pommels and other moving equipment that can impact users.	All edges were as designed with no areas of concern.	LOW

Foundations for exposed concrete, rot and corrosion.	No exposed concrete was found and no base corrosion was identified.	LOW
Trees for potential hazards. NOTE: This may require the skills and competencies of a professional arborist.	No trees impact this area.	LOW
Are chain links or gap areas greater than 12mm or less than 8.6mm	No chains on this item of equipment	LOW
Are all structural attachments affixed tightly to their respective anchor points and attachment points sound with no wear or pull out from fixture points	The grab handles on the main play equipment at one end are loose and will require tightening.	MEDIUM
Comments

The overall condition of this piece of equipment is quite good it does not look like there has been much use as there is low wear within all of the components. The boards on the bridge are all sound and affixed to the railing, there is very little markings on the platforms and all fixtures are firmly adhered to the Main frame. The slide has areas of toggle catchment creating hanging points between the blue upright beams the platform on both sides, this is part of the design before it was recognised that the toggles were a problem. The railing has proper closure within the centre's however the end rail of each end is considered a hang point as the gap is too wide and allows for the torso probe to be passed through but not the little head probe. This is on all the square yellow barriers and not me yellow bridge barrier. The grab handles are also two wide but they are small and it would be very difficult for a young child to get up onto them and actually pass through the grab rail's however it is a non-compliant issue, some of the end grab handles near the council office will need tightening, most of the others will not require tightening. The soffall areas around this piece of equipment are between 50 and 200 mm the area at the run out of the slide is too shallow and will need to be bought up at least 200 mm to get the 300 mm regulated height. The uprights around this area do you not show areas of flake rust and the powder coat is solid down to the concrete face

- Loose handrails on one end needs tightening **Remedial**
- This equipment is not to current AS specification but is in good condition, replace when needed.
- Softfall needs to be topped up, too low in places. **Remedial**

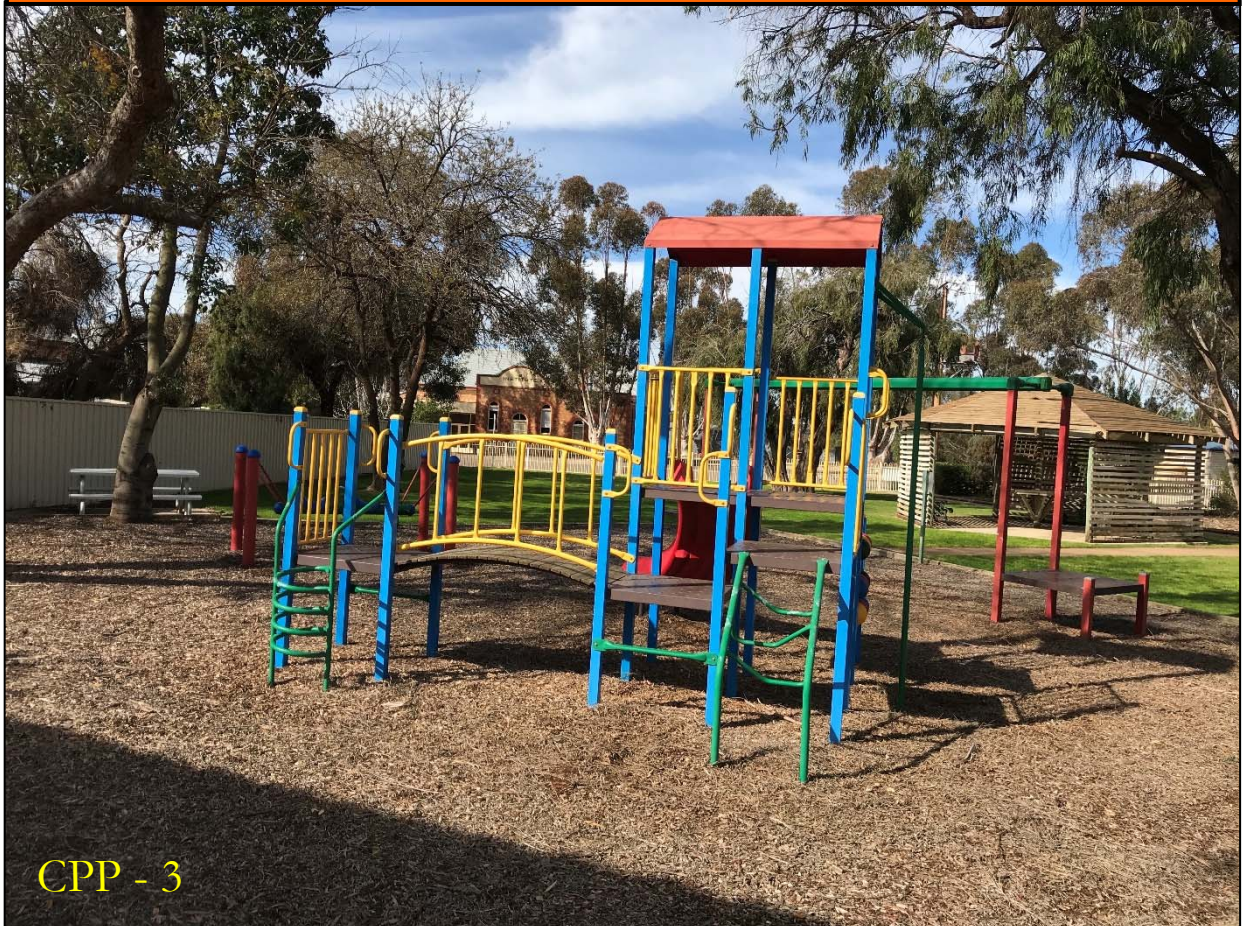
CPP - 3

Some flake rust is starting to occur in the uprights, the handle is missing plastic but overall is still in good condition, the running gear is in good condition, the platforms have surface rust and should be painted.

- Flake rust in main uprights, treat with kill rust to slow the rusting **Remedial**
- Surface rust on platforms, treatment needed to slow the rusting **Remedial**
- Softfall needs to be topped up, too low in places. **Remedial**

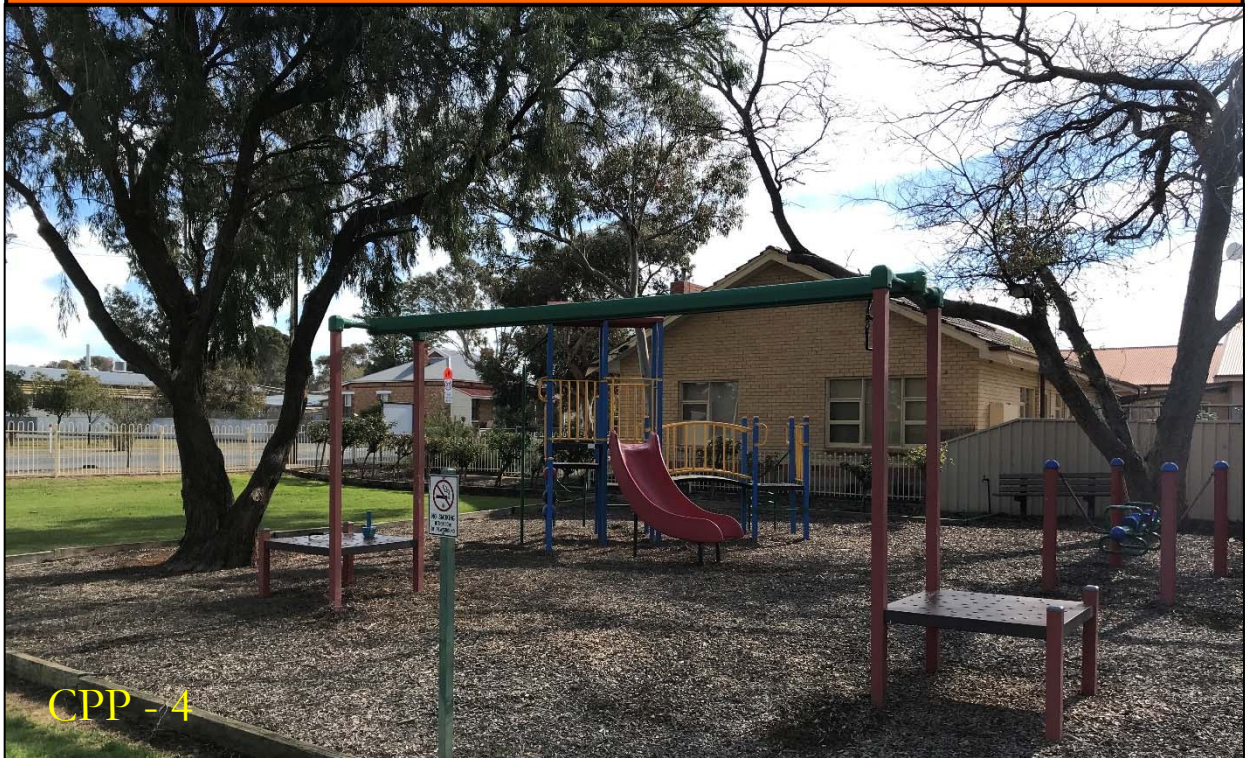
CPP - 4

The two upright end caps are not affixed and need re-riveting, the "S" hooks are 25% worn and don't need replacing. Softfall is down to 50mm in places and will require top up, No flake rust on the uprights.

- Two of the upright end caps need fixtures replaced **Remedial**
- Softfall needs to be topped up, too low in places. **Remedial**

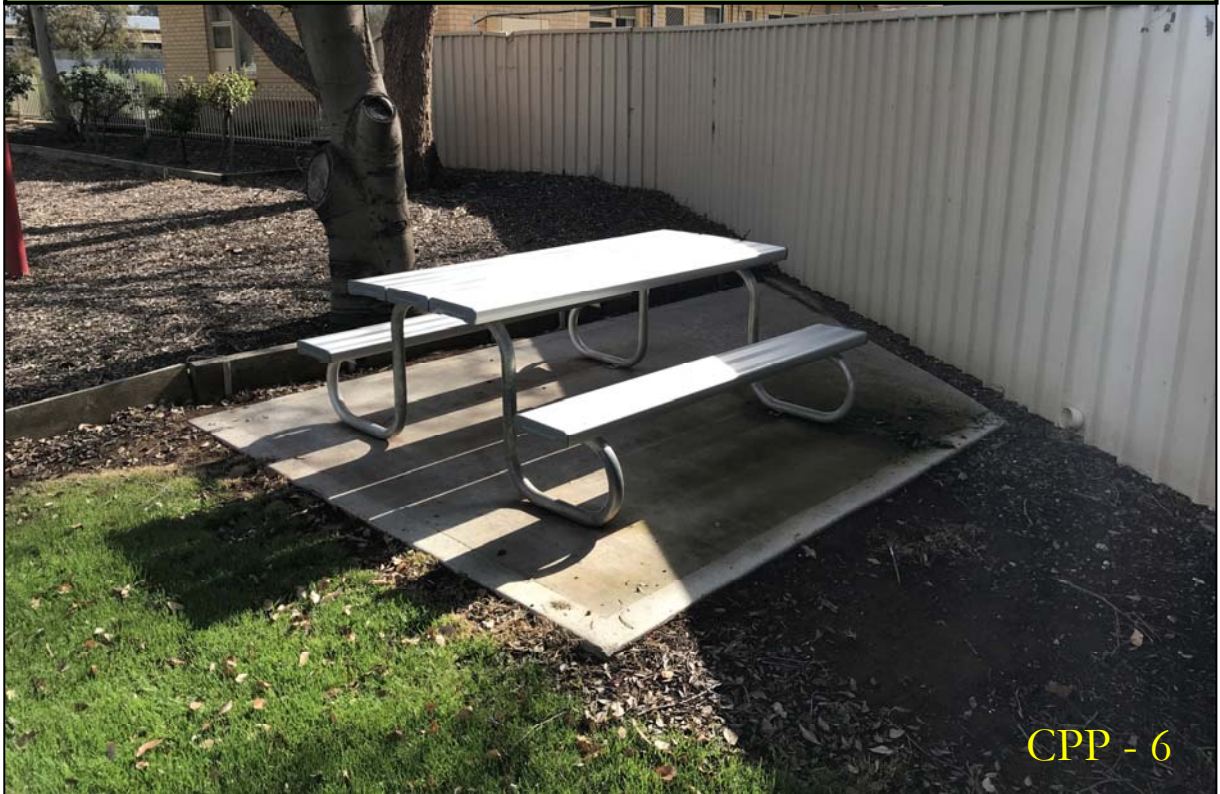
This seat is securely affixed to the ground with no movement in the frame or the wooden beams

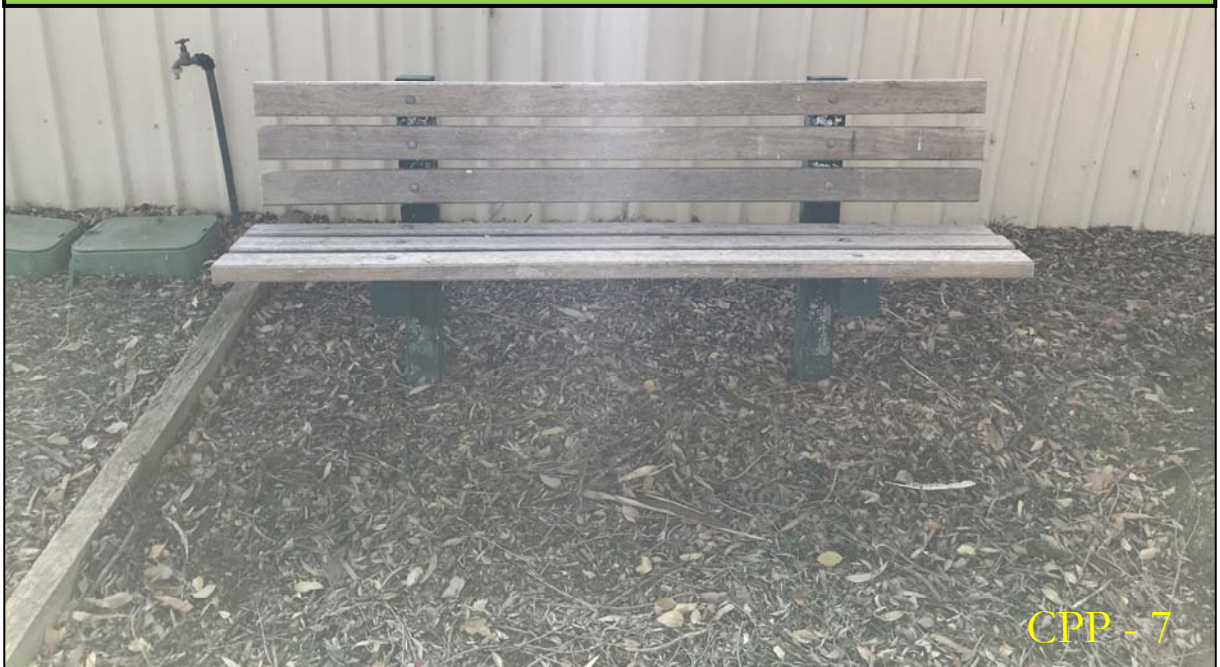
This seat is securely affixed to the ground with no movement in the frame or the wooden beams

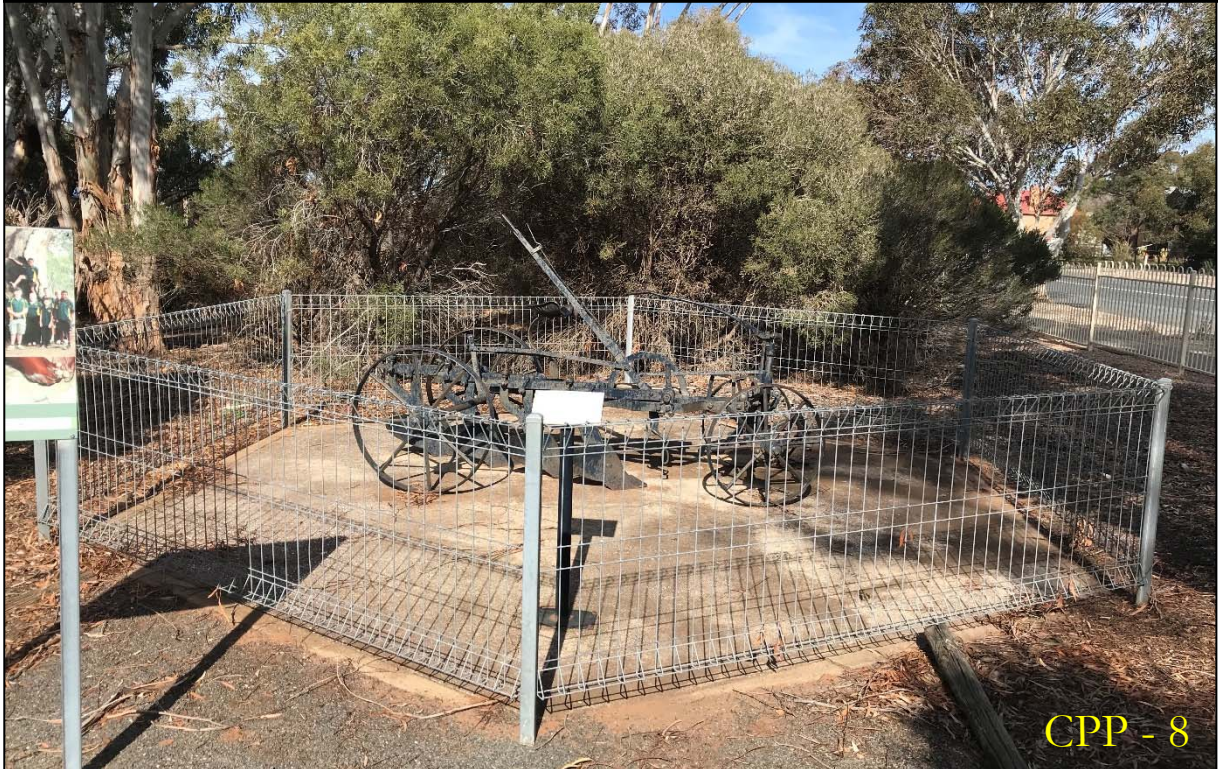
This feature has been fenced to stop people from using it as a climbing item

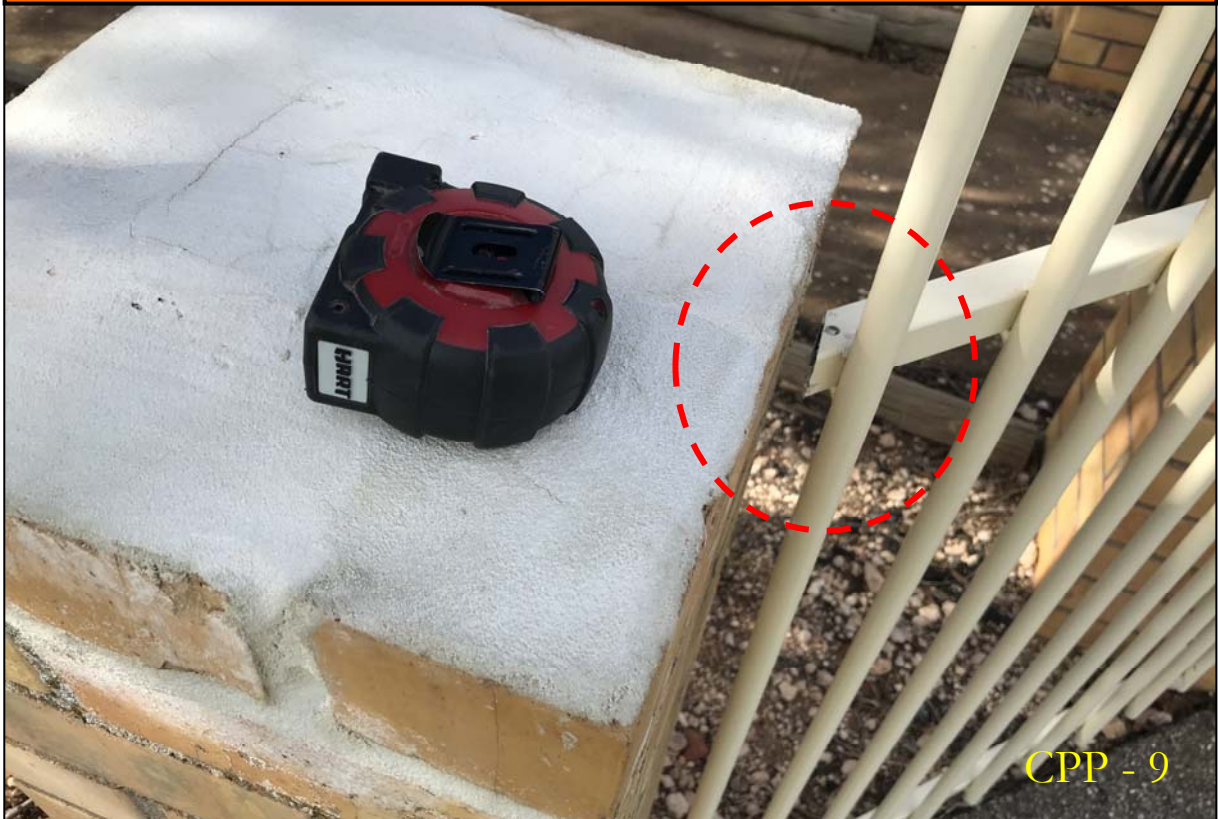
At the front gate, the fence attachment is missing from the top crossmember of the fence, the fence can be moved and could easily be broken off if moved too far.

- Replace end fixture on fence. **Remedial**
