OPEN SPACE SERVICES

AUGUST 26, 2020

Playground Audit LEN WHITE RESERVE SWAN REACH

MID MURRAY COUNCIL

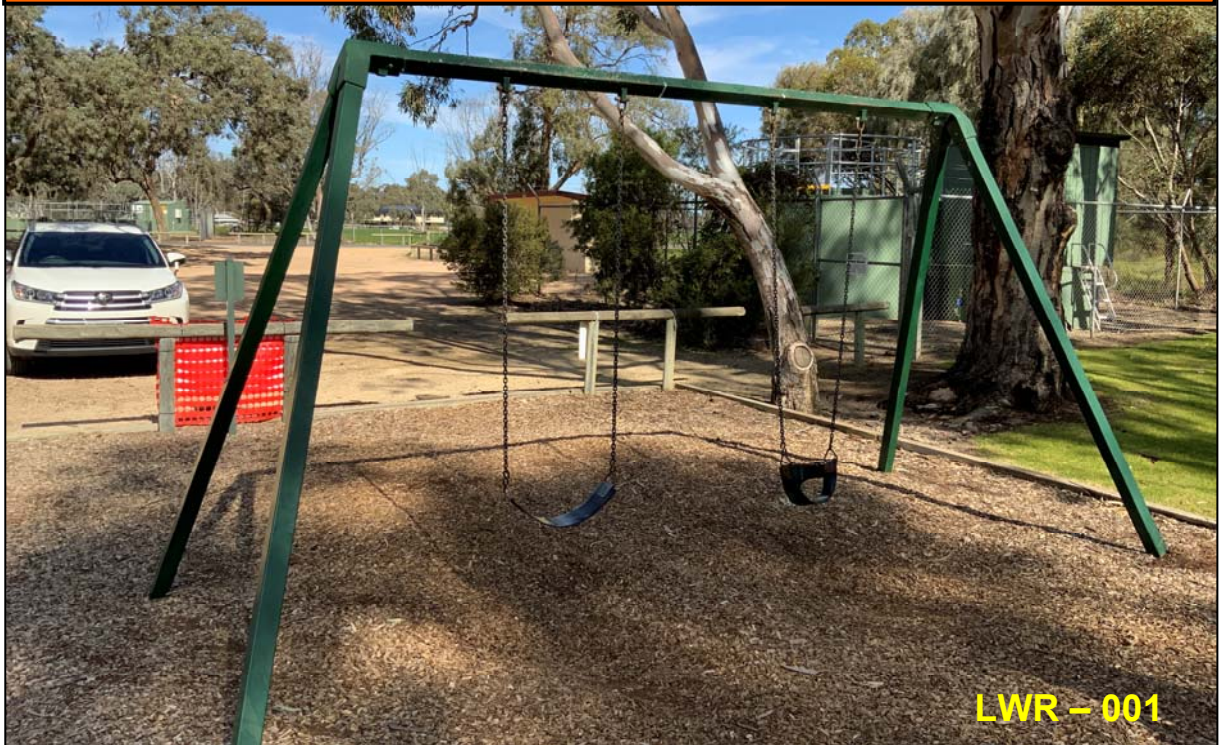
The swings have a significant amount of kick out below the swing through which is an indication of the swing being too low, both swings should be 600mm from the proper level of softfall, this measure is from the bottom of the normal resting swings lowest point to the level of softfall.

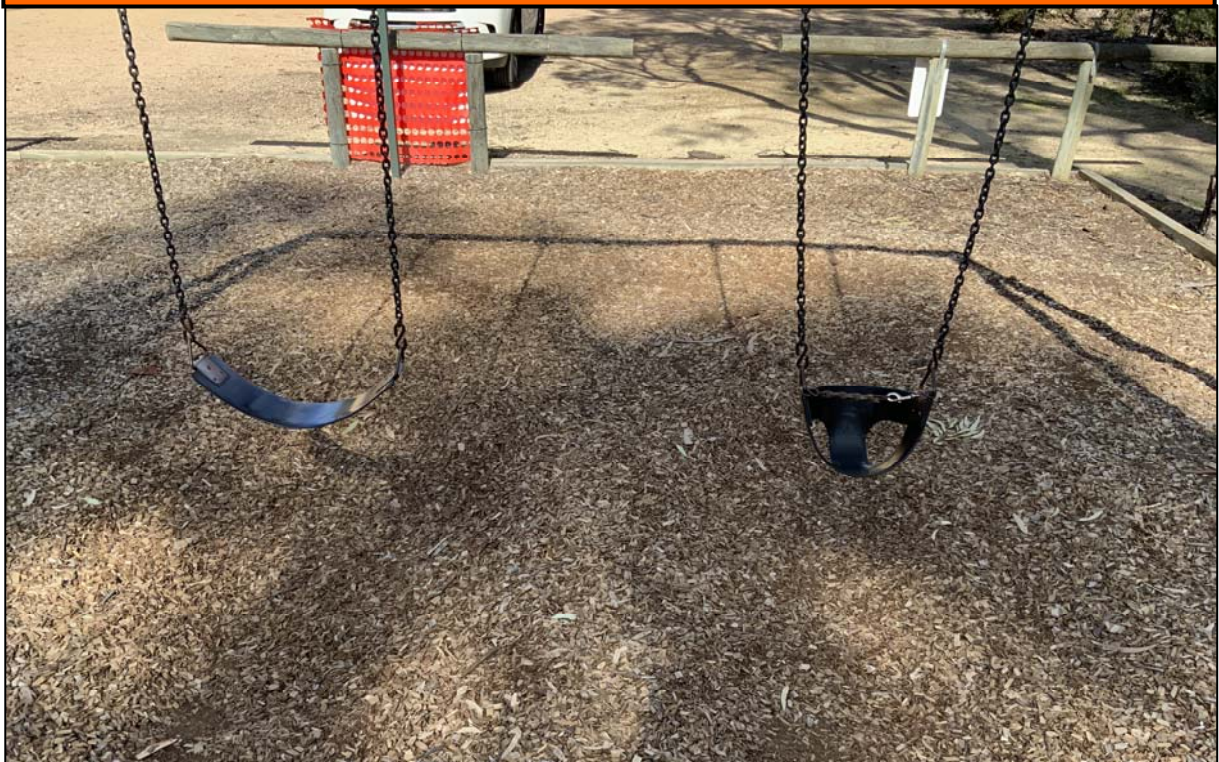
The swing seats are still in good condition and do not have any areas of cracking or splitting. The baby swing requires new plastic hose placed on the hold in chain to keep fingers from becoming entangled in the links.

- The holder chain on the baby swing need to have a tube protector. **Remedial**
- Softfall inadequate, some areas of exposed concrete and soil. **Remedial**

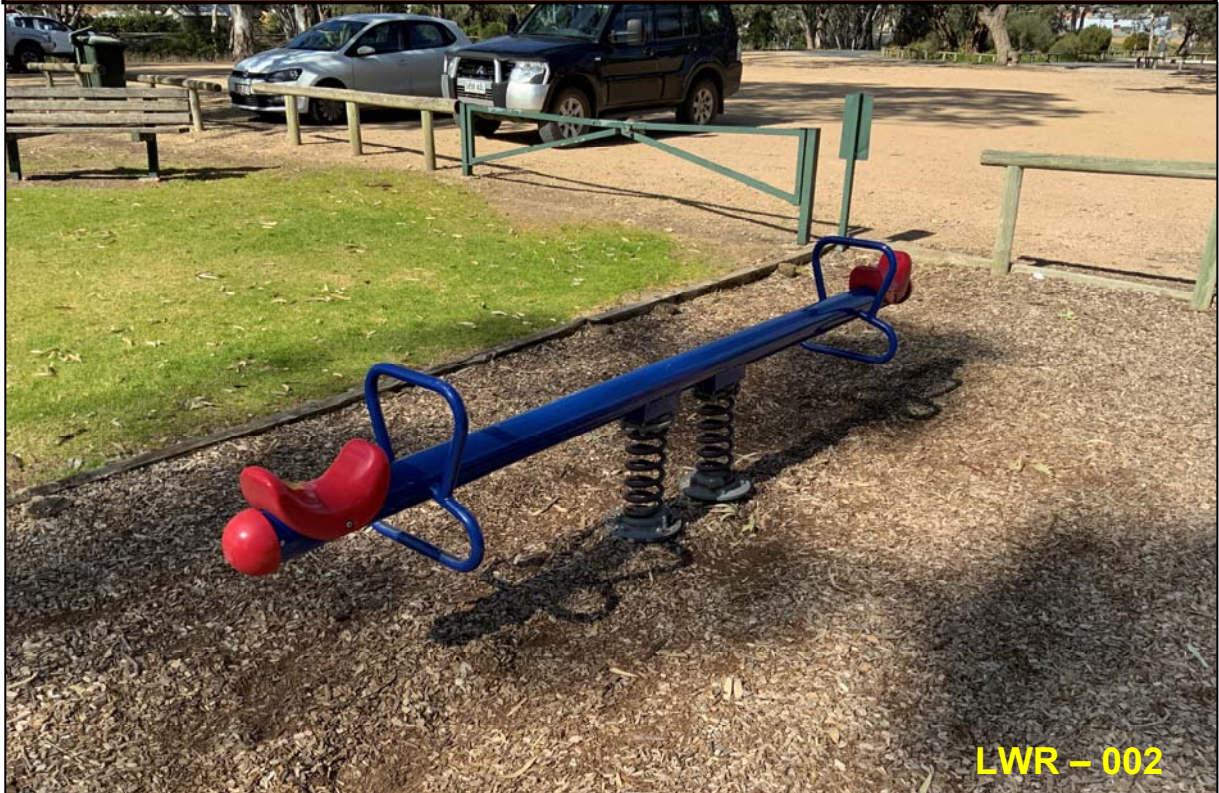
The springs in this springsaw are rusting with flake rust, this decreases the temper and weakens the steel.

- **The springs on this item has flake rust and will need replacing. Remedial**

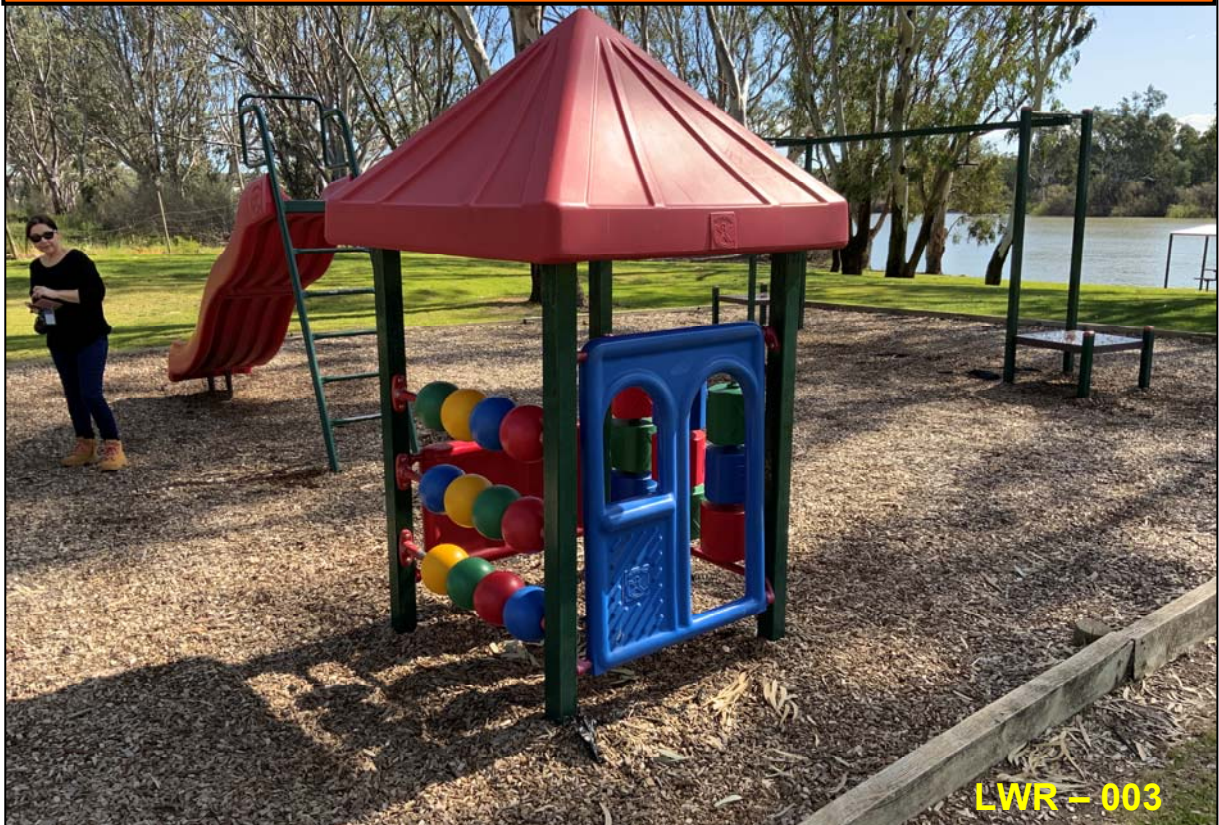
This counter cubbyhouse is in good condition, there is some movement in the blue panel as it moves from side to side, the slide could be a pinch point and needs to be silicone to stop movement.

- The blue door panel needs silicon to stop it sliding. **Remedial**

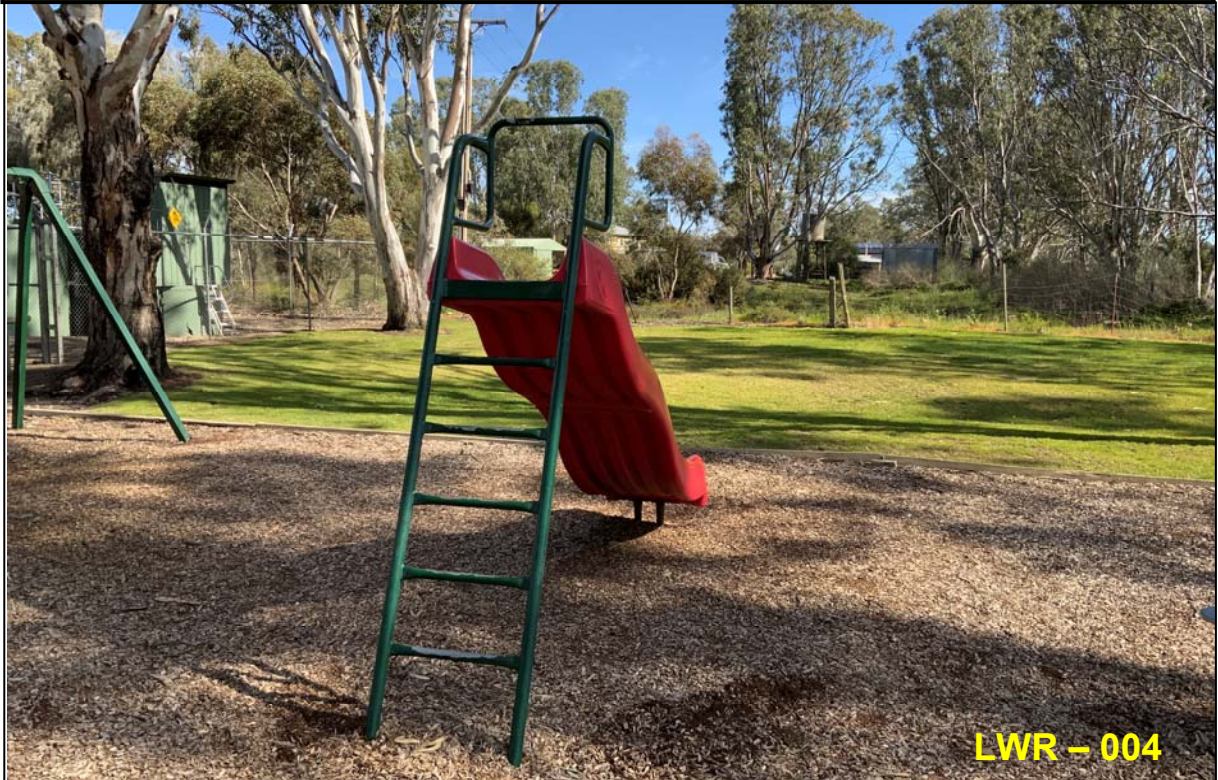
The slide does not have any catchment areas that could snag a toggle. The slide has some kick out at the runout point which happens, but the depth of softfall is sufficient.

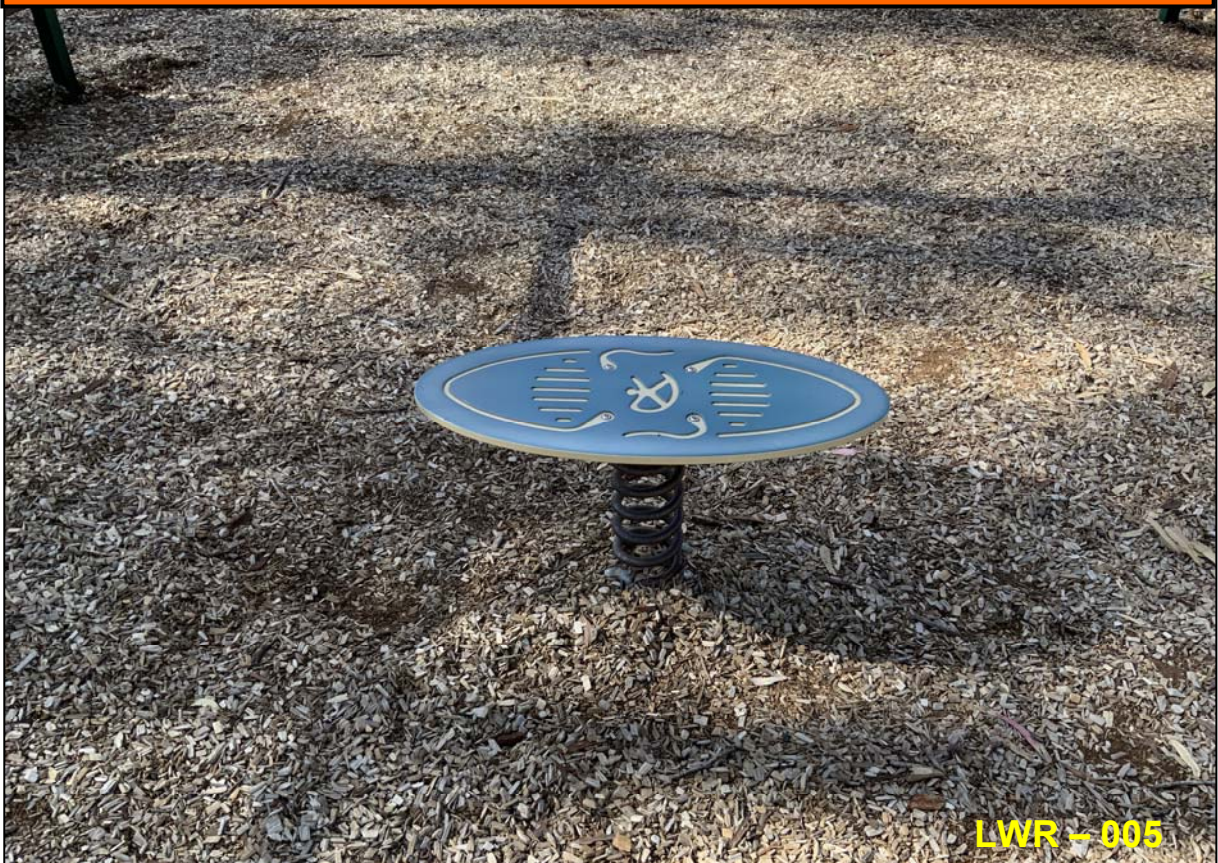
The springer spring has flaking rust and will need to be changed.

- The springs on this item has flake rust and will need replacing. **Remedial**

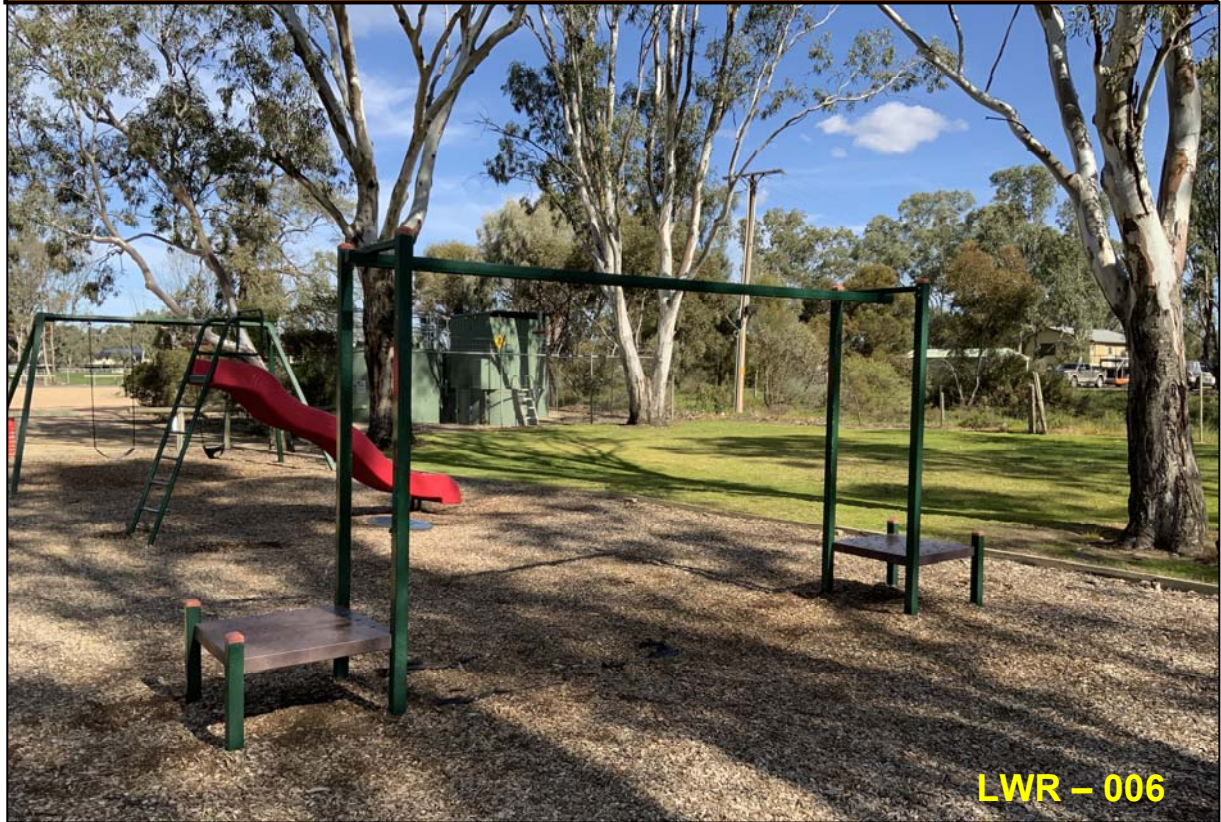
The two decks have surface rust which will most likely continue to slowly deplete the metal until it wears through, these platforms should be removed and treated with such products as kill rust or similar to extend the life of the platforms.

- Both platforms are rusting and will need to be treated and repainted. **Remedial**

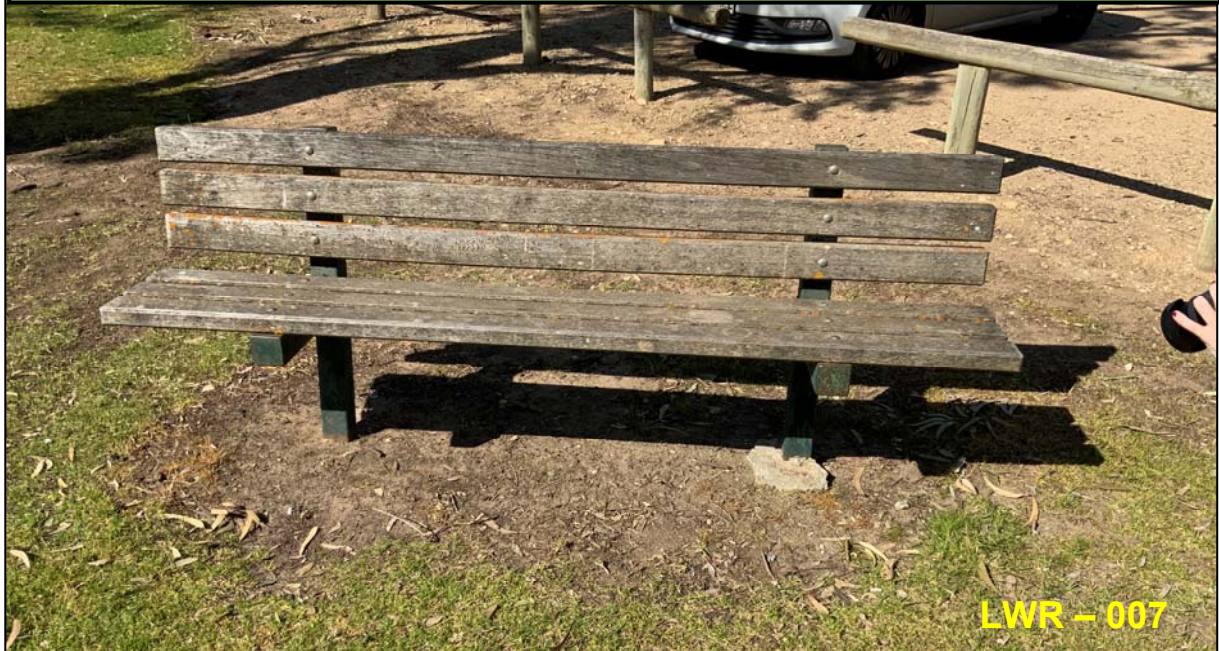
This park seat in good condition, the wood has aged in the elements but the structure is sound. There are lichens established on the wood and when the build up becomes great, the seat will require cleaning. The exposed concrete is not a problem here as the area is not in the impact play area.

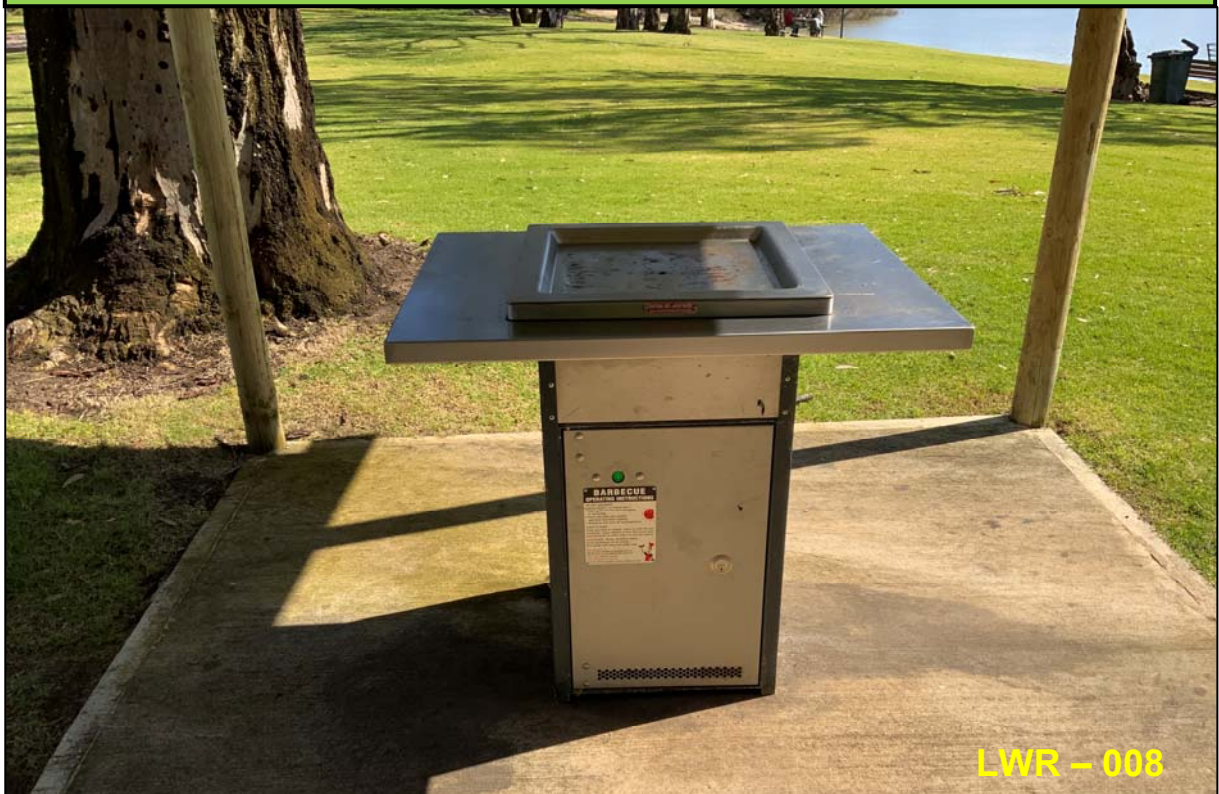
This barbeque looks to be quite new and is still in as new condition and functioning as it should.

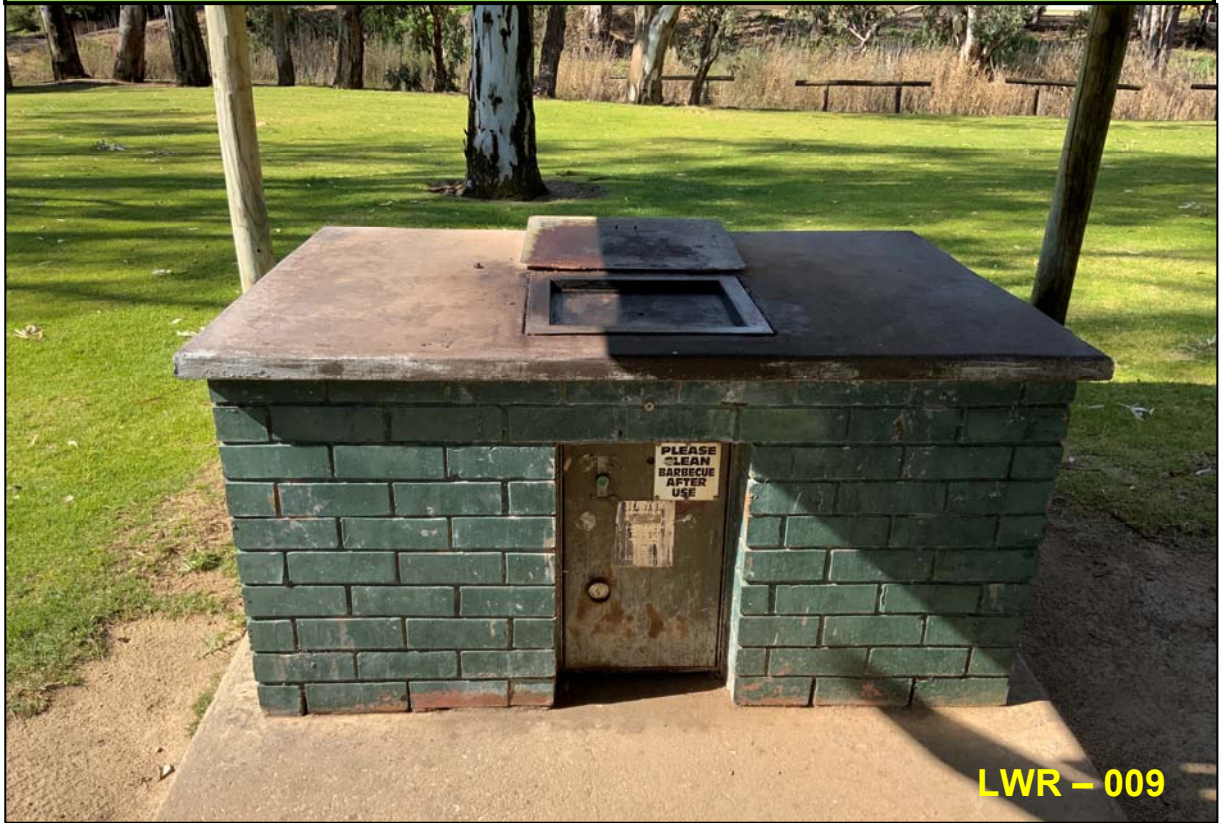
This barbeque is quite old but is still fully functional, it has been well used and at the time of inspection had just been used.

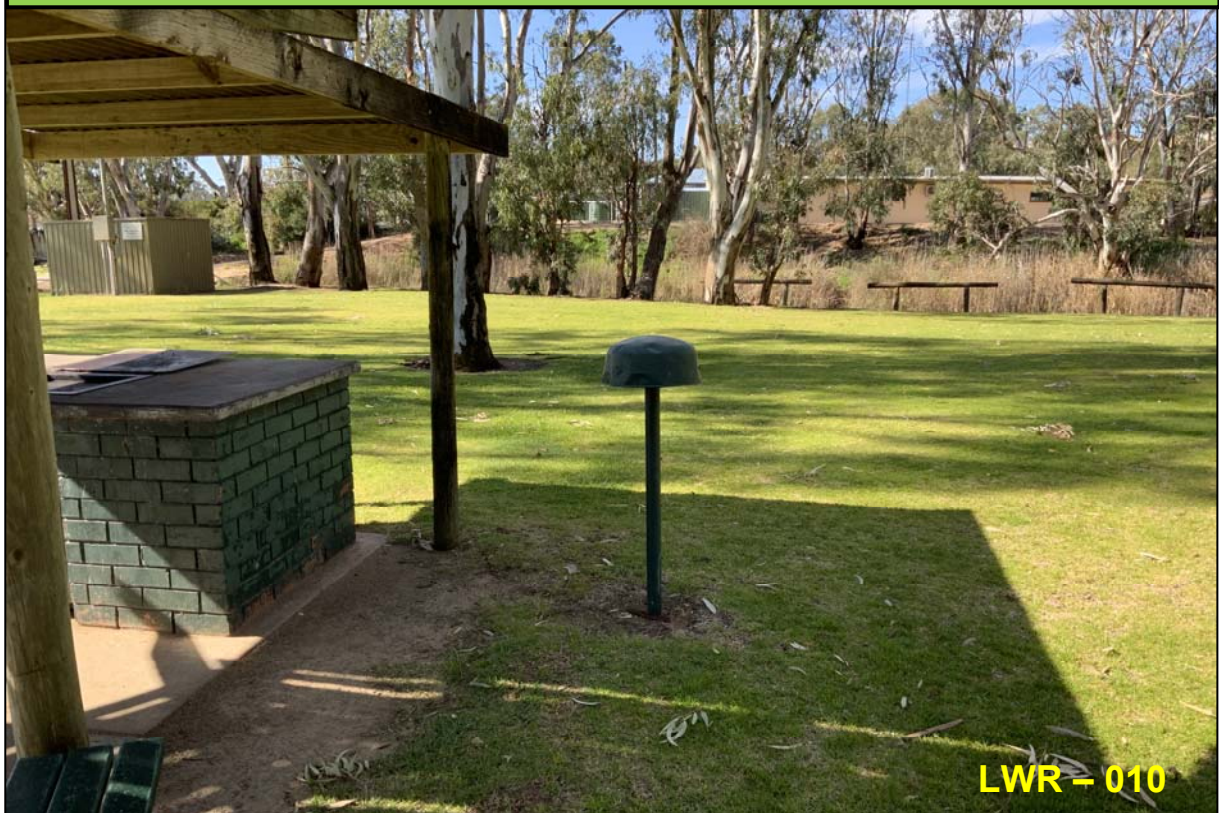
LWR – 009

This power dome is of age where it has been in place for many years, there was no areas of certification and I do not know if this is required, the surface corrosion on the underside indicates that moisture does accumulate in this area.

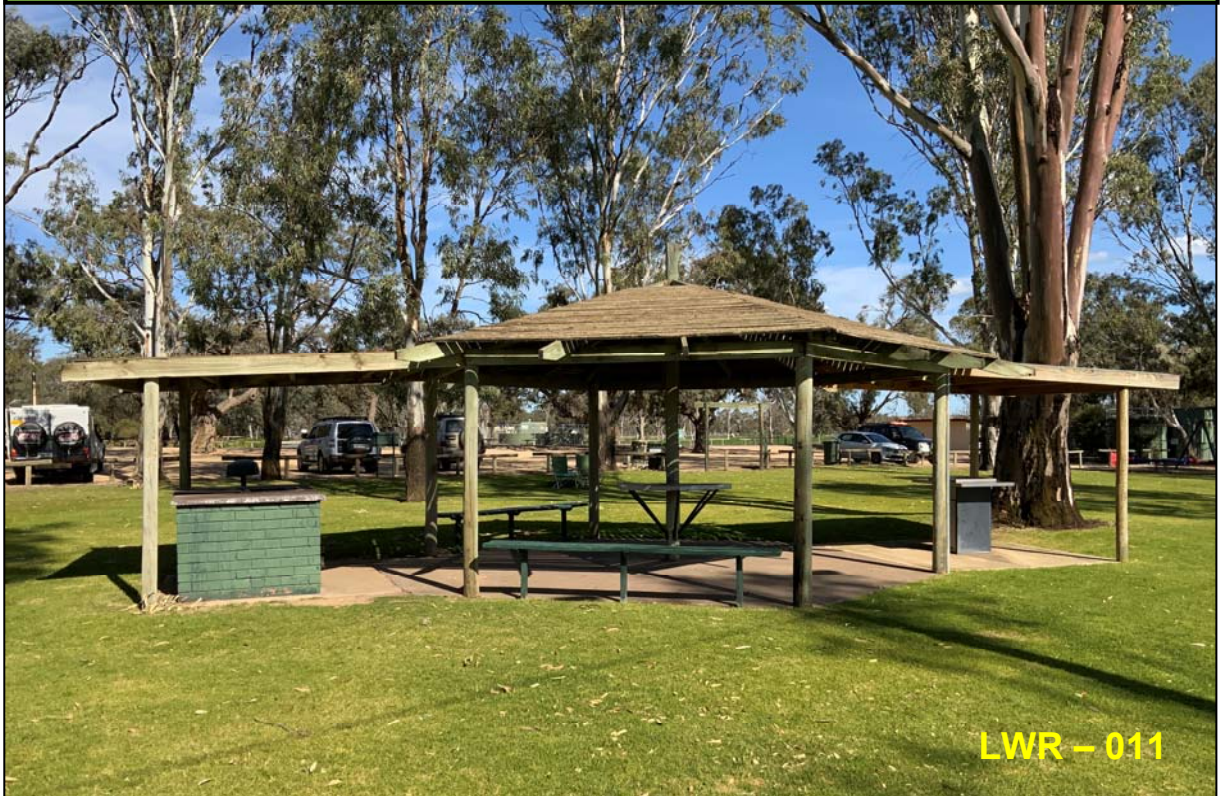
LWR – 010

The overall condition of the Gazebo barbeque shelter is fair and functional, the structure is aged but is not unsafe in any way.

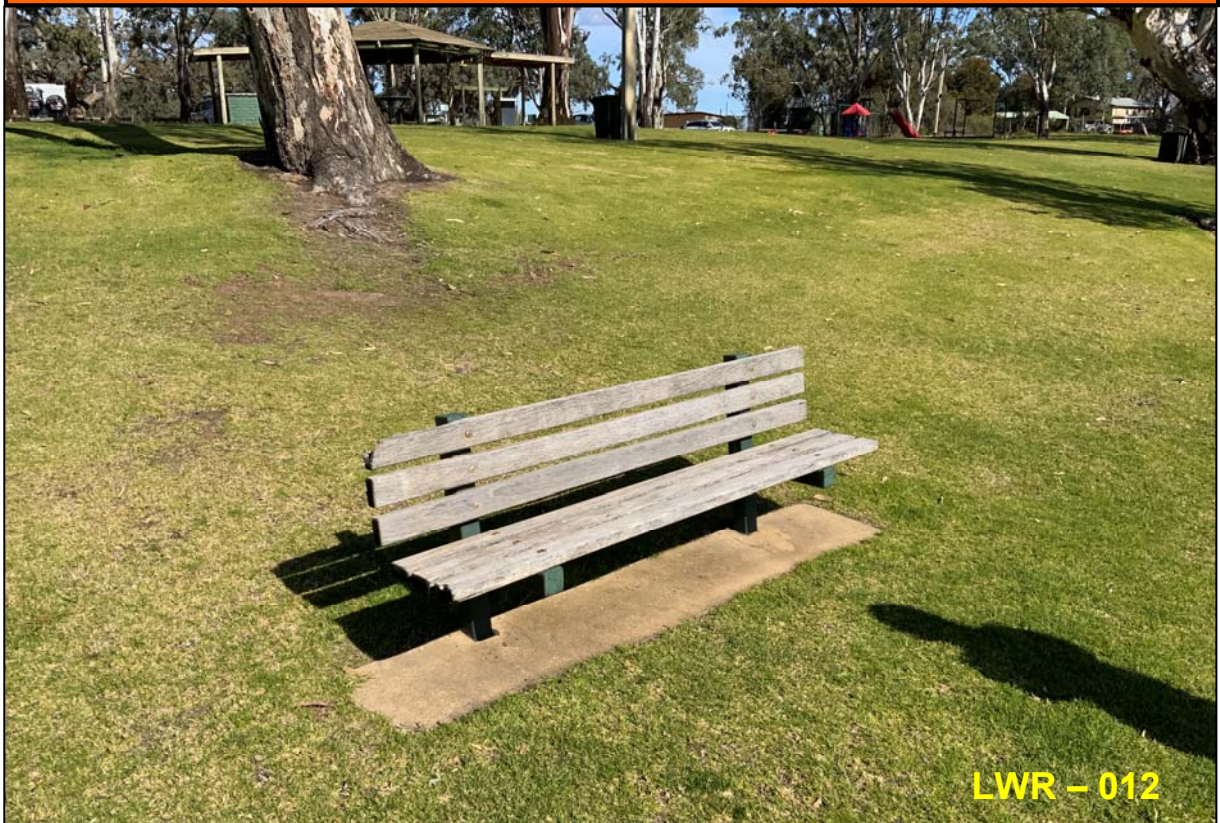
This seat has the top slat broken off on the edge this will need to be sanded down to remove the splintering affect. The rest of the seat is in good condition with no movement.

- The seat has a broken at the top, and will need to be sanded down. **Remedial**

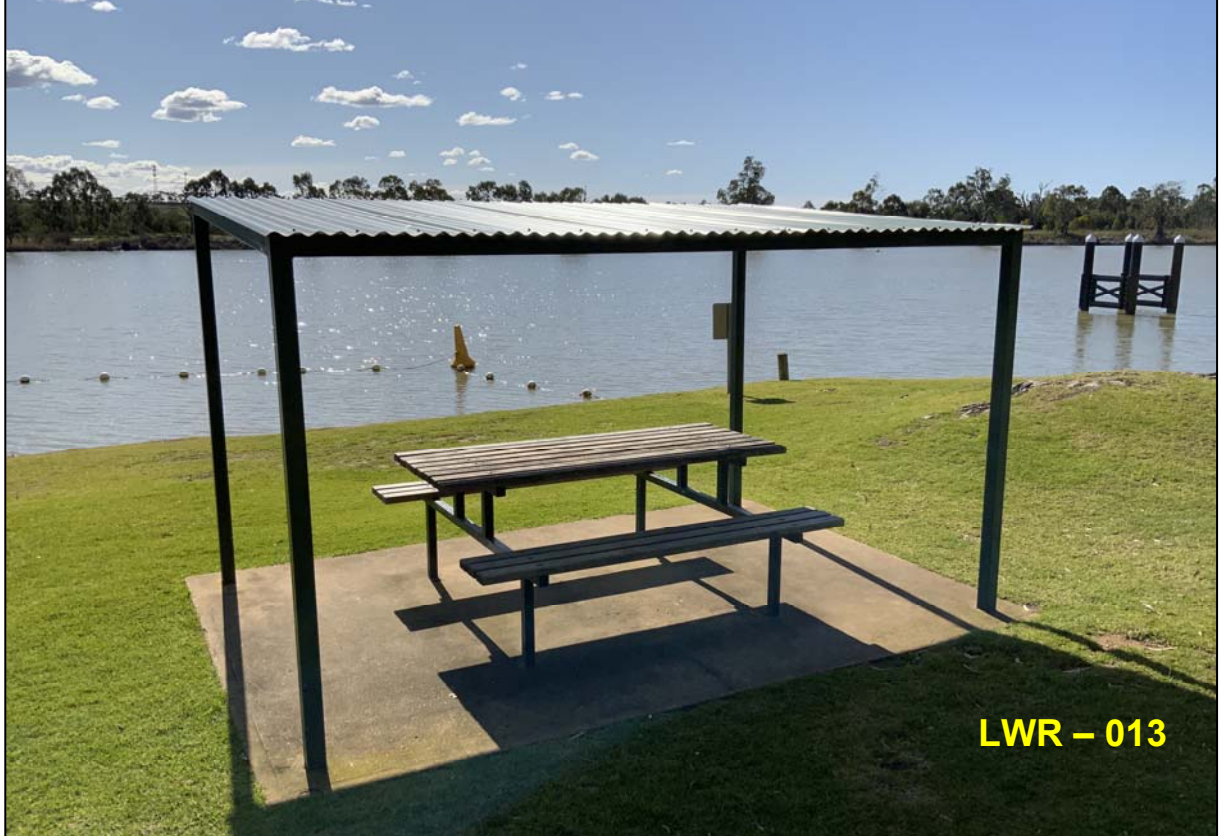
This shelter and bench table and seats are all in good condition, both are as installed.

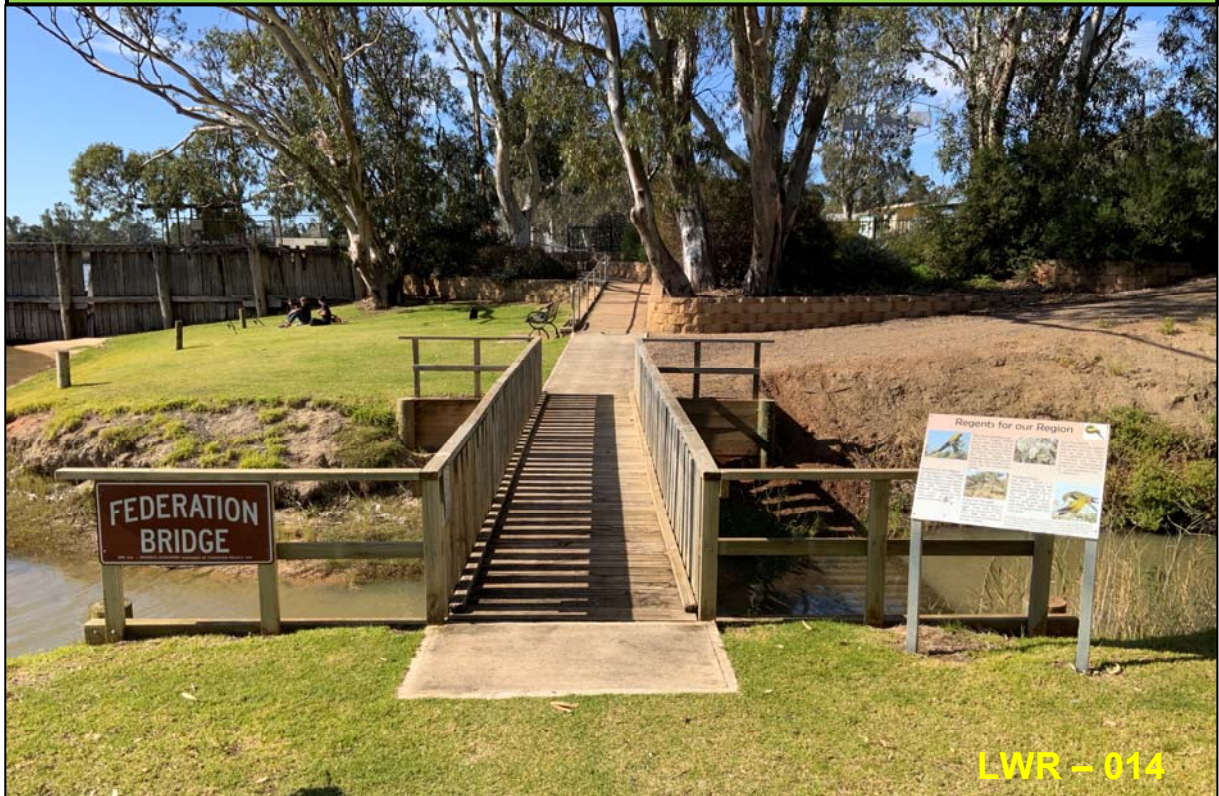
LWR – 013

The bridge is in good condition all wood work is sound, no breakages or loose timber and all fasteners are secure.

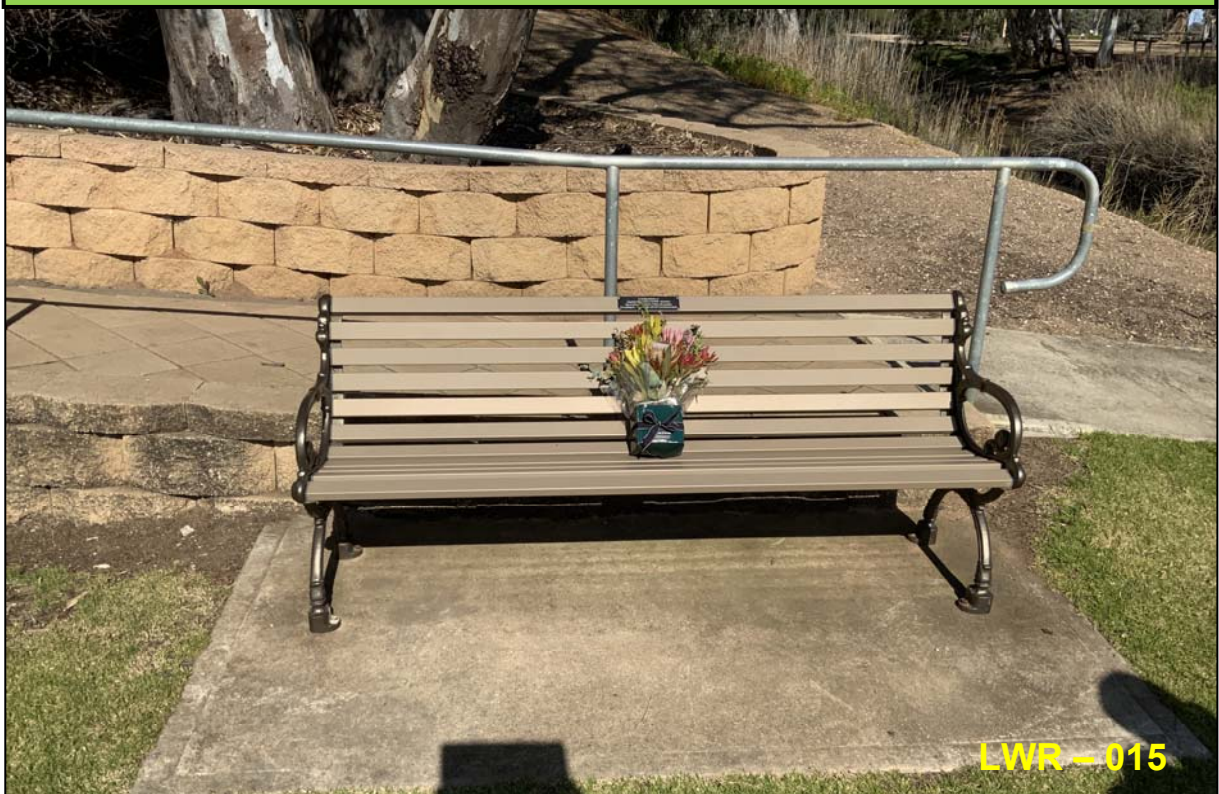
LWR – 014

This seat is in good condition, it has no loose items and the concrete is in good condition

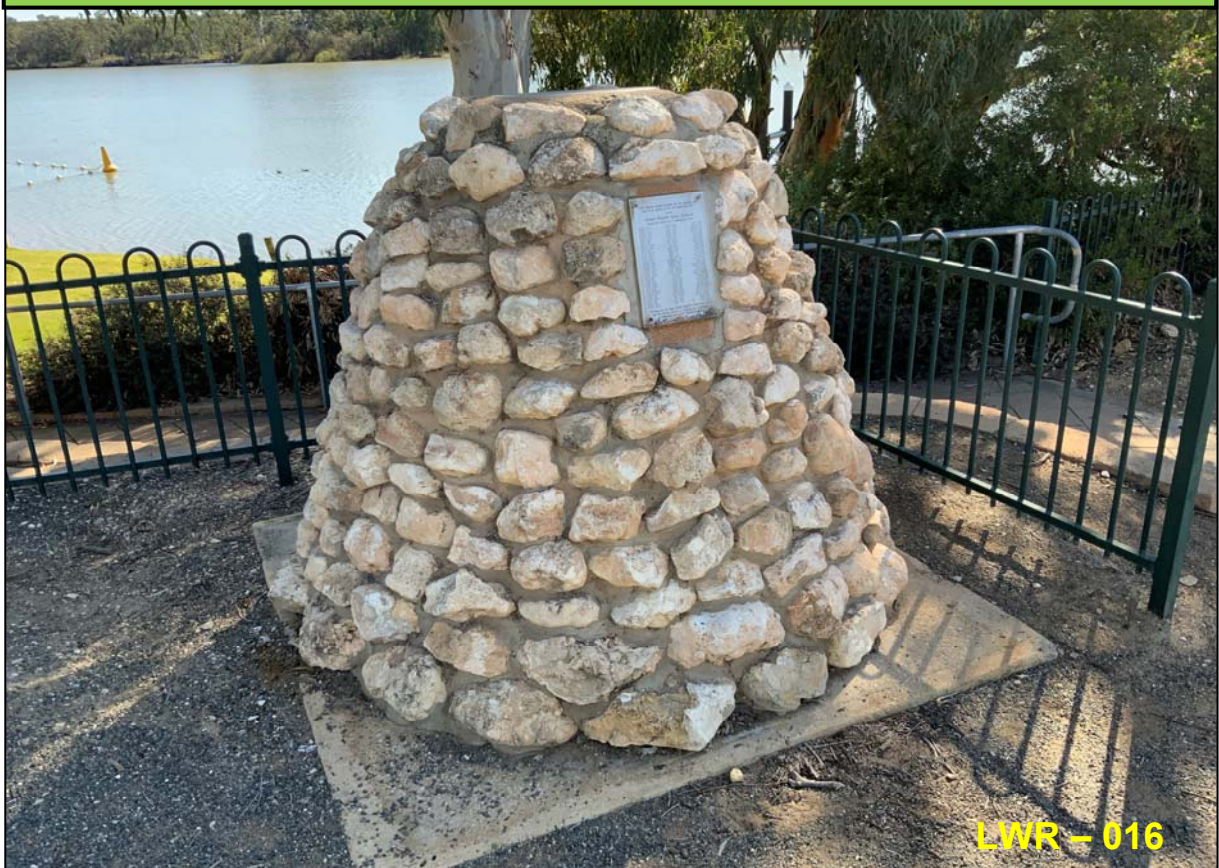
LWR - 015

The formed feature is of sound condition and the plaque is affixed in a rigid manner.

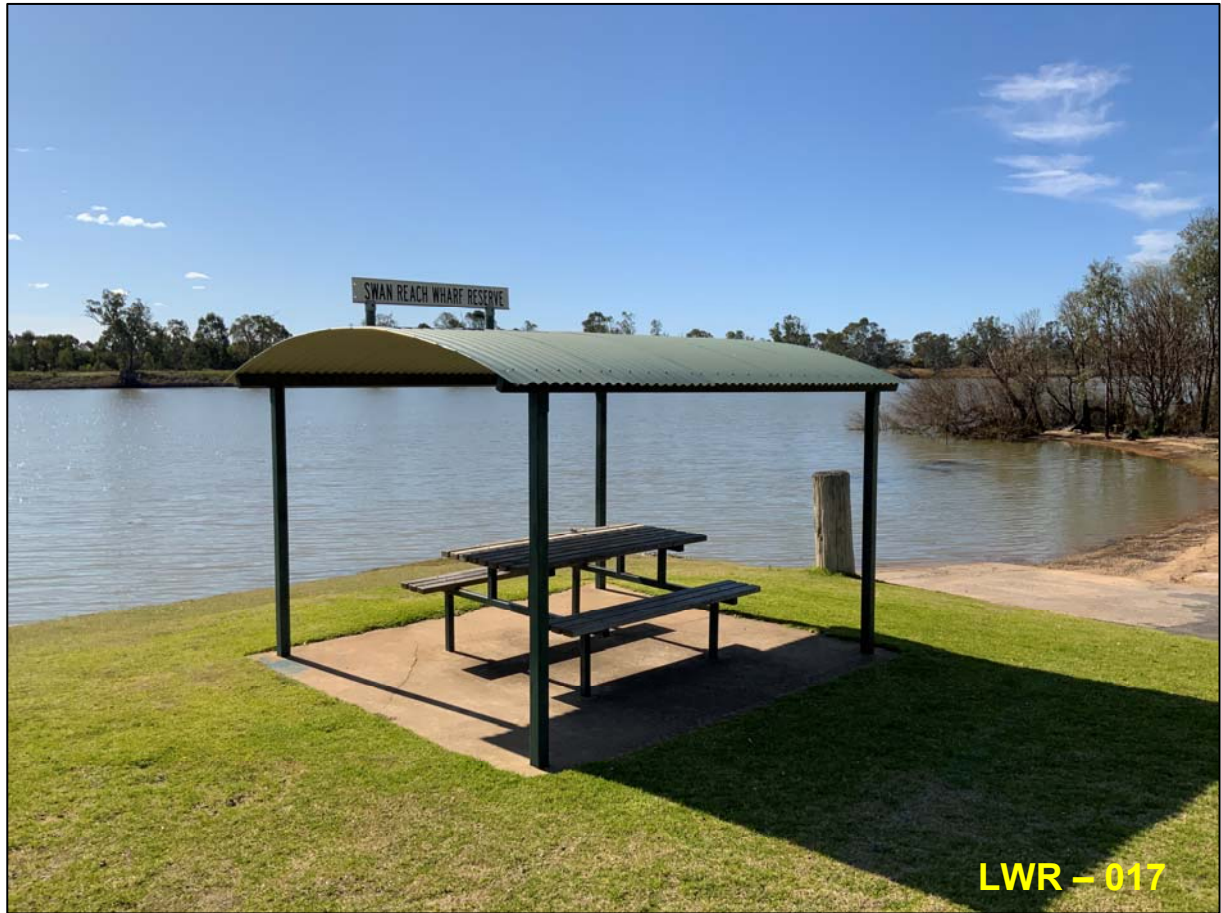
LWR - 016

This shelter and bench table and seats are all in good condition, the items are clean and have no defects or hazards.
