AUGUST 30, 2020

## Playground Audit

# PROSSER PARK PLAYGROUND NILDOTTIE

MID MURRAY COUNCIL

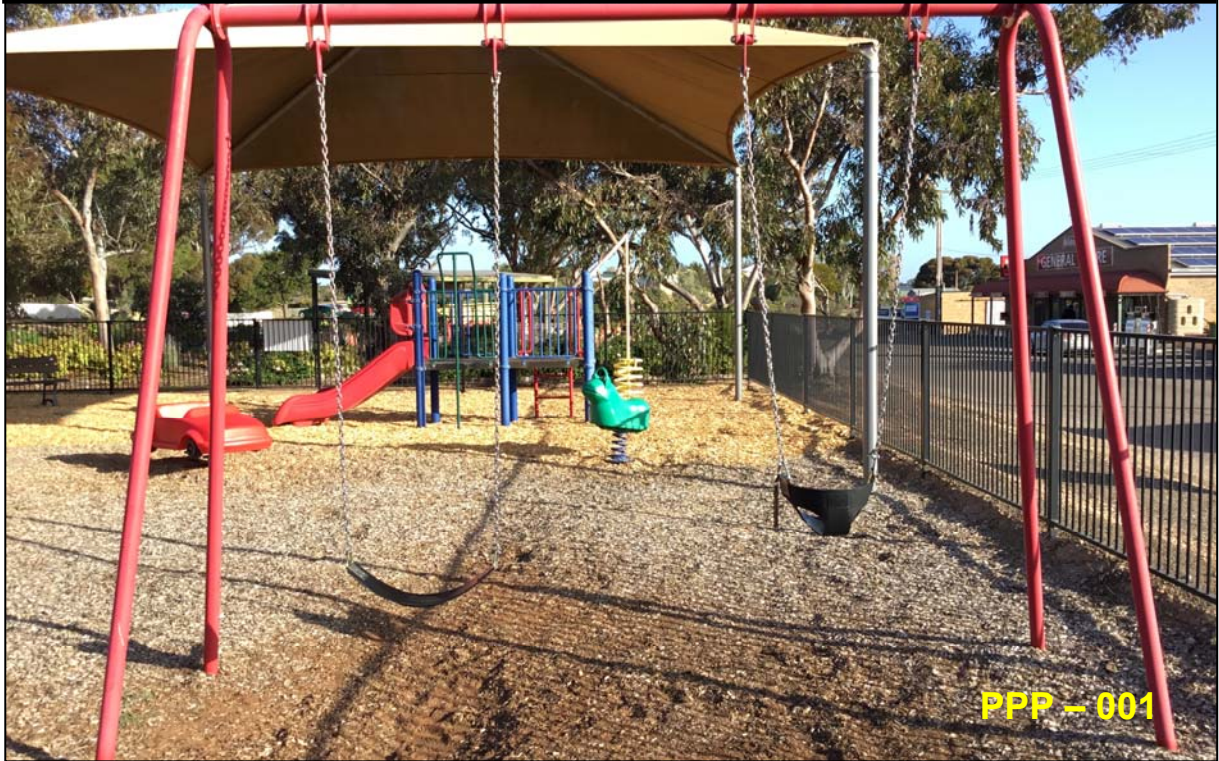
This swing set in good condition, the structure is sound with no rust, the chains look to be new or replacement with the baby seat is high enough to access for the parents, the other swing is too low and should be lifted to reduce kick out area beneath is soil where most of the area should be softfall. Softfall needs to be 300mm in depth currently 0mm

- Children's seat needs to be lifted to stop the amount of kickout. **Remedial**
- Softfall inadequate with only soil in the kick out area. **Remedial**

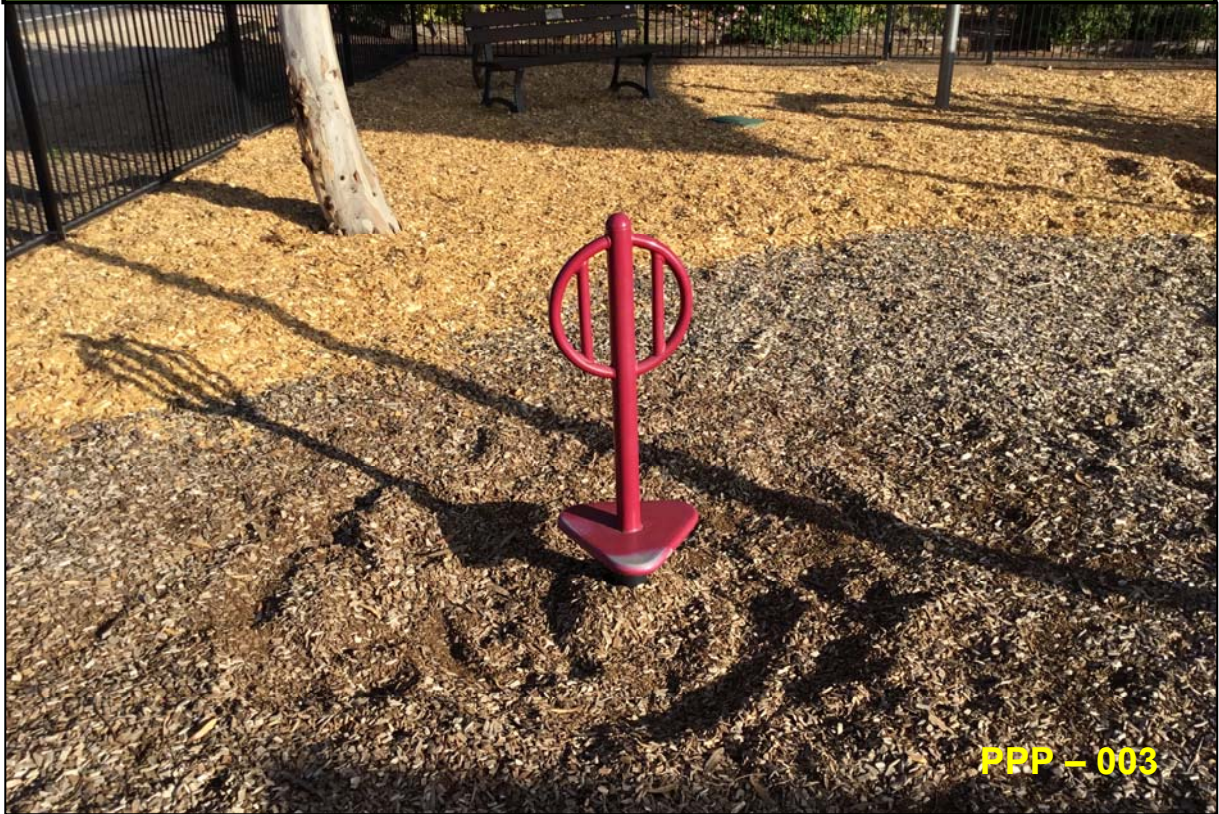
This spinner is sound and does not have any areas of movement in the bearings, the item has wear marks but no rust is present.

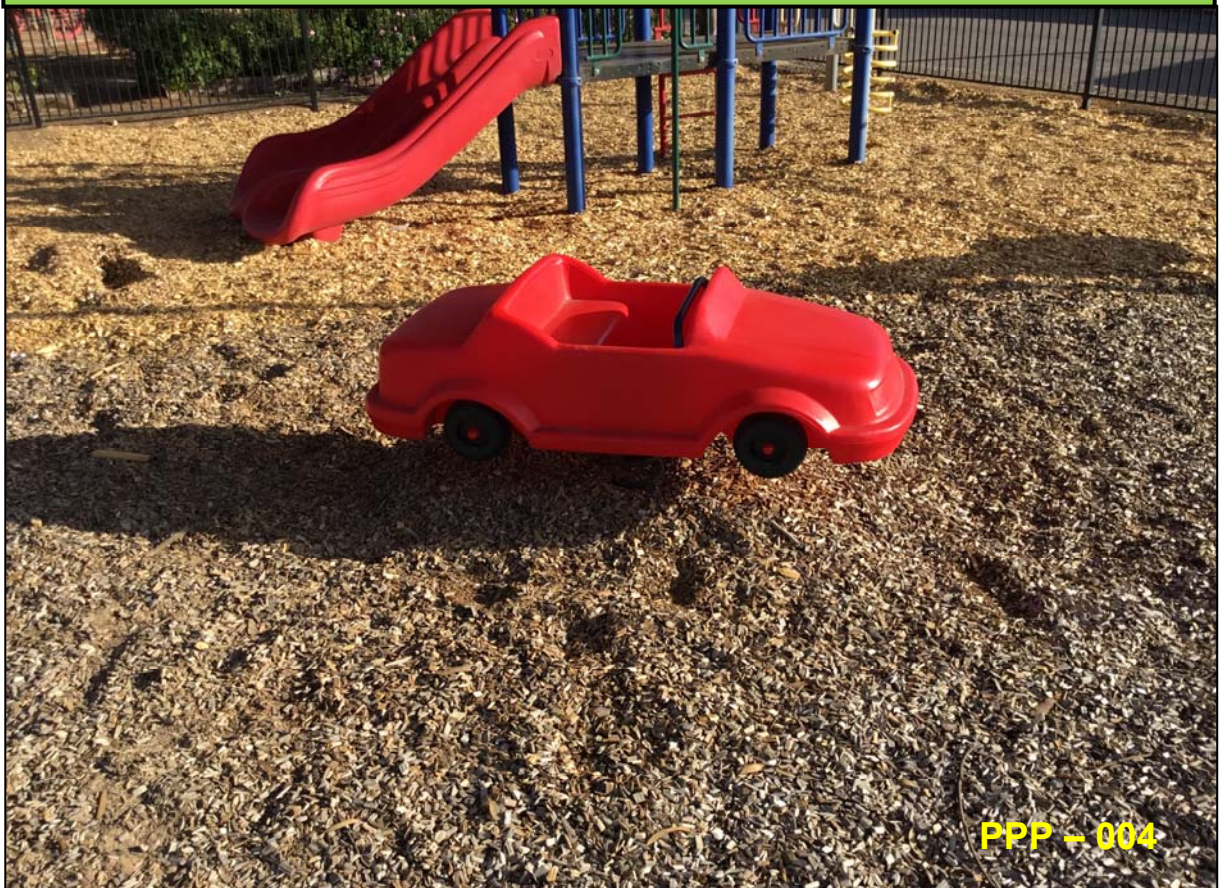
This springer car is in good condition with no areas of rust or corrosion.

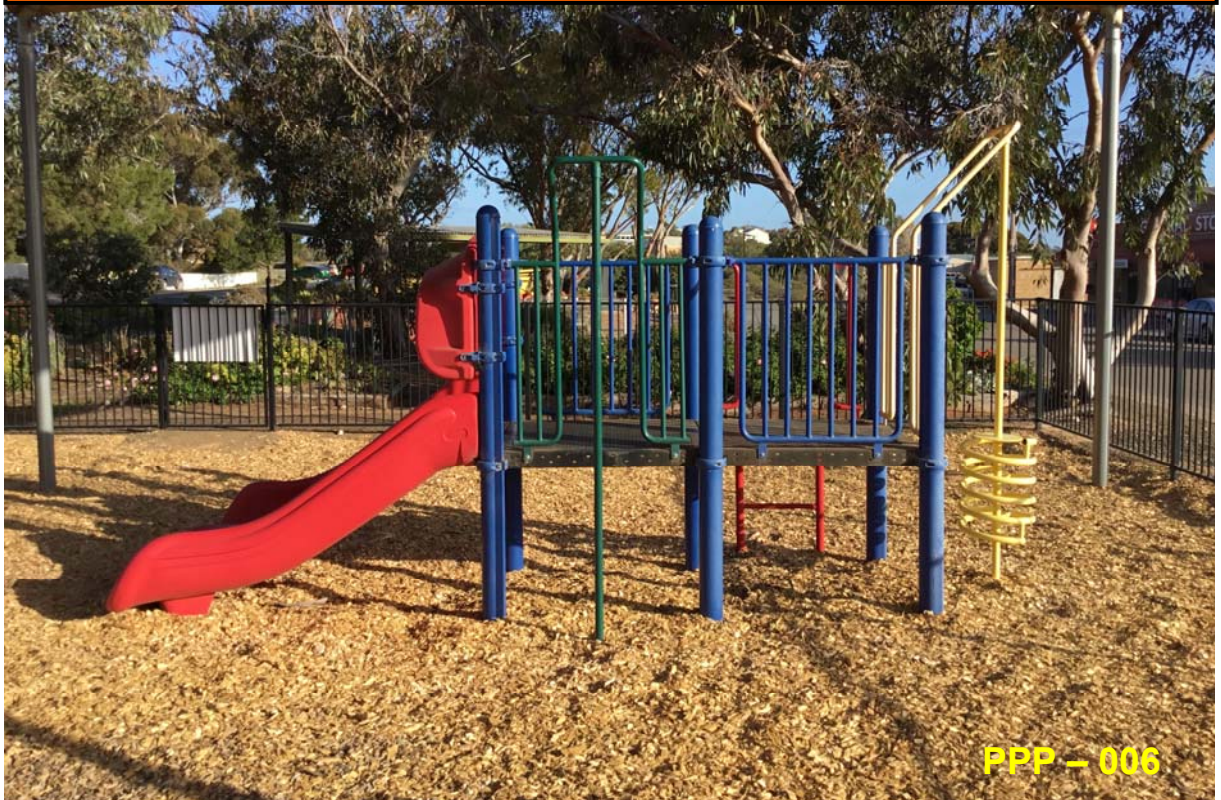
The multi play equipment is only 7 years old and is still in very good condition, all areas are sound and are in a as installed condition. The softfall is only 120mm deep and will need to be 300mm deep on areas of high impact and runout areas.

- Softfall inadequate, needs to be 300mm on all high impact areas. **Remedial**

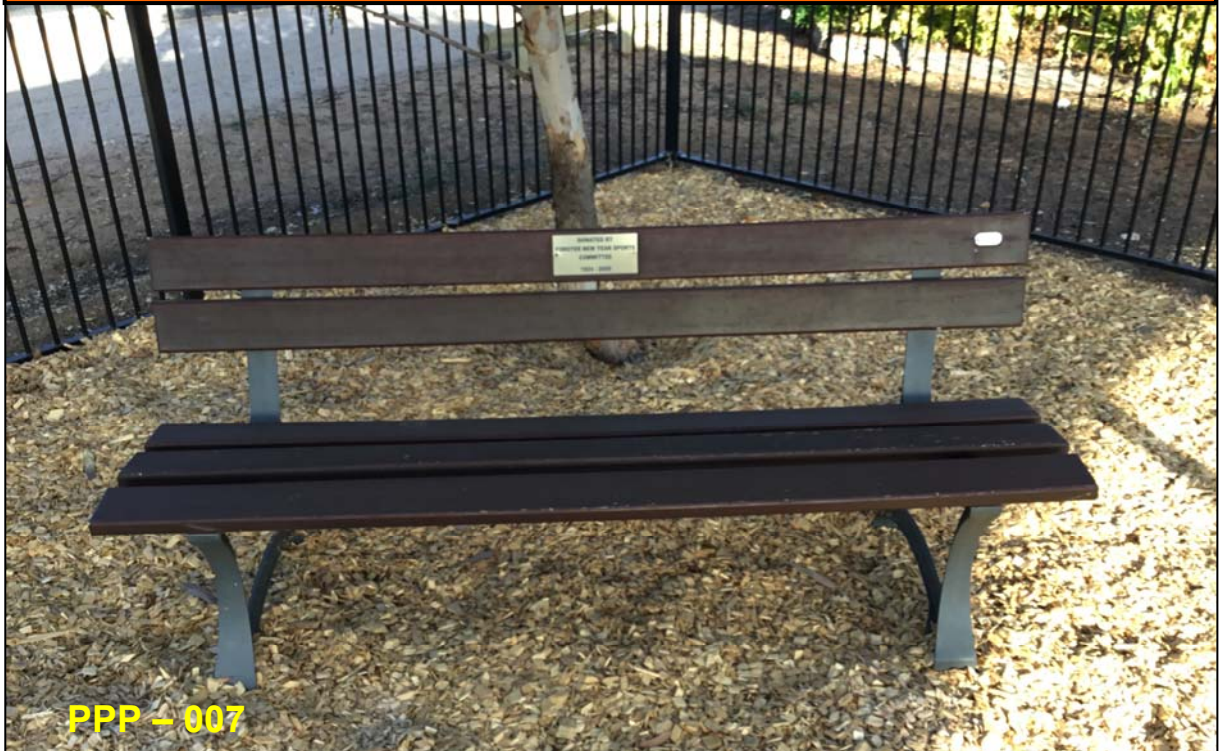
This memorial seat is in good condition however the plaque on the back should really be silicon down and not left with sharp edges especially around the back where people sit.

- Silicon plaque to stop corners injuring people when they sit down. **Remedial**

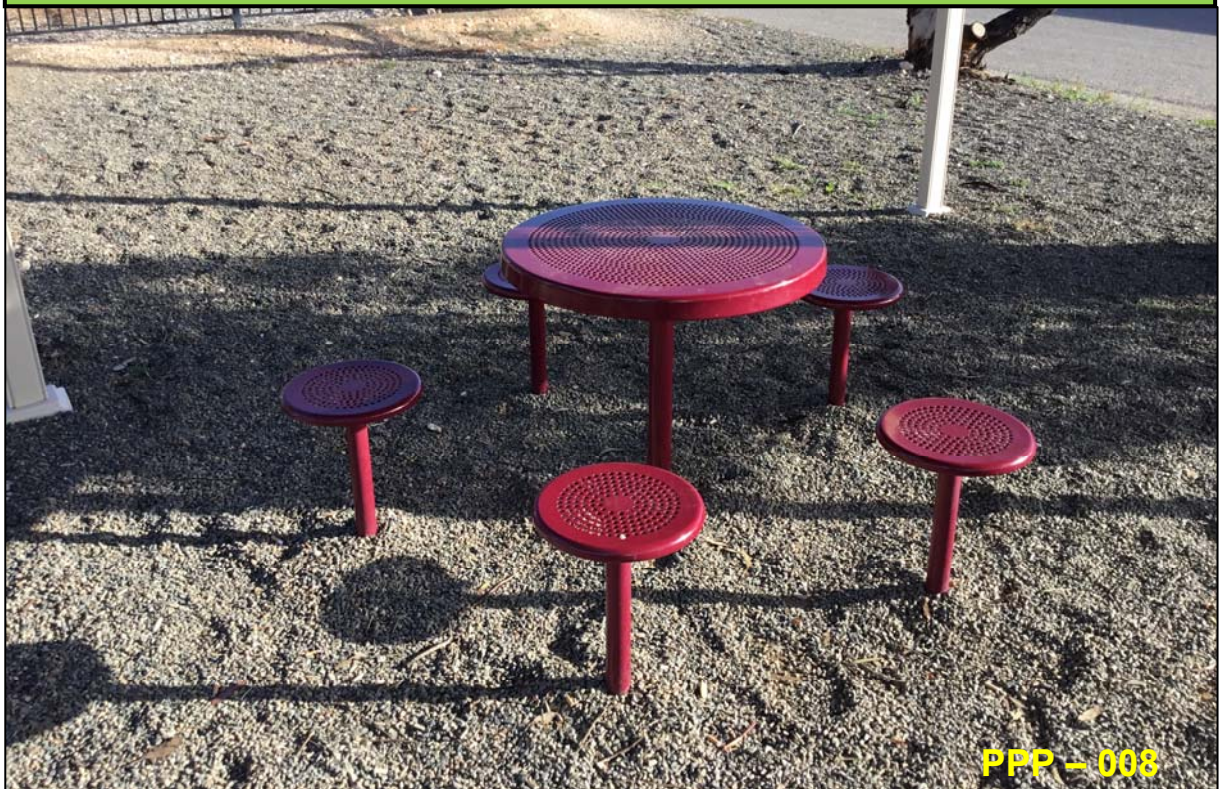
The small table and chairs quite new, all chairs and tables are securely fastened to the ground and do not have any signs of movement.

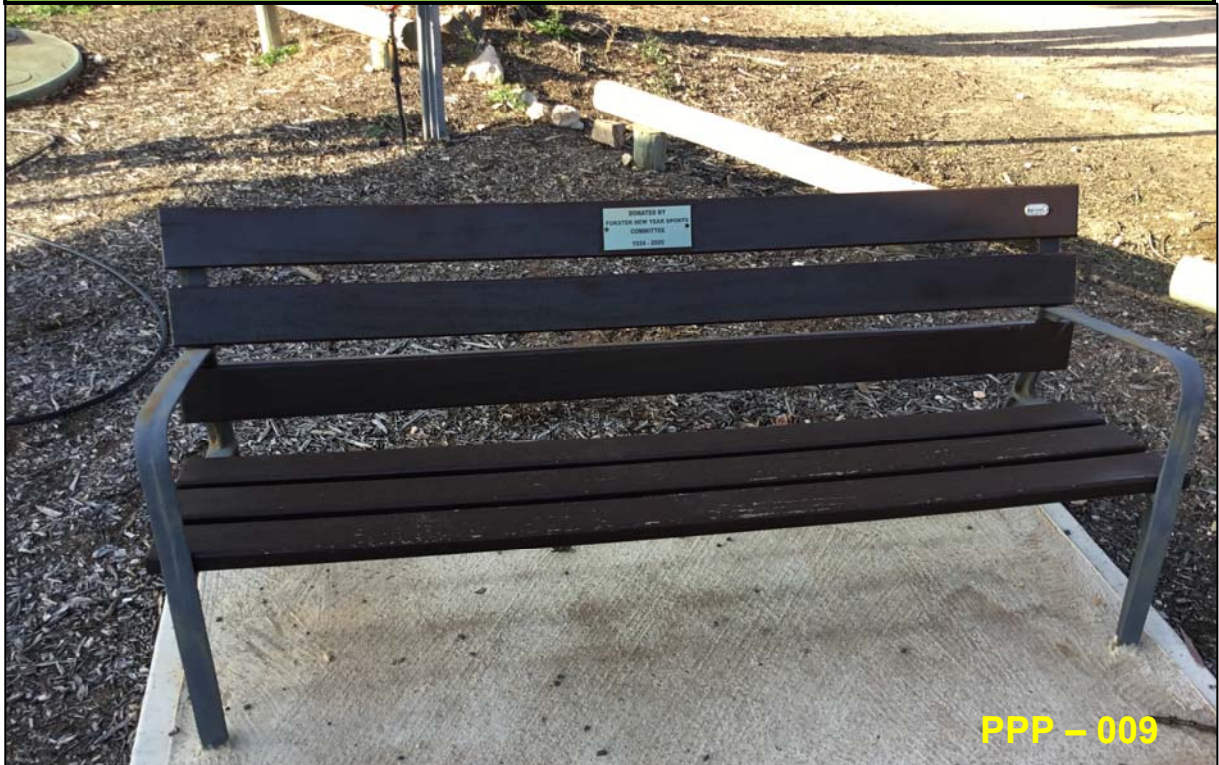
This park bench is concreted to the slab and has no movement, all the slats are in good condition.

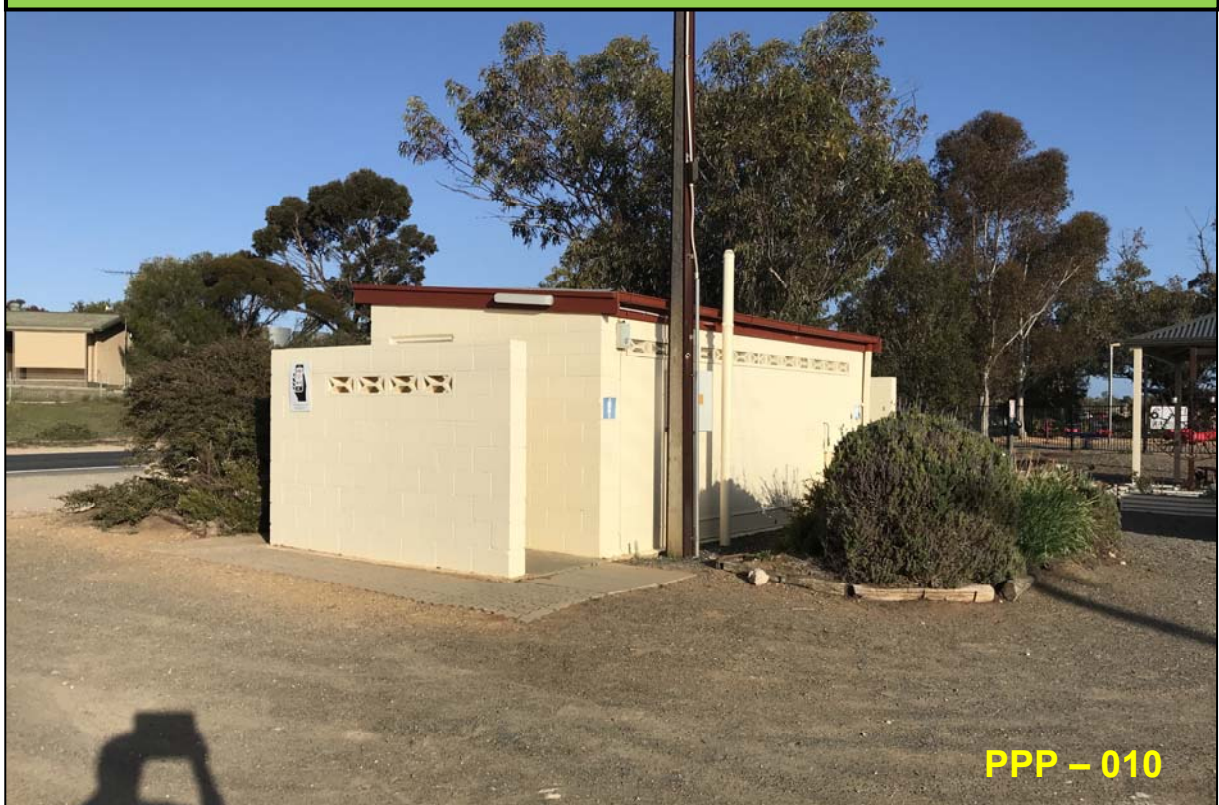
The toilets are all clean with all features working as required, no vandalism was found and the doors are lockable.

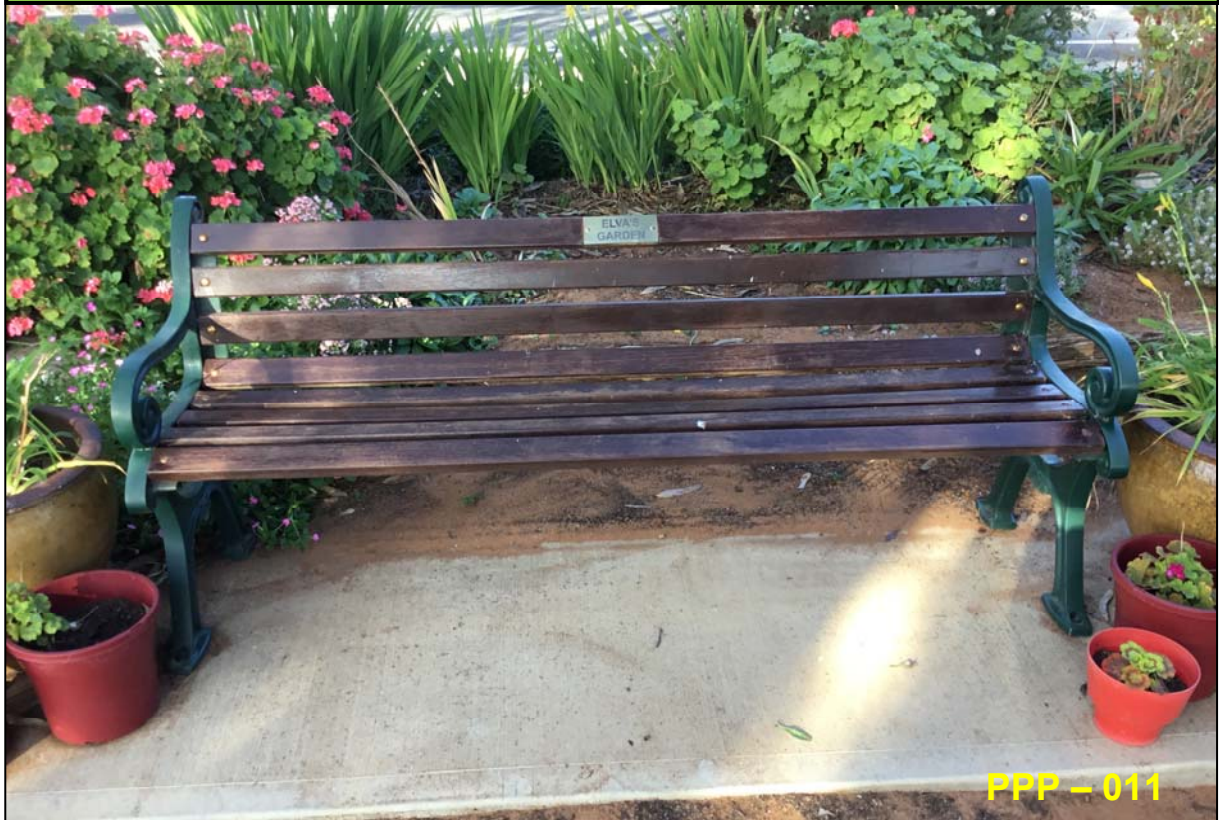
This park seat is bolted to the slab and the seat overall is in good condition.

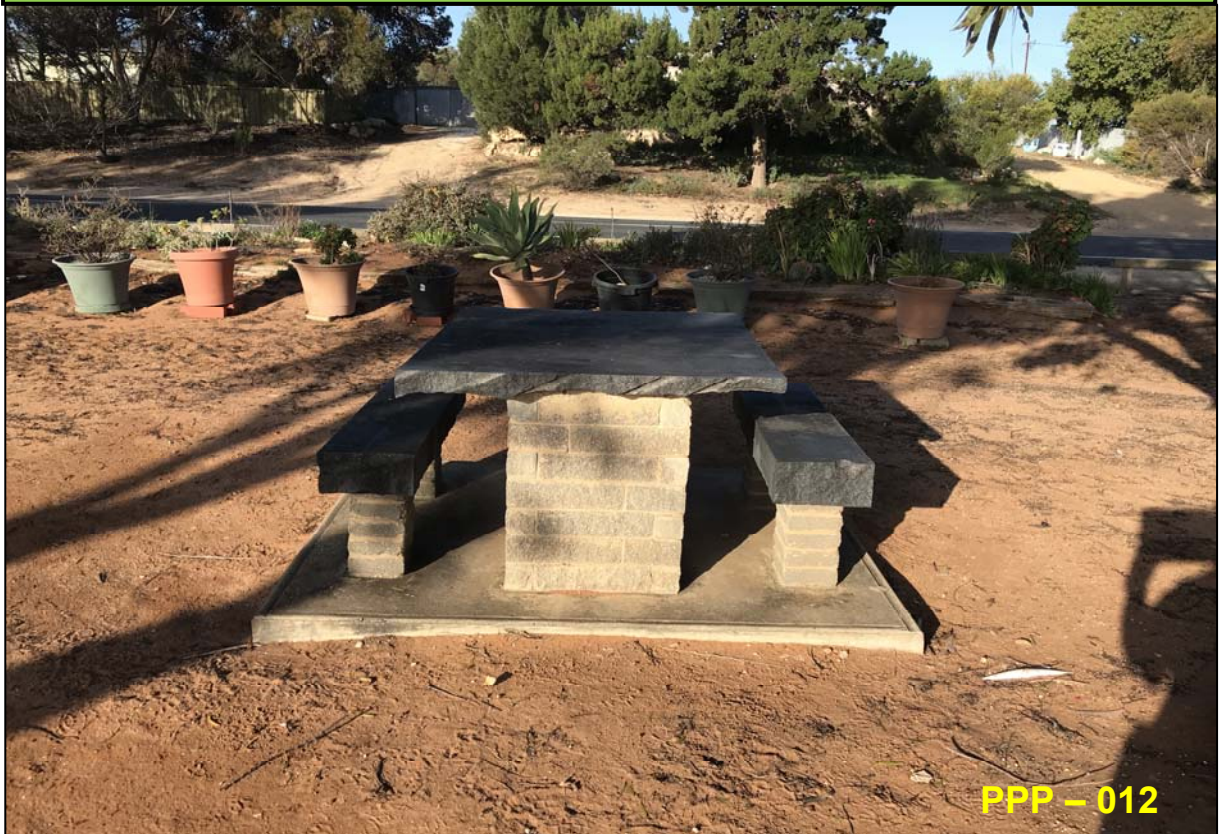
This feature bench table and seats are securely fastened together and are a good solid form.

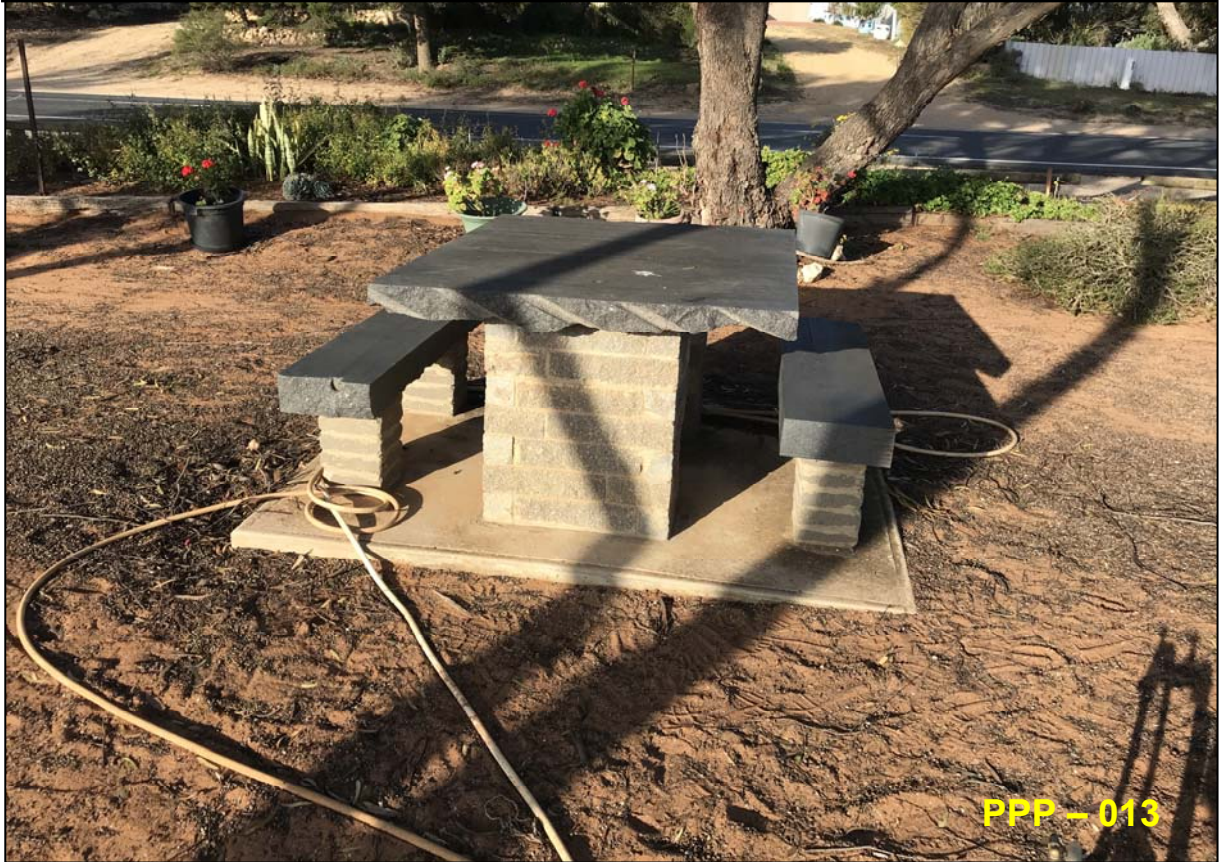
This feature bench table and seats are securely fastened together and are a good solid form.
