JULY 29, 2020

Playground Audit

MANNUM OVAL COMPLEX PLAYGROUND

MID MURRAY COUNCIL

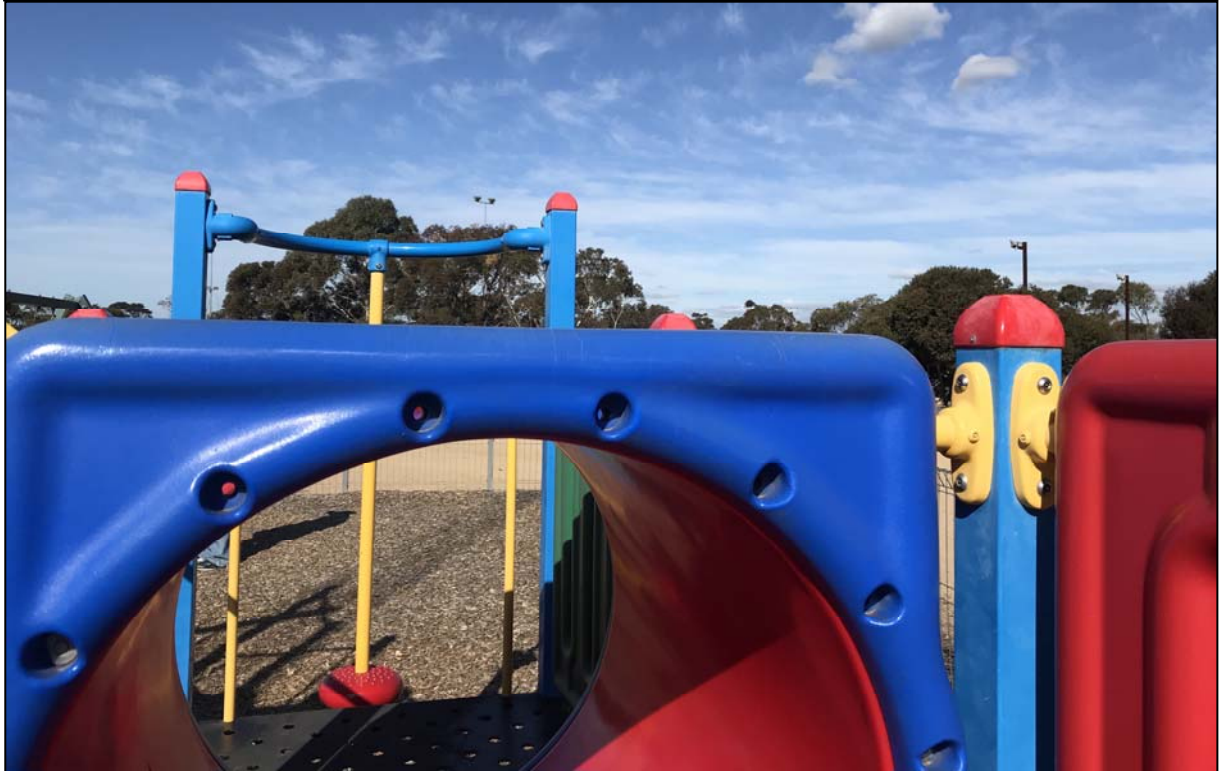
6 bolts missing from the tunnel

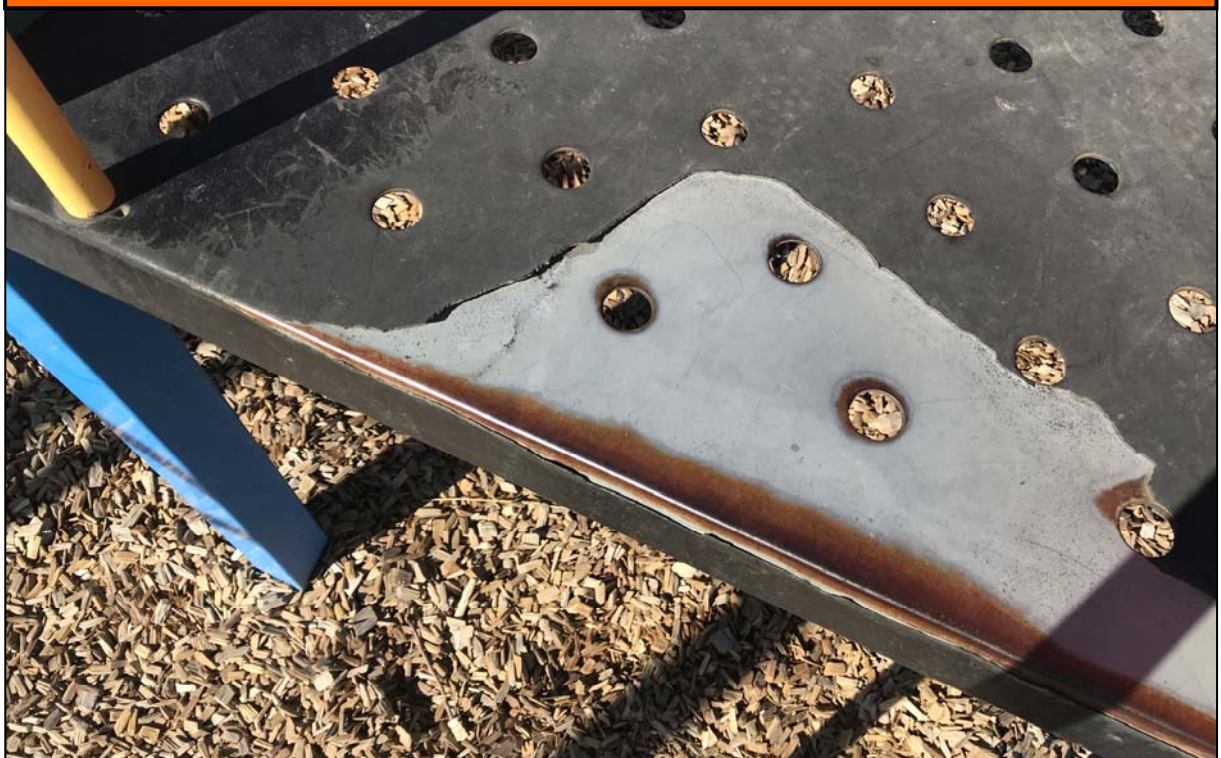
Are platforms and other standing surfaces free of moss, mold and other unhygienic matter that may cause corrosion or slipping?		No		Platform 2 had missing rubber coverage and is showing surface rust.	MEDIUM
Are all guardrails and barriers around decks and platforms secure, free of sharp edges and small enough for a child's grip?	Yes			All platforms are within specification	LOW
Are all equipment surfaces and parts in good order? (Check for splits, splinters, cracks, cuts and open joints. Look at specific pieces of equipment such as swings and slides. Swing seats should be made of a soft material rather than wood. Slides should have a smooth surface and gradual surface at the bottom.)		No		Some of the wooden items are starting to show wear, the swing bridge will also need replacement boards soon.	MEDIUM
Are the covers or guards which conceal pinch, crush or entrapment points well maintained?	Yes			The playground is a design that has very few guards.	LOW

Platform 2 has missing rubber from the steel platform

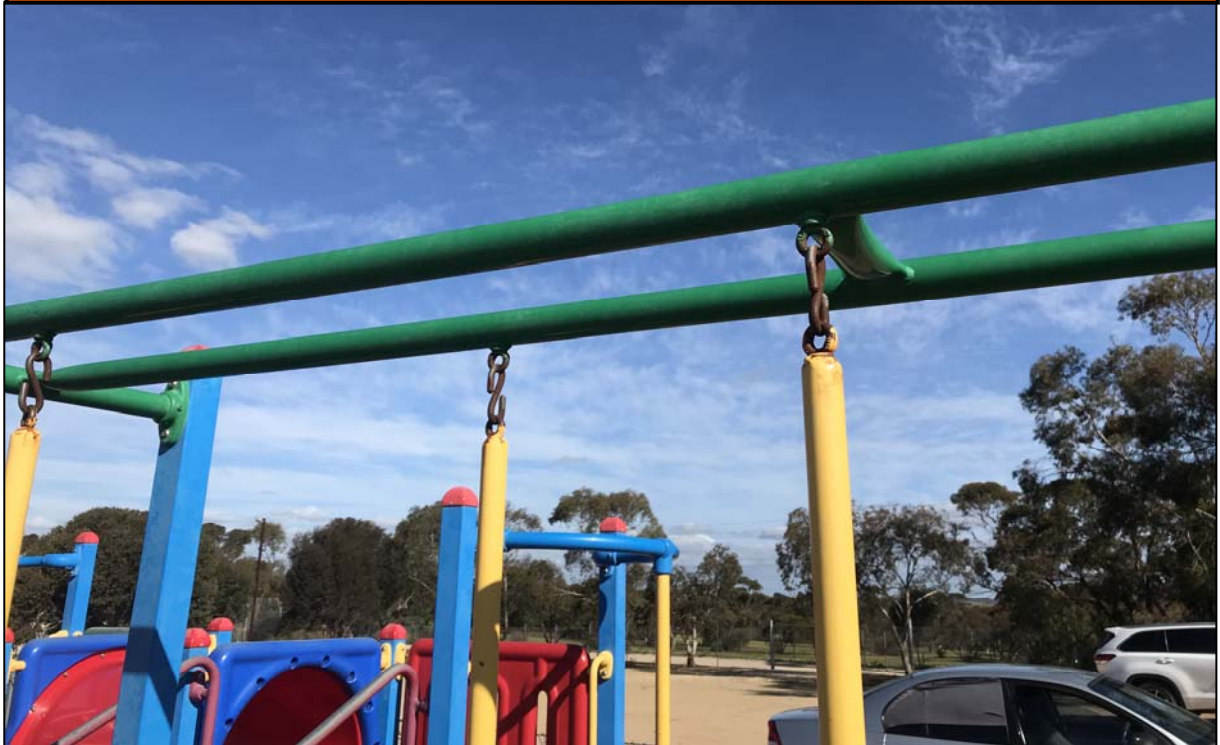
The panel hangers have “S” hooks on the top which are all worn through almost 50% and will require replacement. The bottom areas of attachment are a mixture of split links “S” hooks and “U” bolt

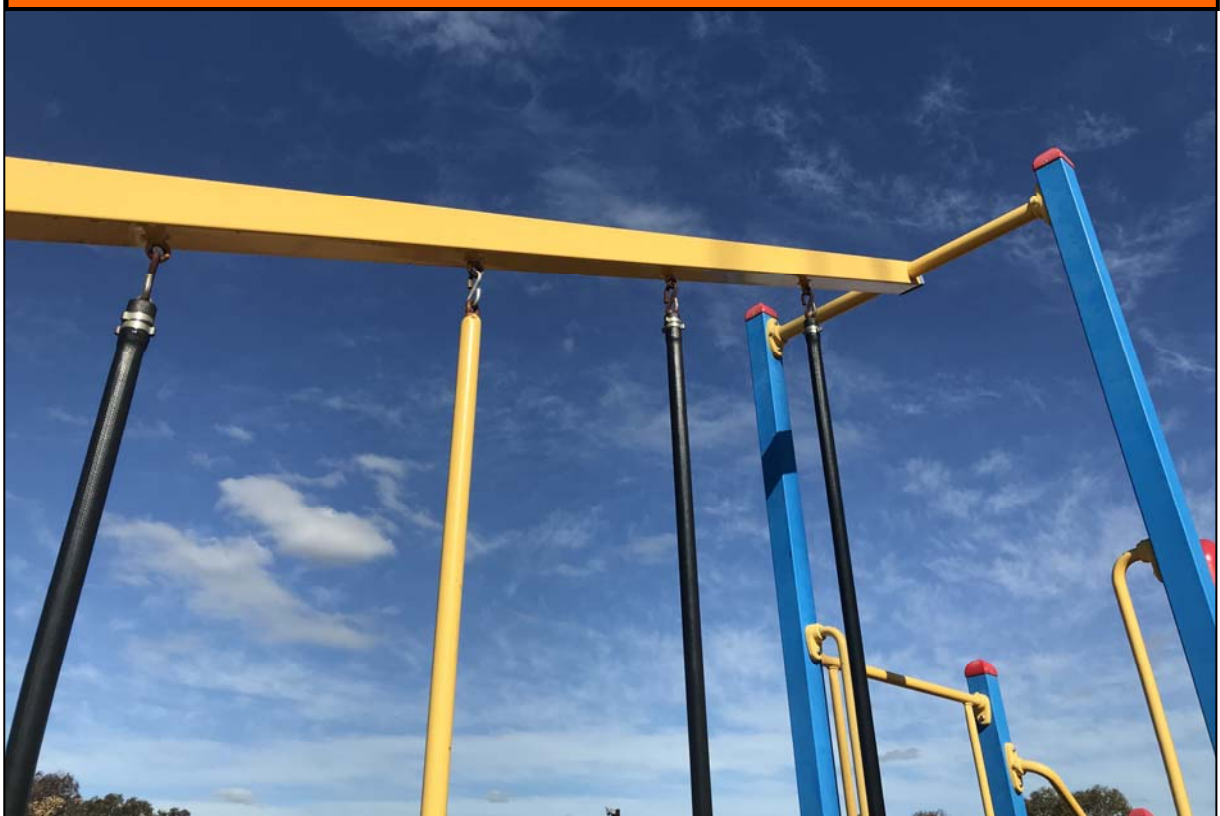
The chain climb has sufficient sheathing which has only been replaced. The top “S” hooks need to be replaced as they have reached 45% and will wear through much more quickly

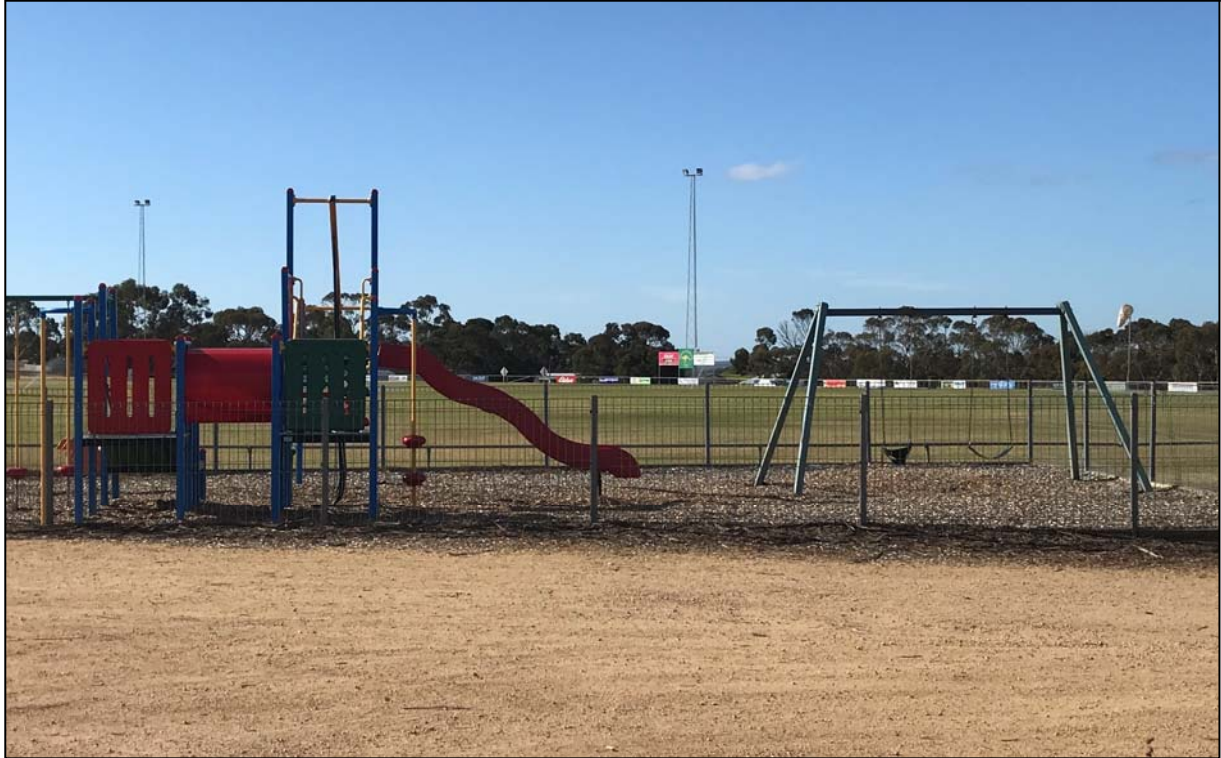
Is there enough space between equipment so that children can move freely between areas without bumping or running into each other?		No		The slide runout is 600mm too short when it comes out to the swing upright.

The slide is not compliant for run out and is approximately 1 m short of the maximum or minimum run out requirements for the slide exit, the swing is the obstacle in the way of the run out. The area from the slide to the swing is 1.9 m the area supposed to be 2.5.

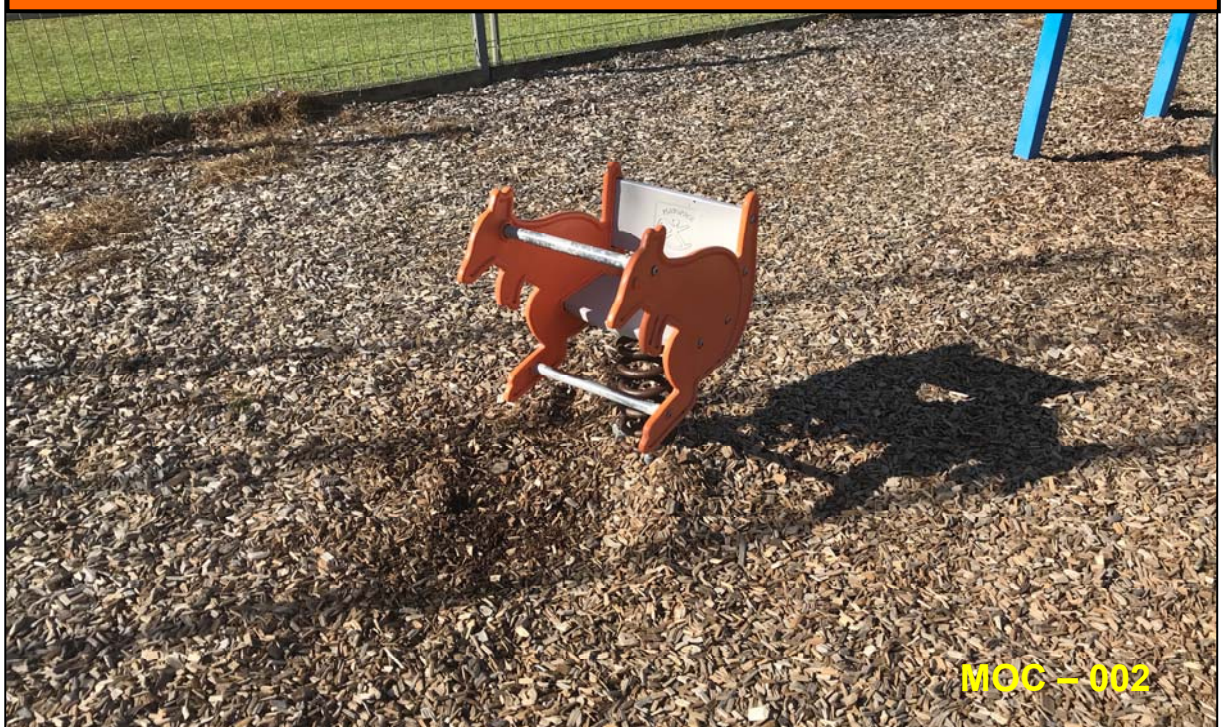
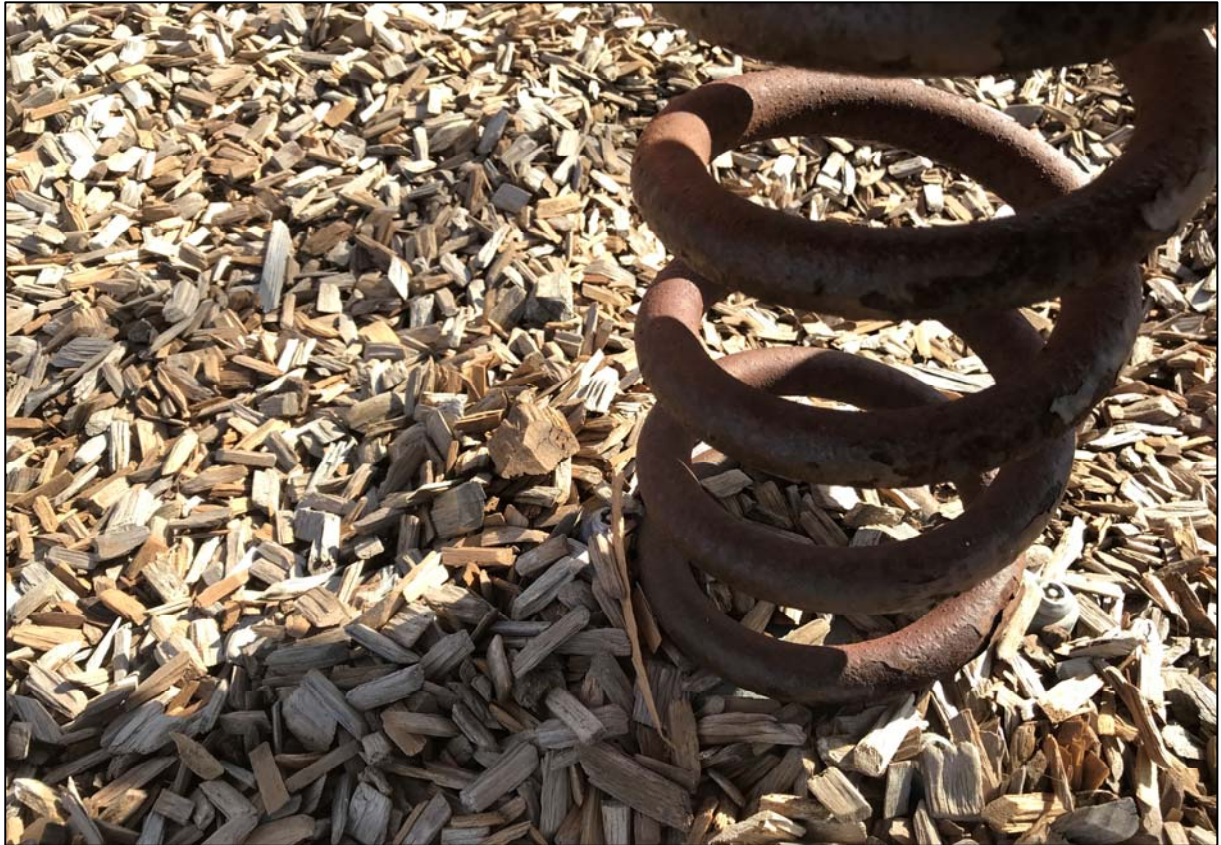
The kangaroo springer spring is rusting with the rust becomes flaky on the spring it is time for the spring to be replaced. The rust takes away the structural integrity of the metal causing it to snap when weight is applied to the spring by reducing integrity of the metal.

- The kangaroo springer spring is rusting with the rust becomes flaky on the spring it is time for the spring to be replaced. **(Remedial)**

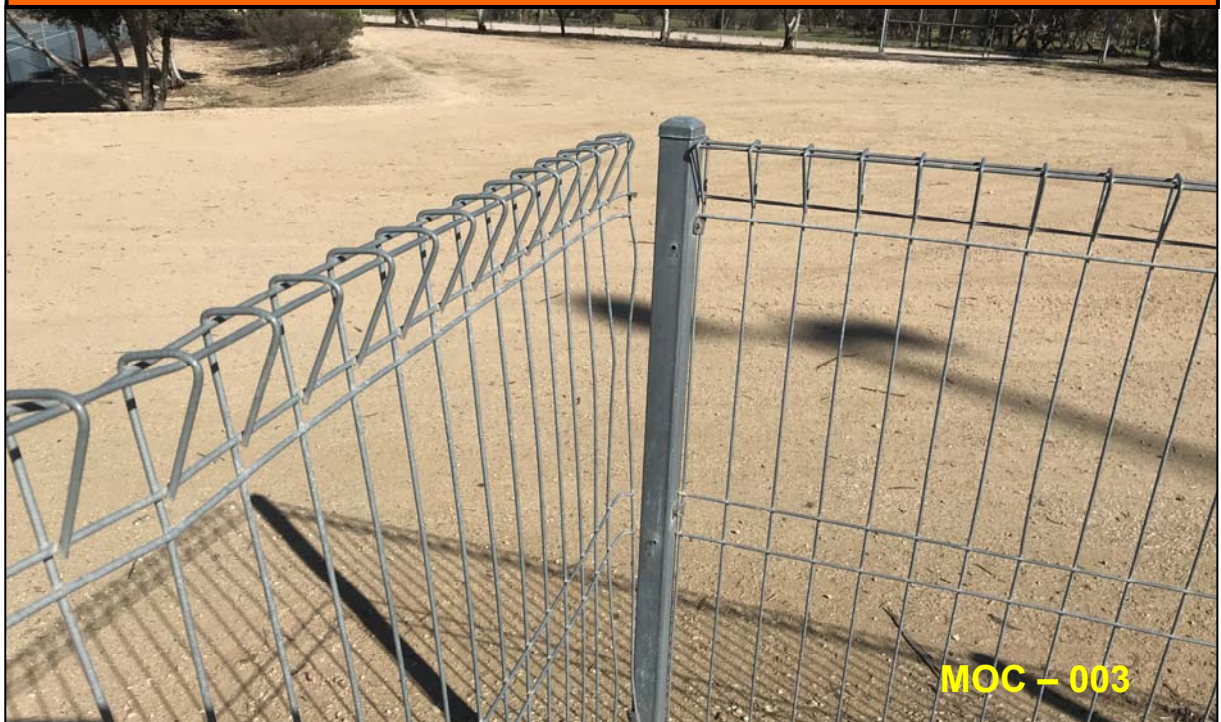
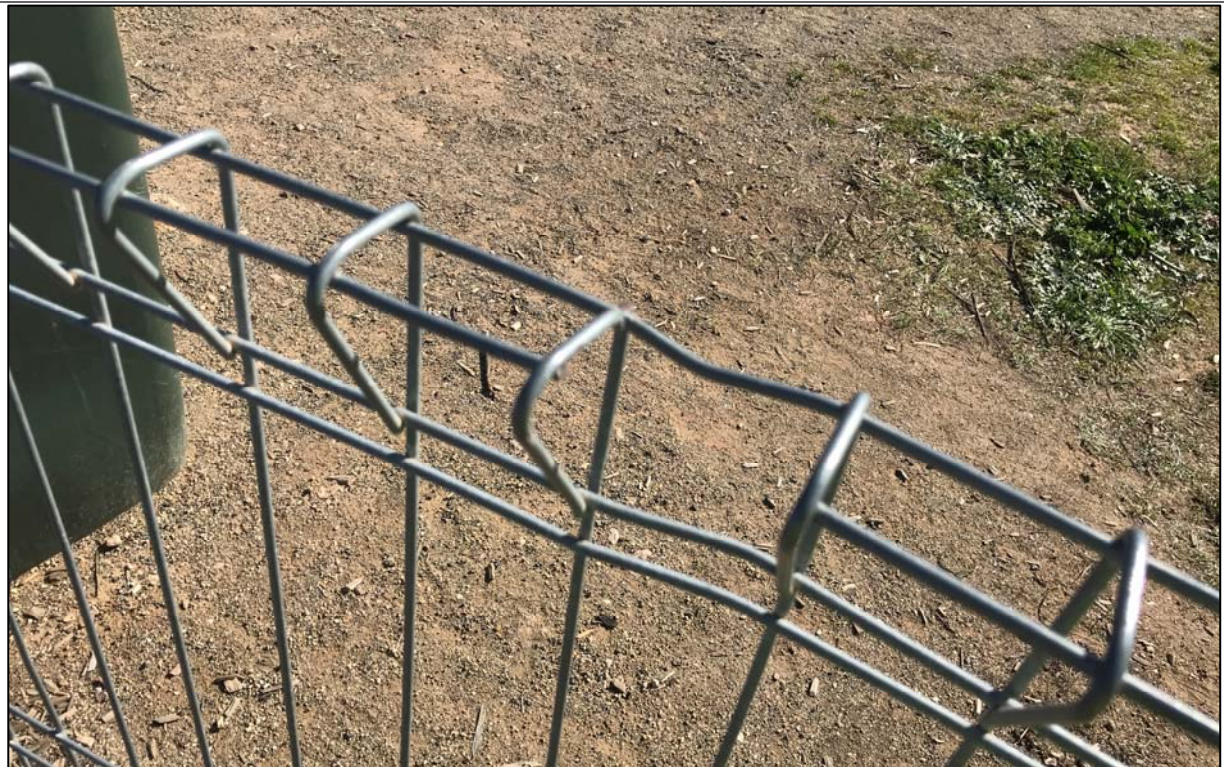
Are all access and entrance points to the playground and equipment free of exposed protrusions and sharp edges?		No		The fence is missing several fixtures and in places are broken

Five panels along the boundary fenceline of the playground either need replacing or they need to be repaired, some of the panels have broken crosswise specifically at the top which allows them to flex which will end up breaking the fence as it flexes within the points through the area. There is also a panel in the corner near the roadway opposite the entry fence which has two fasteners missing from the corner post allowing the fence to be pulled right over. This will need to be reattached.

- Five panels along the boundary fenceline of the playground either need replacing or they need to be repaired **(Remedial)**

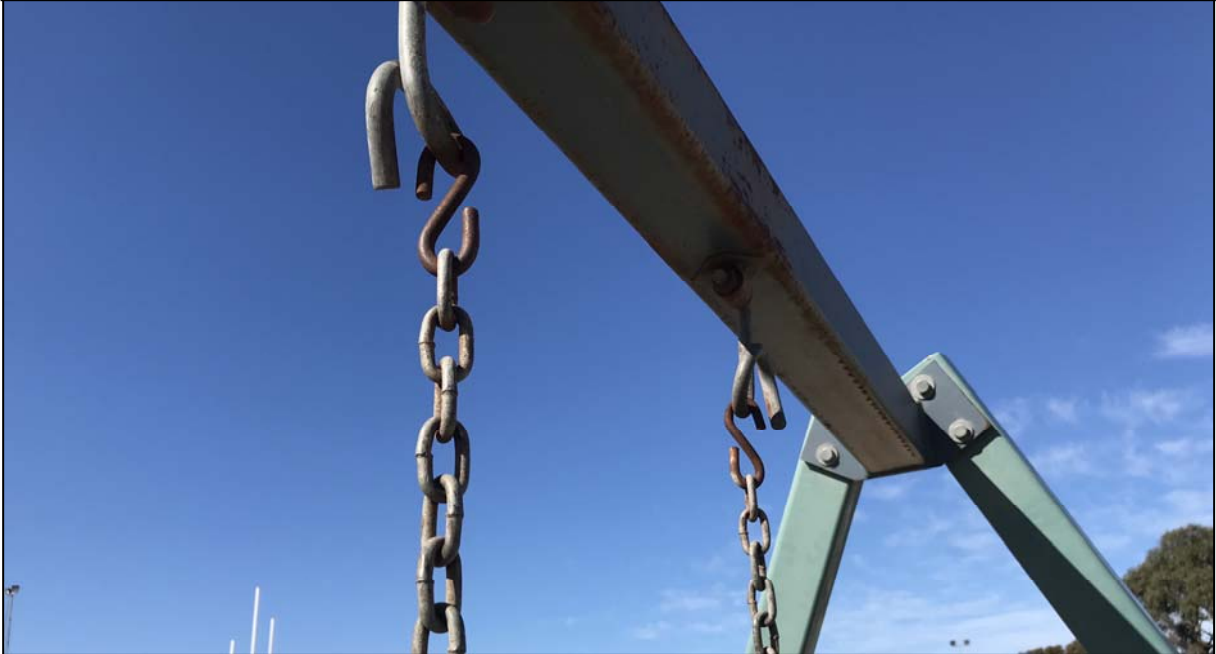
The swings have chains were three of them are non-compliant and are a finger trap. One chain has just been replaced which is the correct size. Also, the "S" hooks are not close properly. The pig tail chain swivels are the type which are used on removable swings and mainly used in kindergartens where supervised use is needed, the swivels should be of heavy-duty swivel with sealed bearings. In this case the swing does not have a long remaining life and will soon fail in the uprights from excessive rust.

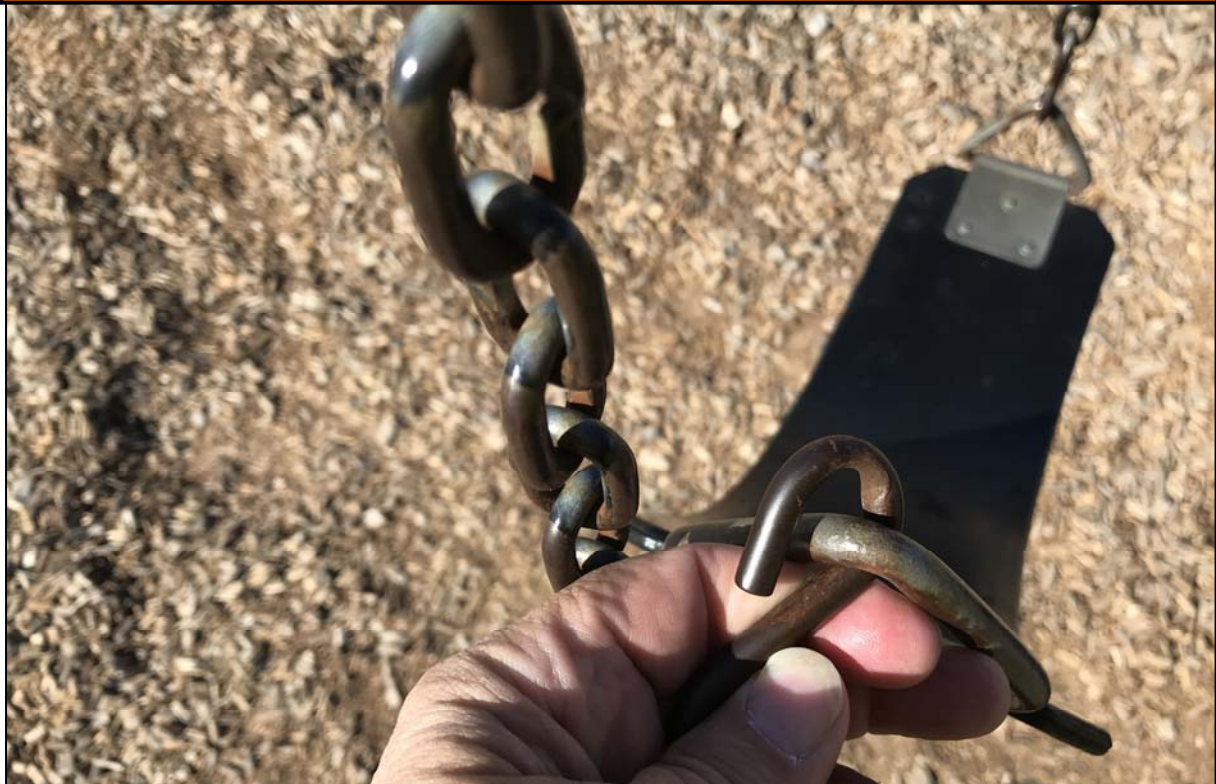
The "S" hooks also have worn down to about 45% which indicates that it's time for them to be changed over with new S hooks.

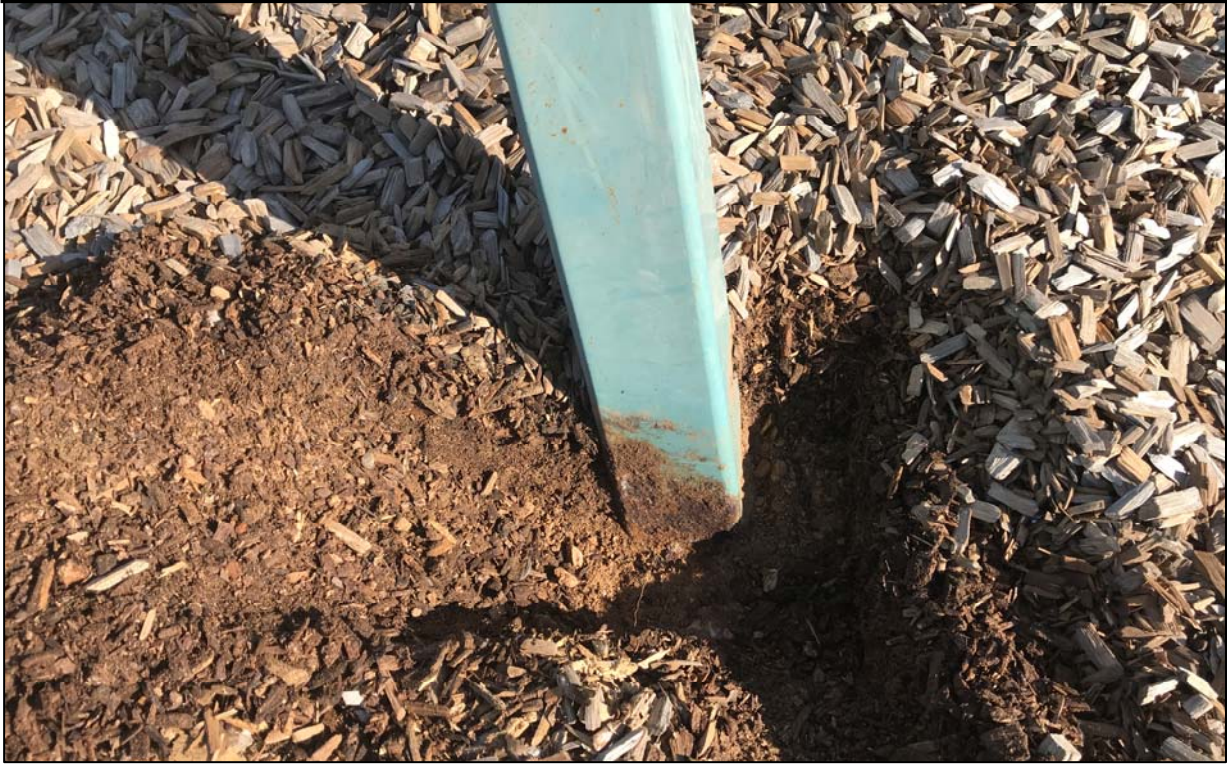
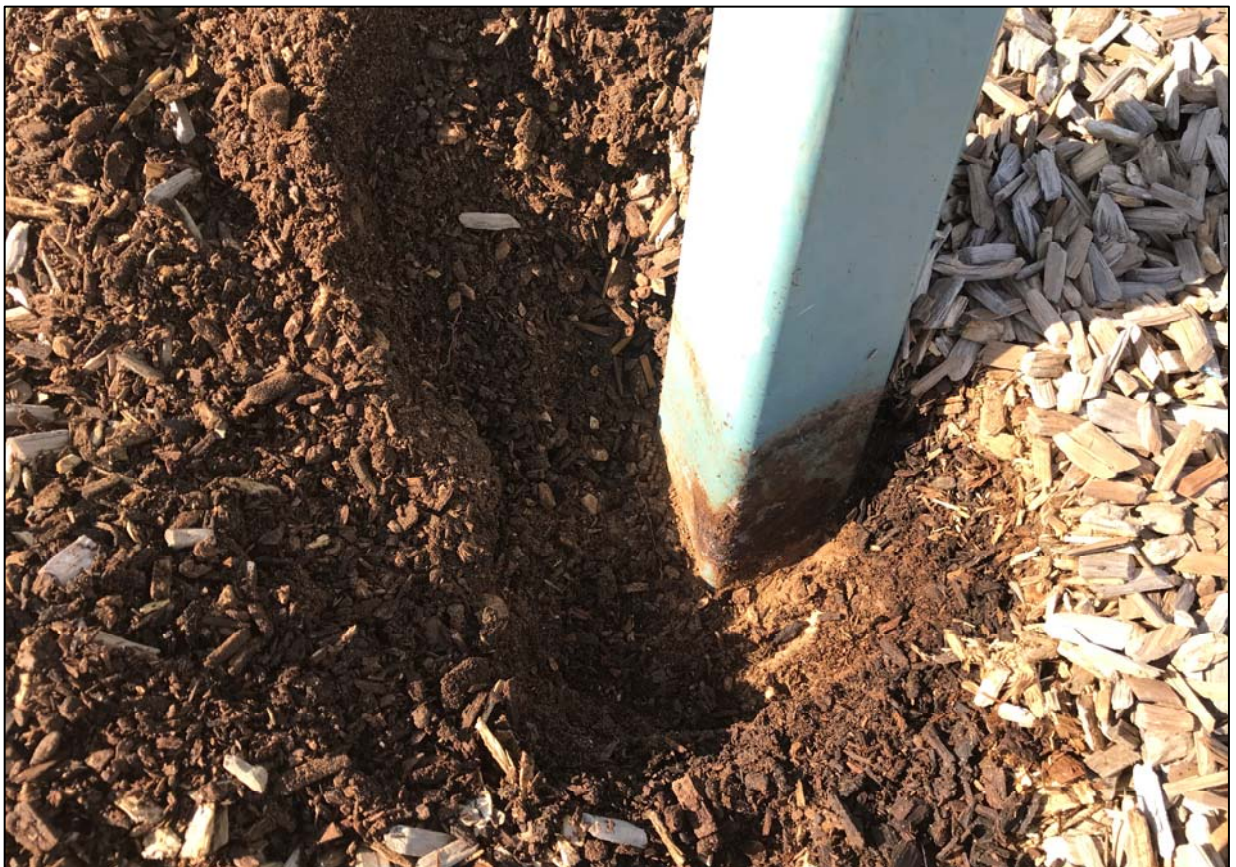
Are all structures free of rot or corrosion and have no missing parts, panels or fittings? (Check that plastic equipment is sound and free of cracks and deterioration from the sun.)		No		The swing uprights have flake rust emanating from the ground up.	MEDIUM
Are all components designed to prevent water entering enclosed areas and free of deterioration? (Check cap ends, grommets, on bolts or screws.)	Yes			All caps and grommets are in place.	LOW
Are all components free of corrosion and bulging and all nails and fixings flush with surface or countersunk?		No		The swing does have rust in both the uprights and the top crossmember.	MEDIUM
Are all bolts and fasteners secure?		No		The tunnel is missing 6 bolts.	MEDIUM
Are all exposed protrusions and sharp edges removed? (Check for protruding nails, rivets and bolts, which may need to be covered or sawn off.)	Yes			There are no protrusions that were of risk or out of the ordinary.	LOW

Flaking rust is quite bad on the swing's uprights at ground level, the flaking is causing a cancerous void within the steel upright I would say most likely two years of the best before this becomes bad that it will rust right through.

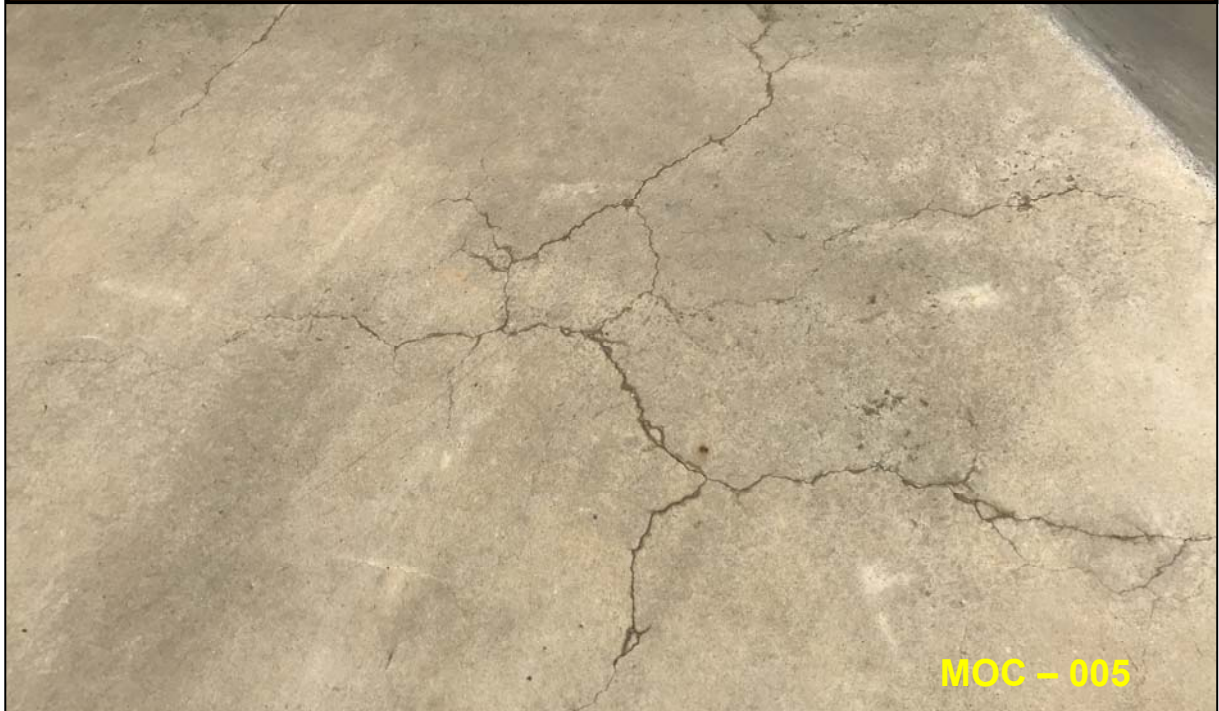
Foundations for exposed concrete, rot and corrosion.	The concrete on the skate pad will require sealing as its starting to crack.

The concrete that makes up the main body of the skate pad is cracking which allows both moisture and fine debris to rest within these areas, the concrete needs to be treated with a heavy-duty concrete sealant to prolong the life of the concrete and to keep the surface smooth.

- The concrete that makes up the main body of the skate pad is cracking which allows both moisture and fine debris to rest within these areas, the concrete needs to be treated with a heavy-duty concrete sealant to prolong the life of the concrete and to keep the surface smooth. **(Remedial)**

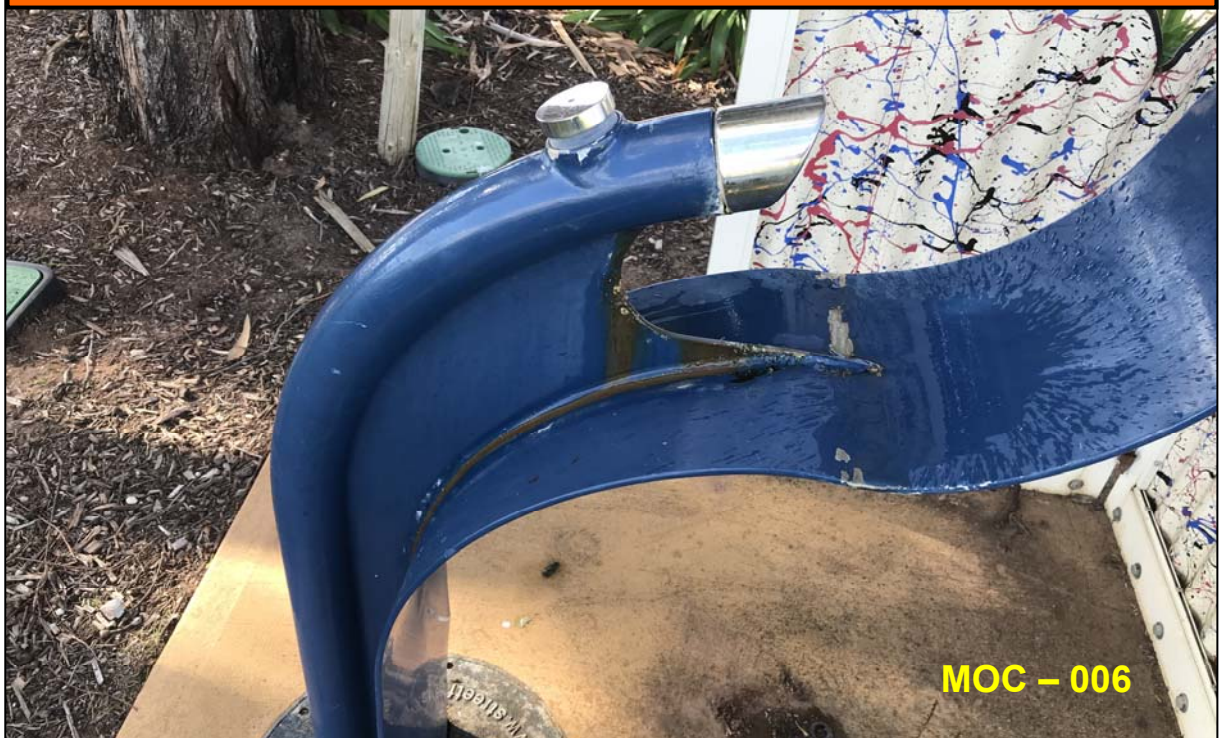
Excessive corrosion, particularly within structural members.	Small areas of rust on the fountain due to leaking tap, but not of major concern.

The water fountain has a leak which is constant below the push tap, it's probably only needs a washer or a ring to stop any of the leaking happening, the leak has been prevalent for some time as rust have occurred down the side of the actual water fountain. There is corrosion around the exit point where the chrome meets the powder coated upright.

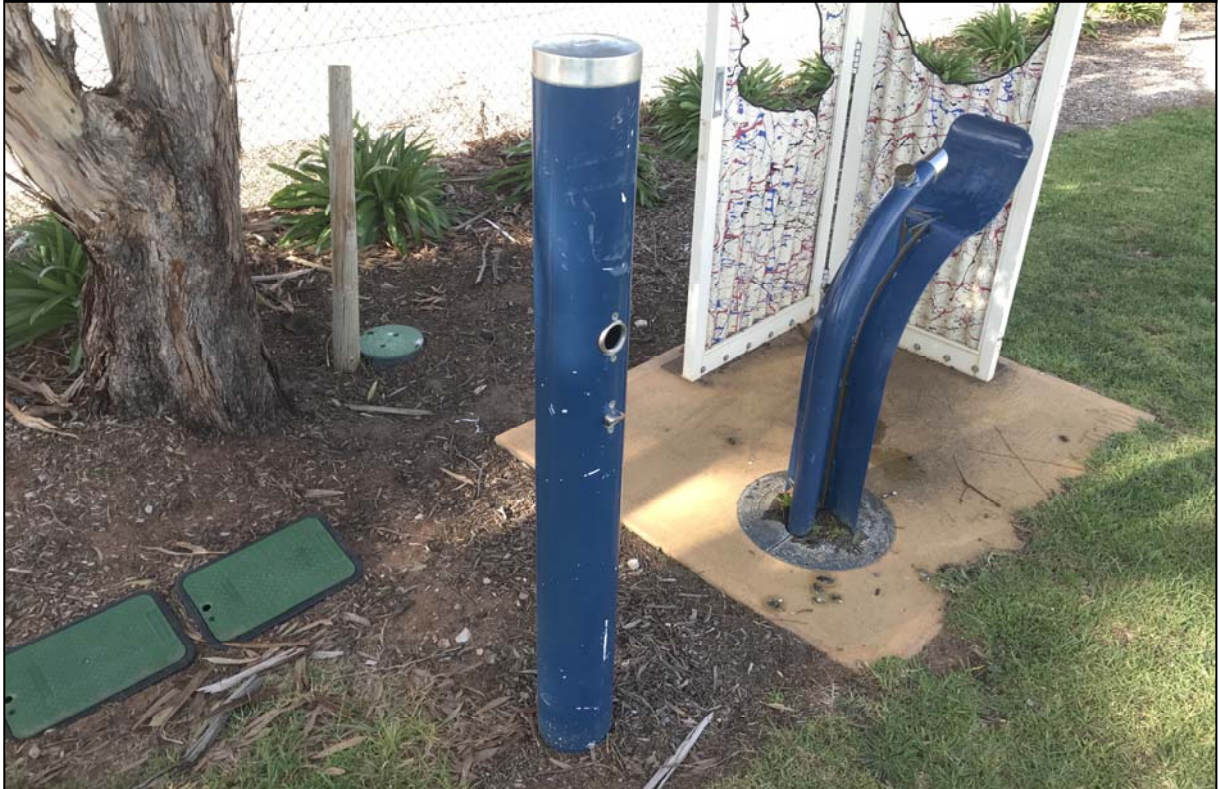
The fountain next to it looks to be non-operational there is no way of turning it on and I'm not really sure how it supposed to work there is a piece missing.

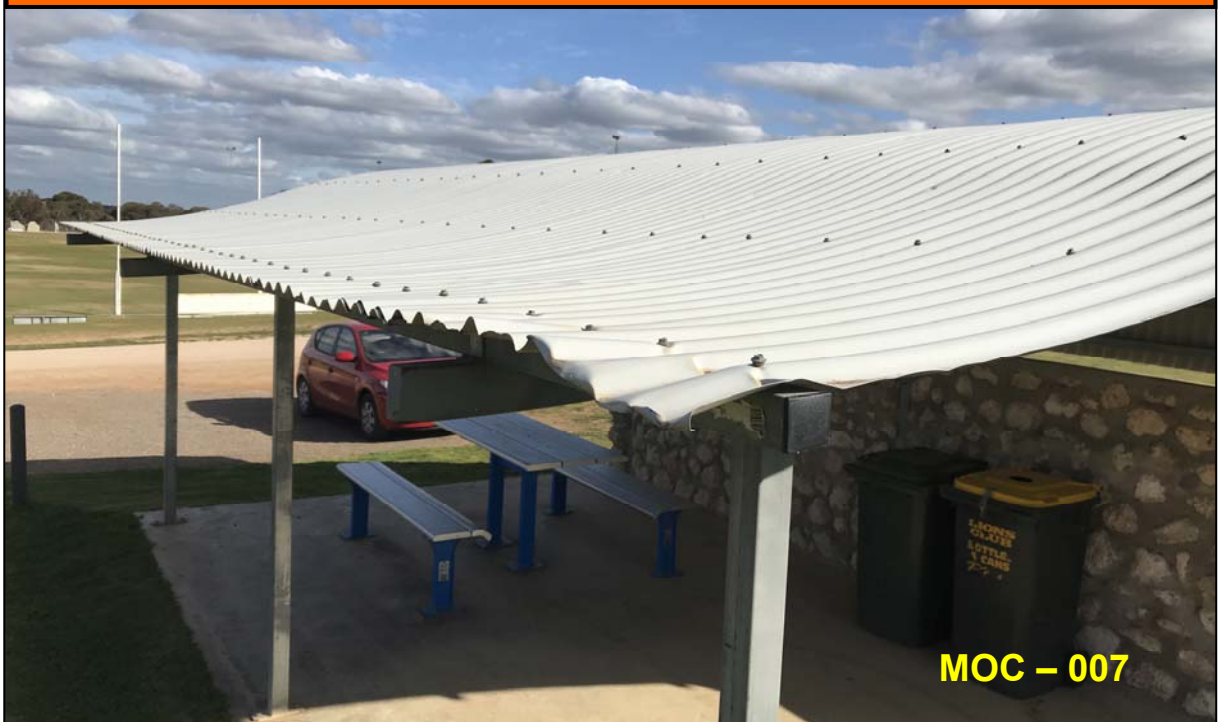
Any protrusions and sharp edges.	The top of the shelter has a sharp edge which should be made safe.

The roof of the shelter which is the skate park seating area on the corner which is very close to head height and can easily be reached. The tin roof has been damaged before in the past it looks like it has been rolled over. This should have a protective component such as a rubber capping, usually the end tin is covered with guttering and usually is not this low.

- The tin roof has been damaged before in the past it looks like it has been rolled over. This should have a protective component such as a rubber capping (Remedial)

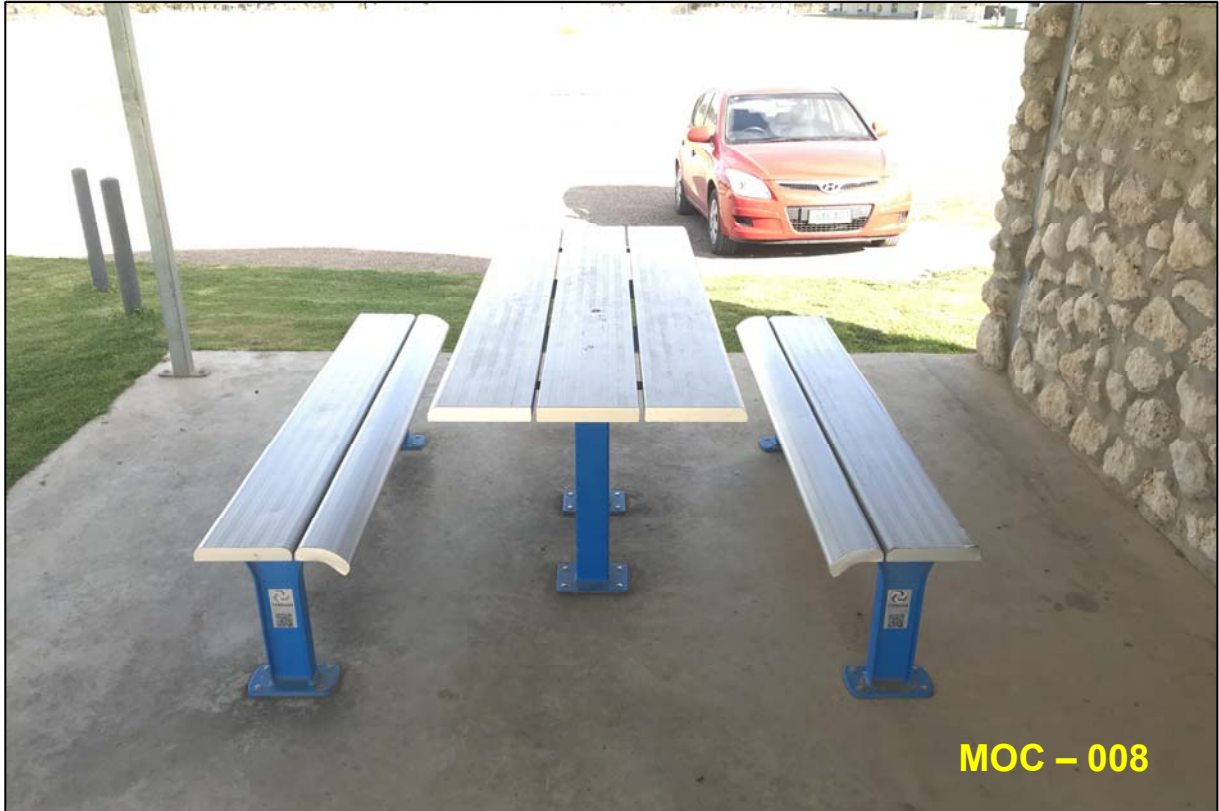
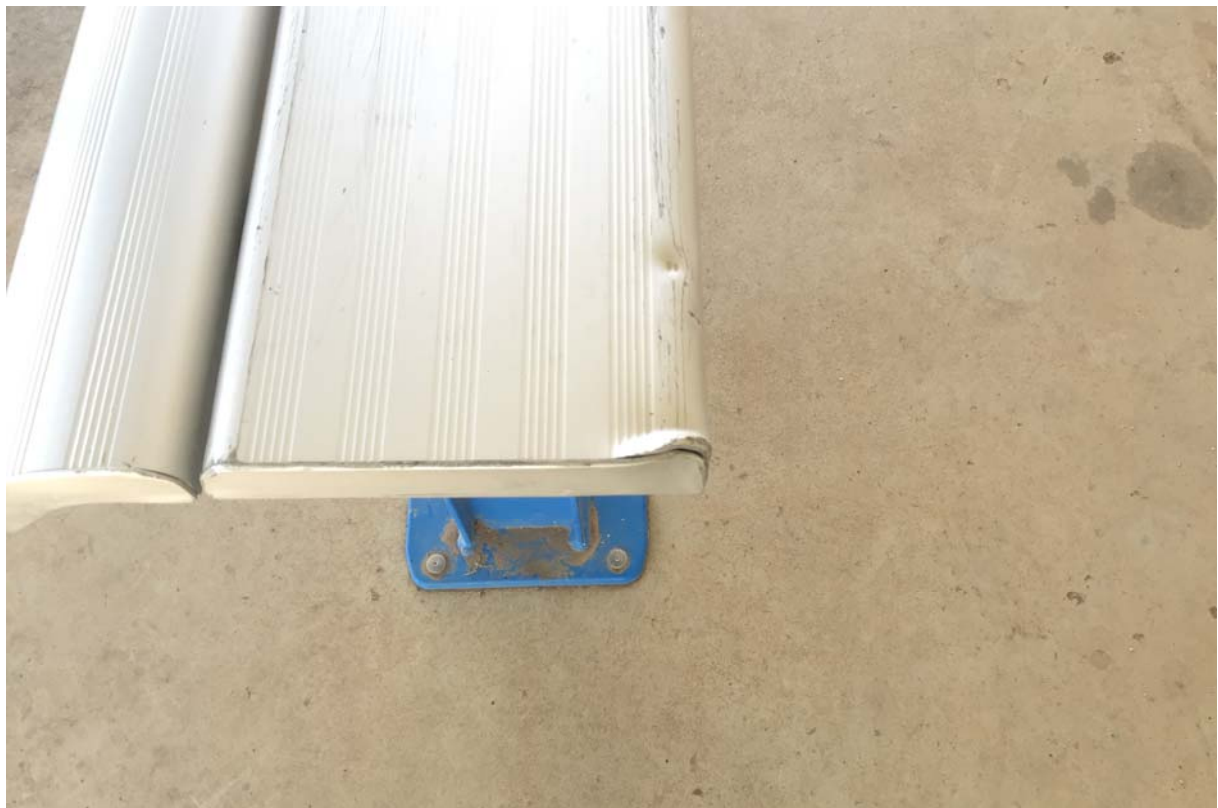
The aluminum Bench seats and table shelter is still quite good condition with only one area of damage on the back seat along the back edge. This has been crushed in on both ends but only slightly and it still does not remove any of the use from the seat and doesn't need to be changed at this time.

- No work for now.
