OPEN SPACE SERVICES

AUGUST 3, 2020

Playground Audit MANNUM CARAVAN PARK

MID MURRAY COUNCIL

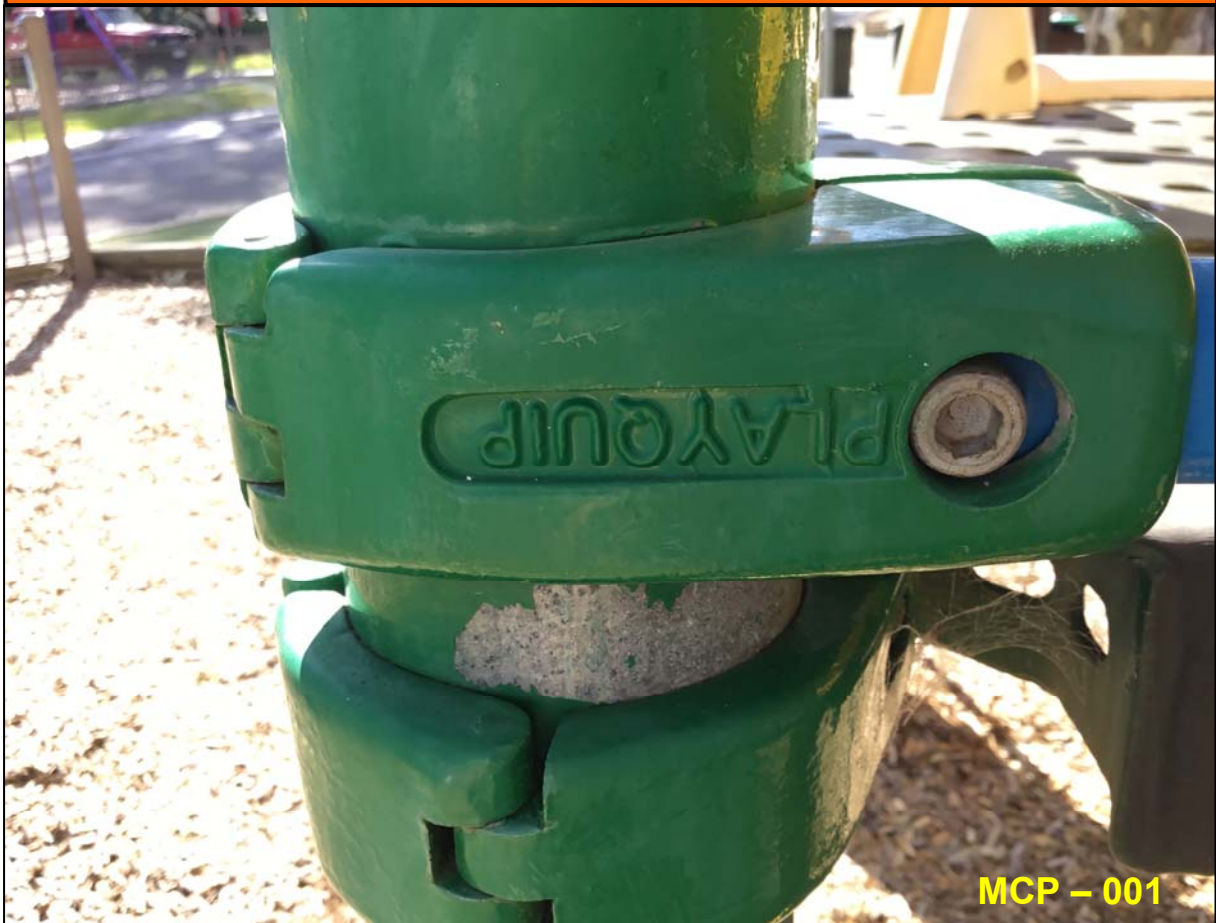
The older play structure showing signs of wear and tear, the platforms are still intact with no peeling of the rubber coating that was applied this could be attributed to the paint that was used to paint the top of the rubber which has reduced significantly amount of cracking that usually occurs with the rubber on these platforms. It also could be due to the shade within the tree as there are many surrounding trees that deliver shade cast upon this area. All handrails are out of spec and a greater than the pelvic probe which is 91 mm this allows the pelvis to go through but the head probe does not pass through the point which creates a hang point for the head with the body suspended above the entrapment area. This is prevalent with young toddlers only. The area of nougat's and crosses is also out to spec for the pelvic probe which allows toddlers bodies to pass through the area but their head gets caught as it is not wide enough to pass through. There is no rising rust within this area but the average softfall is 100 mm which is below specification for this area and the height of platforms. The slide also is not a fixed and can be lifted up and could be broken off if lifted too far.

- The piece of equipment is out of spec and will require replacement at the end of life
- Softfall top up required

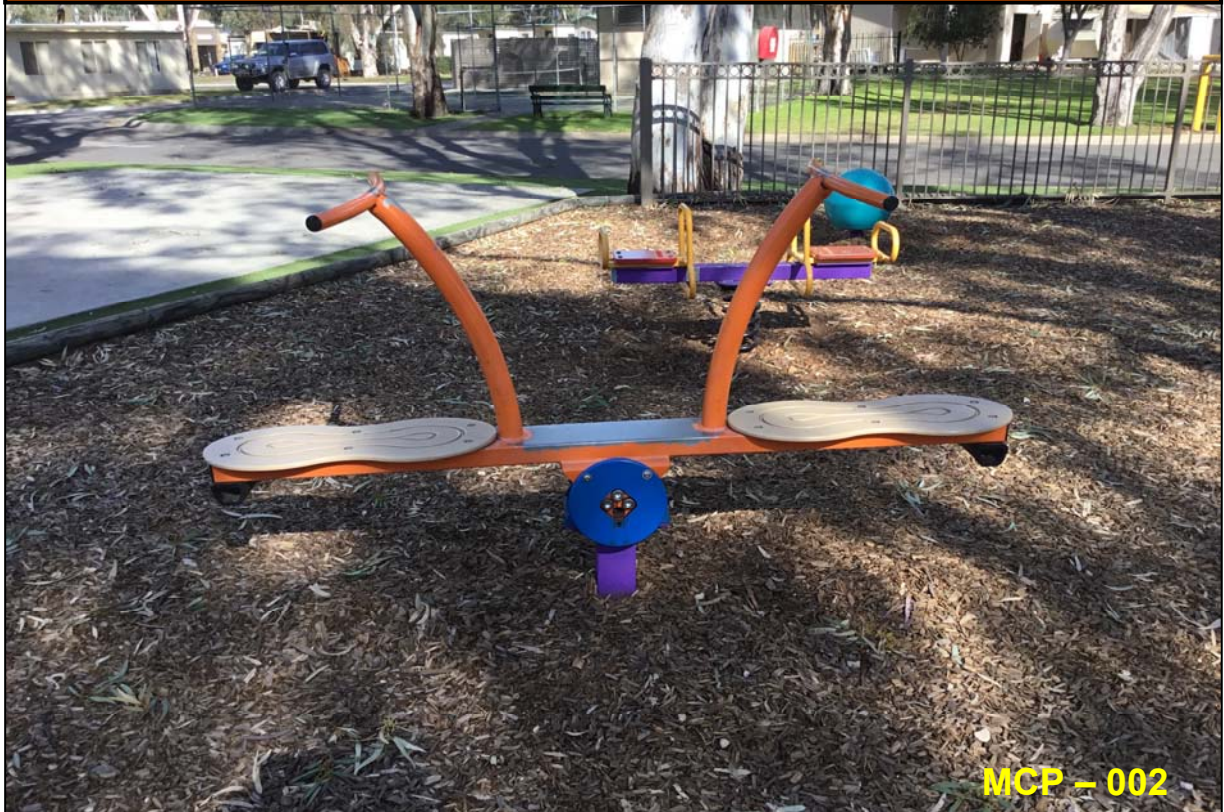
MCP – 001

This seesaw still functions correctly but it does have two large bolts missing both one in the side. Some of these bolts are also loose and will only tighten up to a certain degree when replacing them. The maintenance person has the bolts that have come out but the thread in one is stripped and may not work anymore, the two end plates are missing.

- There are two bolts missing and the side plates have come off. **Defect**

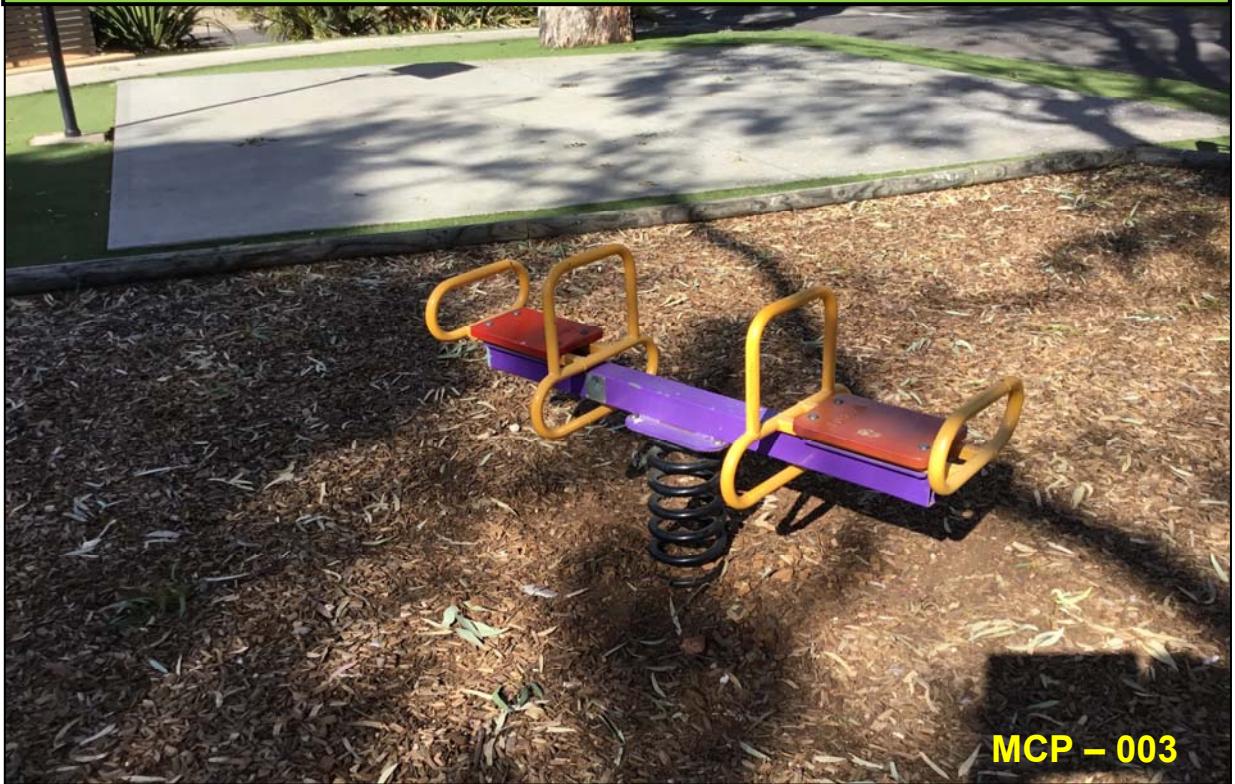
MCP – 002

This springer is in good condition with the base plate being sound with no areas of rust within the bracket hold down or any of the spring bass. Spring is also still having original paint and no areas of paint cracking lifting or bubbling from any type of rust within it. The crossmember section is all still intact this type of equipment.

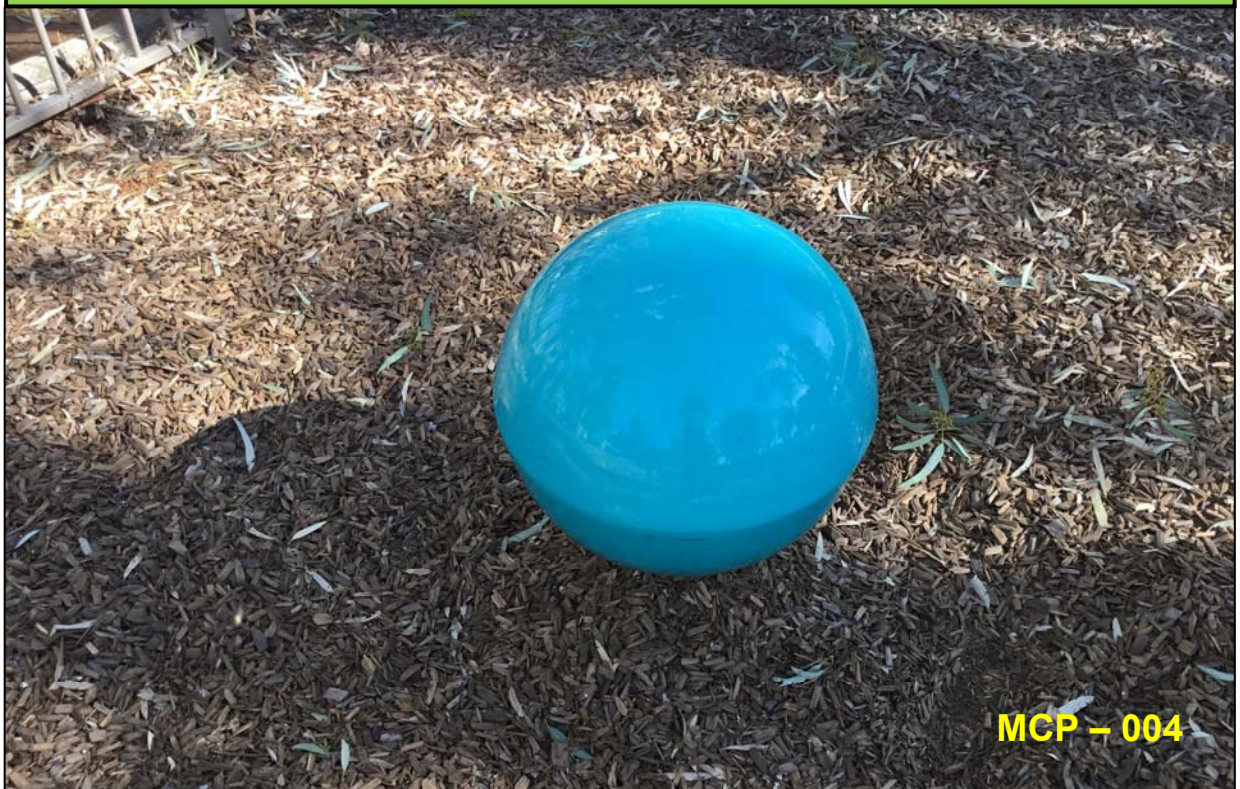
The ball is still in good condition and bearing does not show any wear and does not have any movement by sideways or up and down.

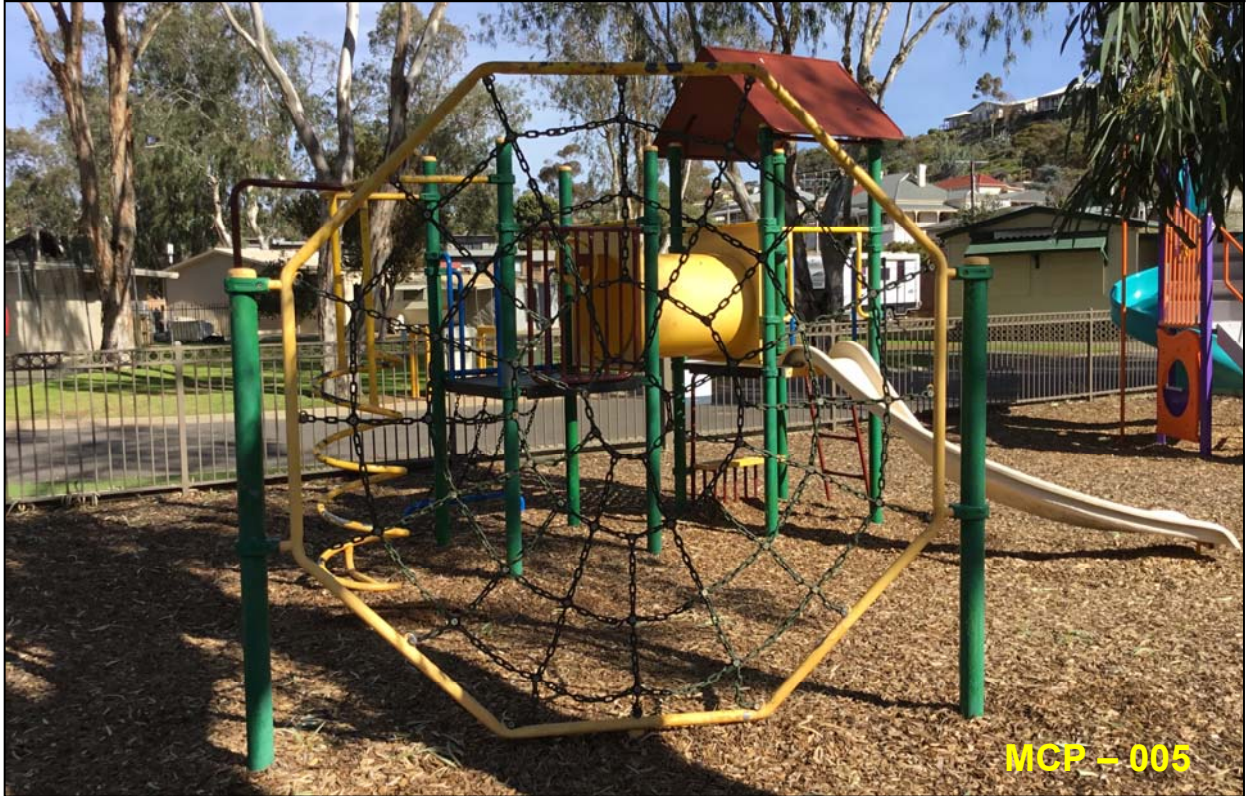
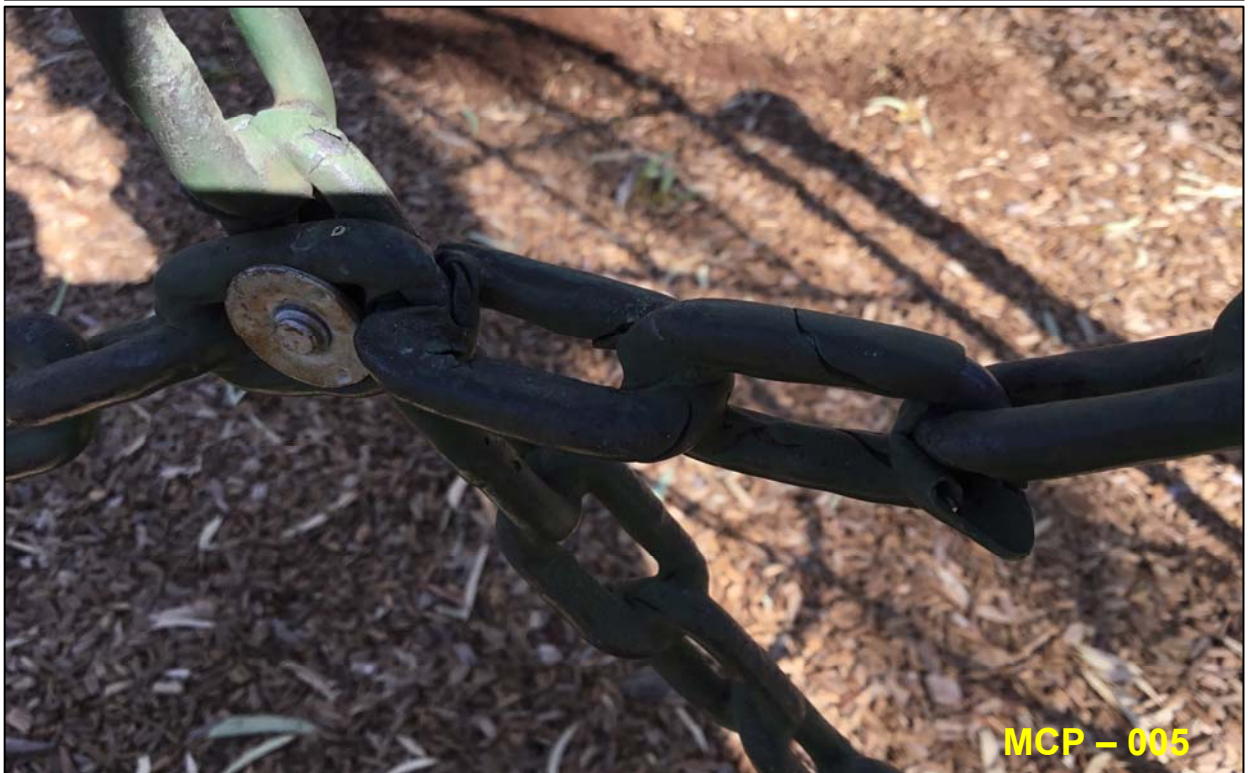
The chain web climbing equipment is of old rubber coated chain, the chain is not within spec and is classed as a finger trap being greater than 8.1mm but less than 12mm. The equipment structure itself is in good condition there is very little wear within the point of attachment and overall frame is good and has been painted which is probably extended the life of this piece of equipment. I would recommend the chain be removed and new chain used to replace it, the have links will need to have an opening less than 8.1mm usually a 7mm chain will be in this category of link opening, use 7mm S hooks to affix it to the frame.

- Remove and replace chain into the existing frame **Defect**

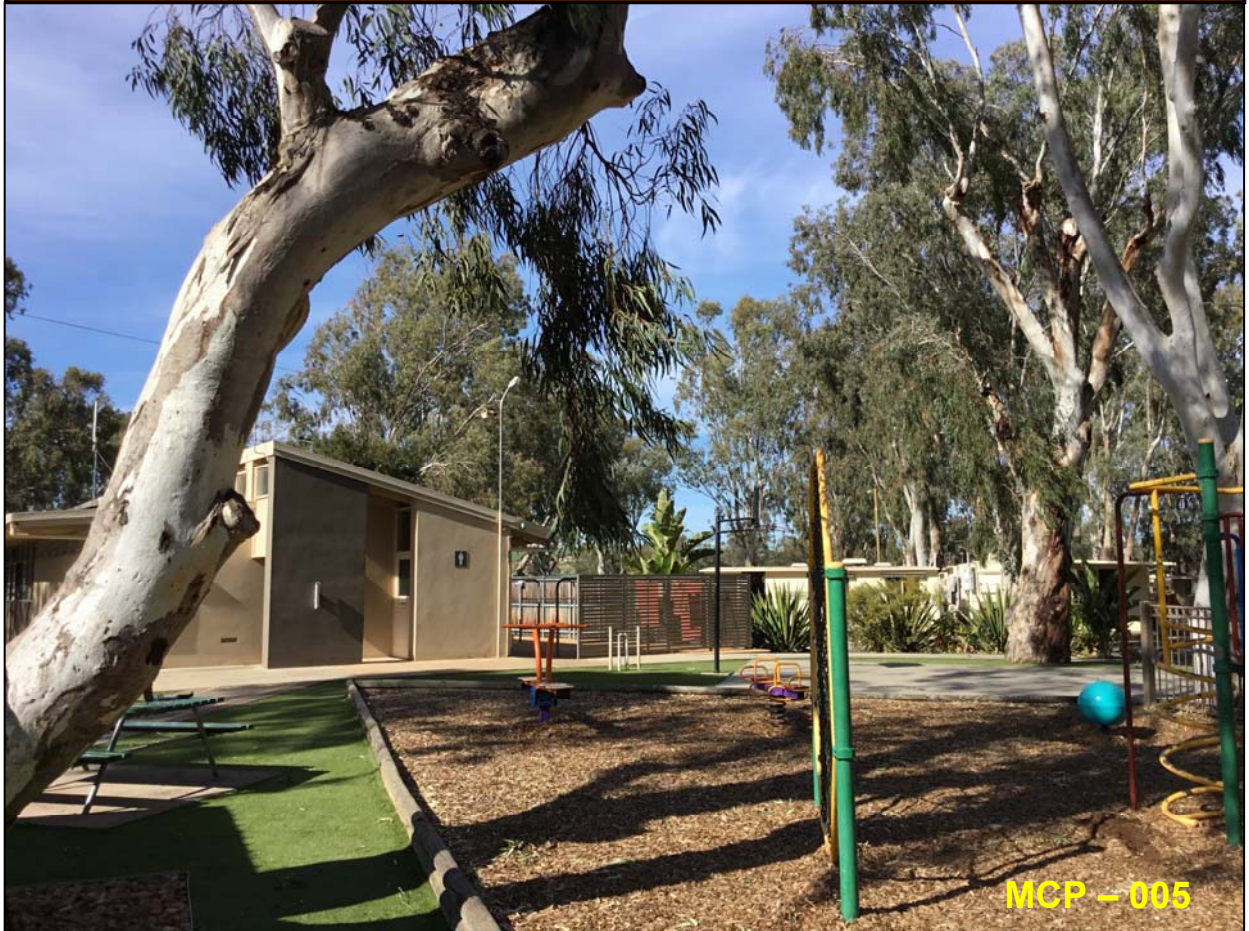
Pruning of the *Eucalyptus camaldulensis* (River Red Gum) will be required, the chain web as it is too close to this item of equipment is only the drooping foliage that is to close this can be cut off back to the attachment point to the main leader.

- Prune River Red Gum away from the Chain Web **Remedial**
- Softfall top up required

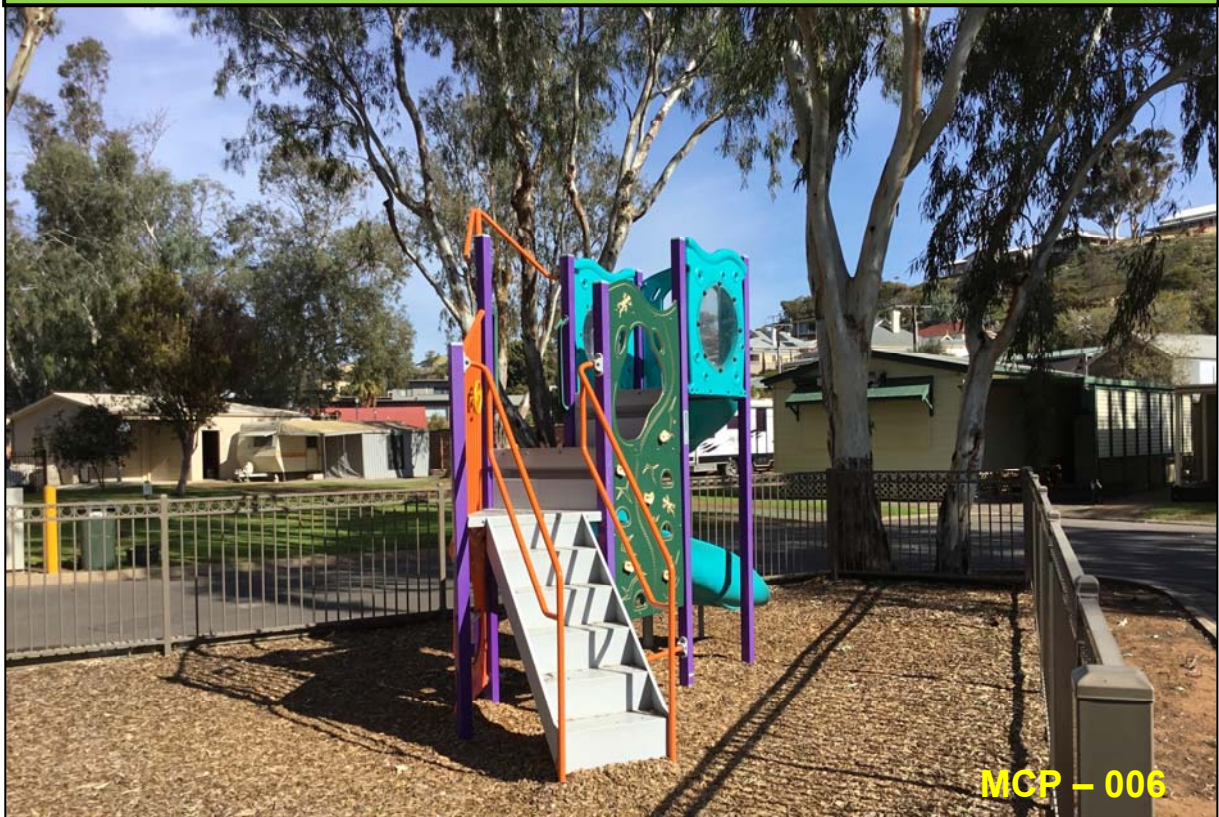
This piece of equipment was installed in 2013 and the item is in as installed condition with normal wear for the period it's been standing. The structure is stable with all barriers fastened and in place.

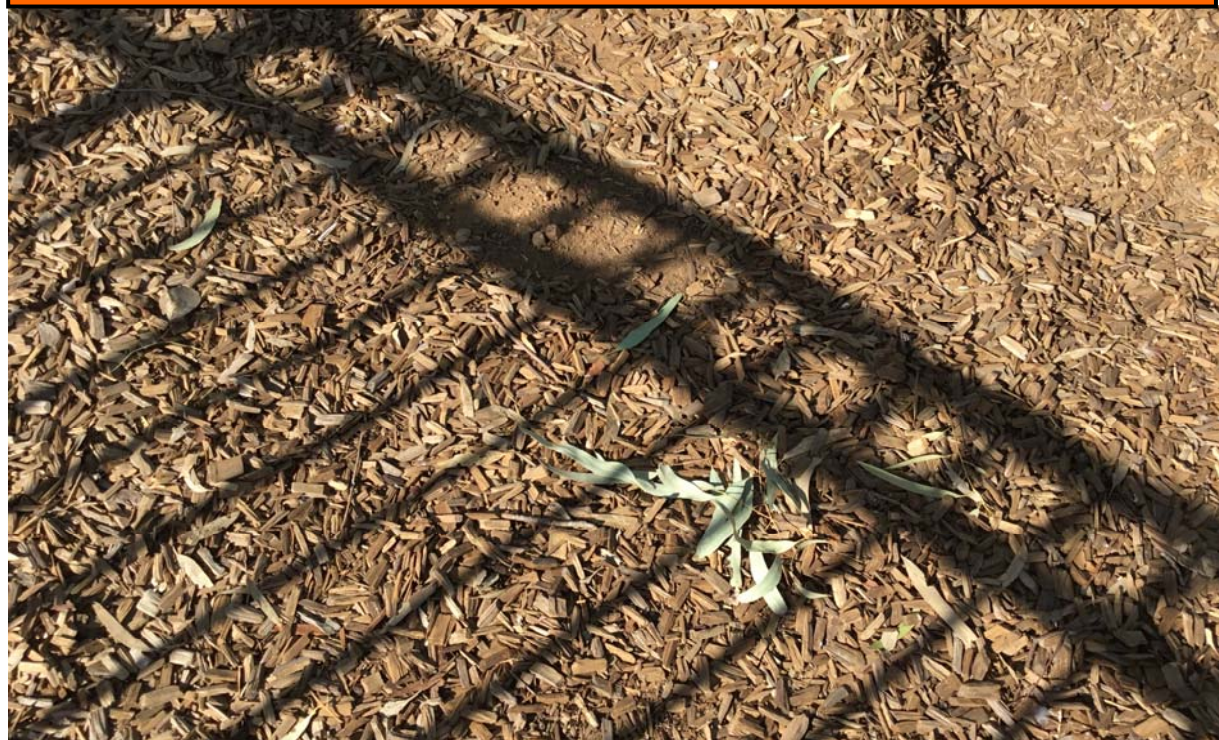
The amount of softfall is inadequate and needs to be a minimum of 200mm with a 100mm overfill for gradual decay of lower chips.

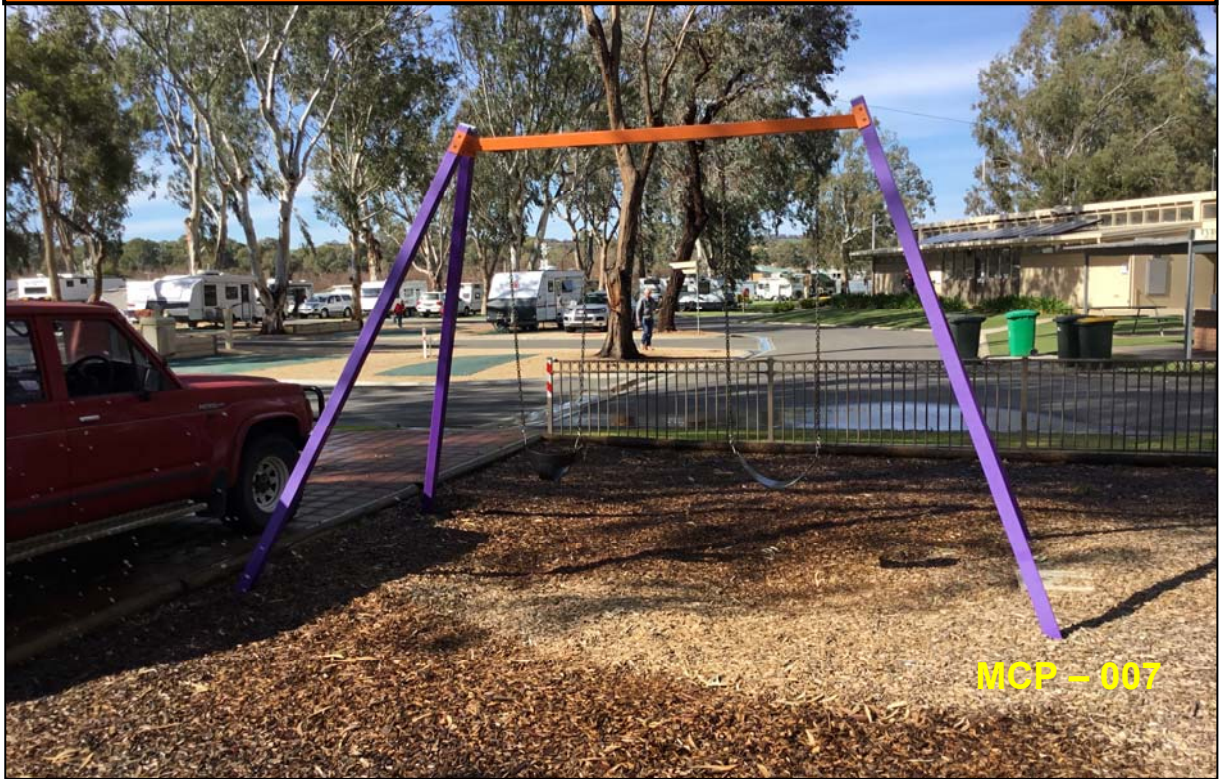
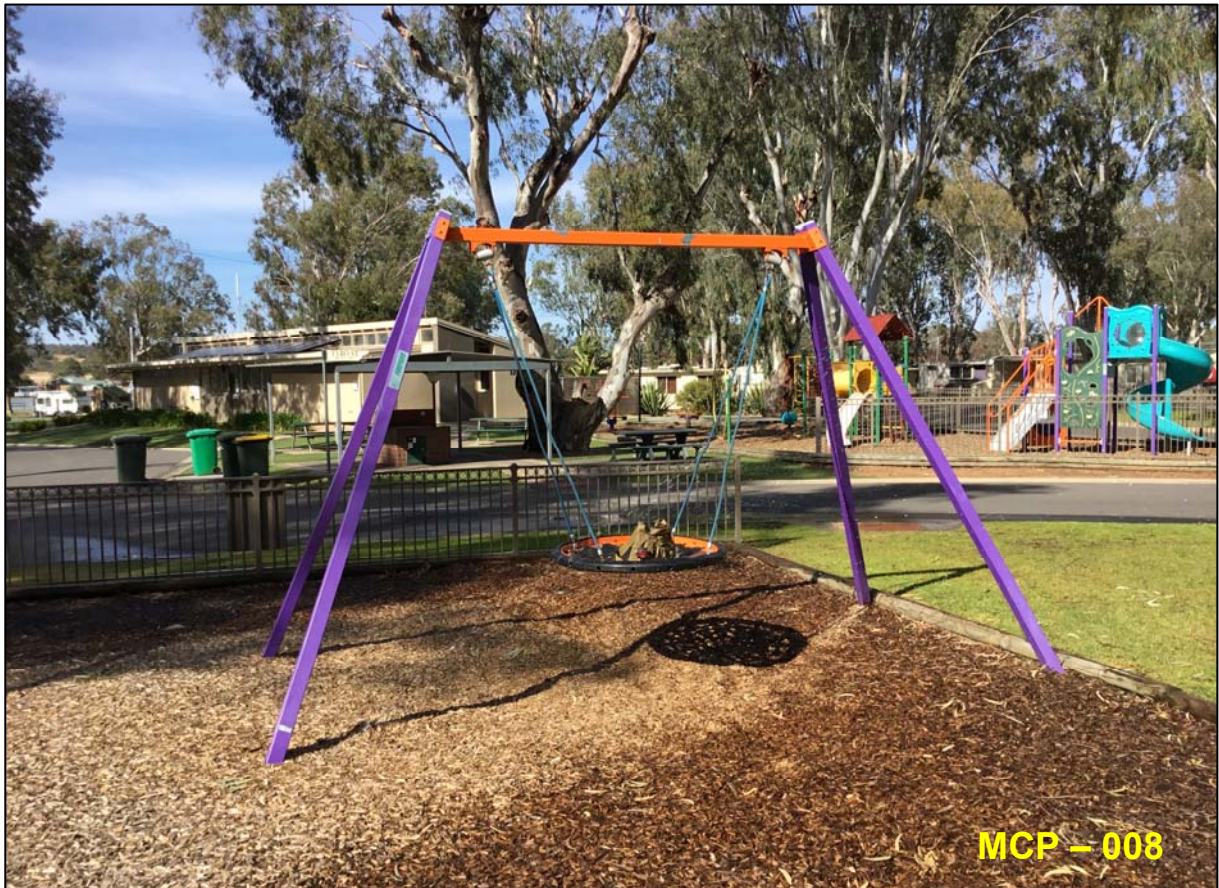
The swings are only five years old and are in the condition as they were first installed, there is some kickout under the swings which is quite usual, the overall depth of the softfall is on average 100mm deep and will require topping up.

- Requires softfall top-up

Requires softfall top-up

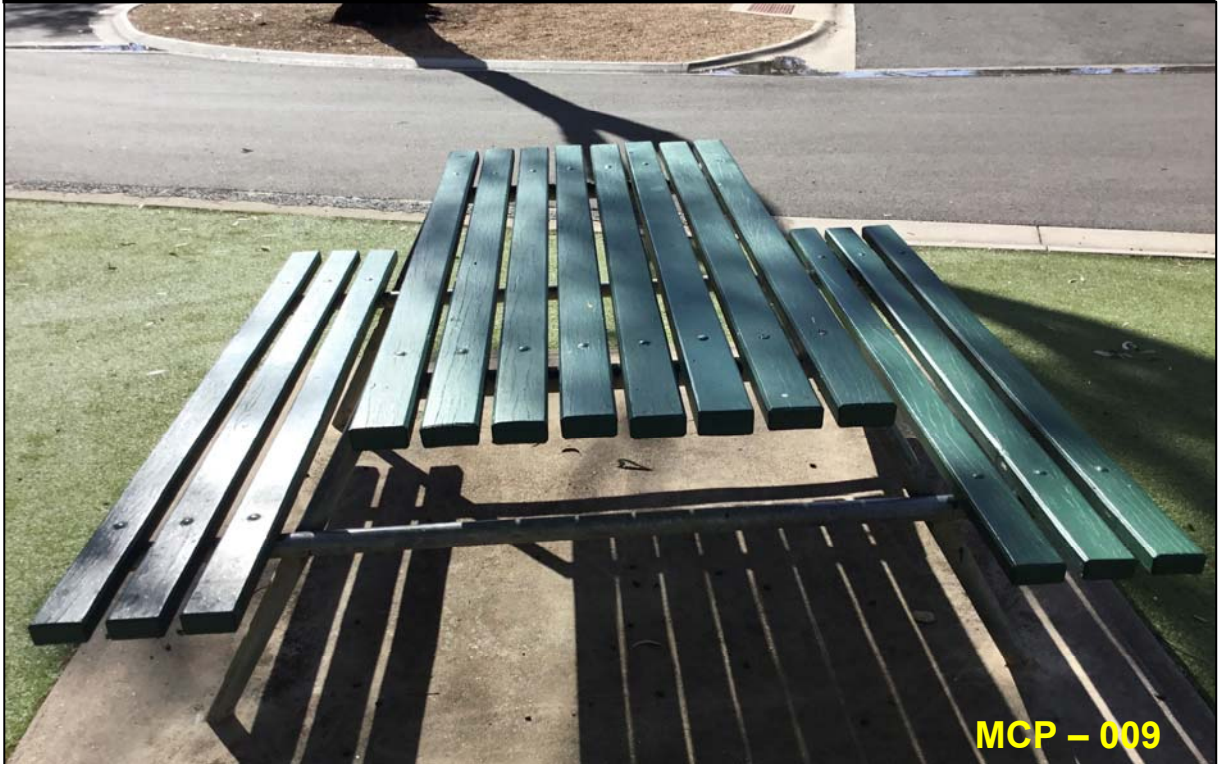
This park bench is in good condition and affixed securely to the concrete base.

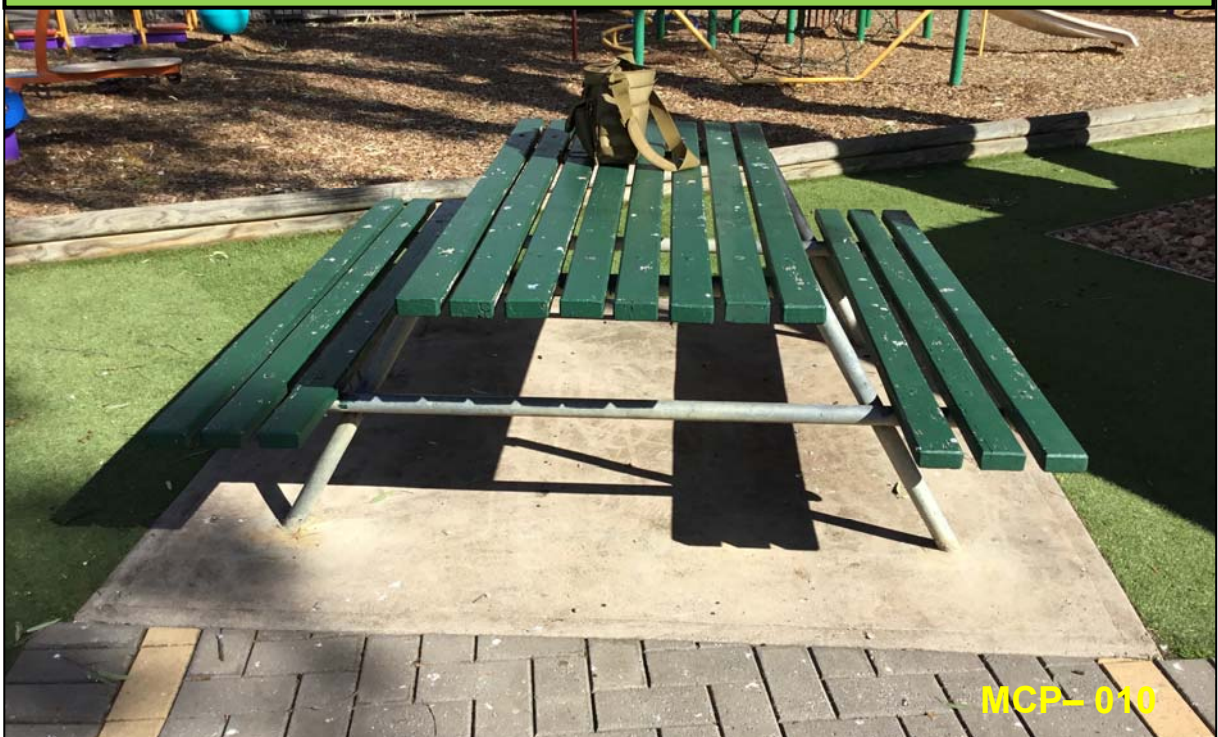
This park bench is in good condition and affixed securely to the concrete base.

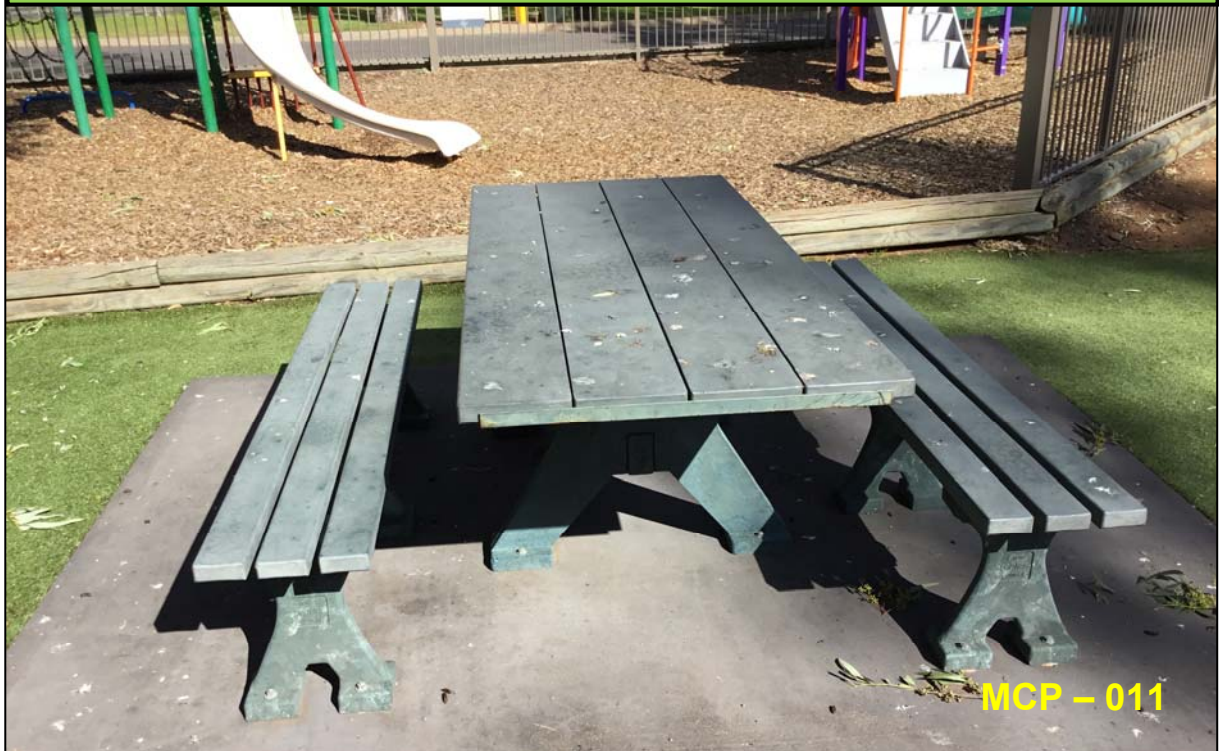
The bench seat table and seats are in good condition, all planks and beams are secure and the components are securely bolted to the concrete slab, the seats and table did have bird droppings on it the day of the inspection.

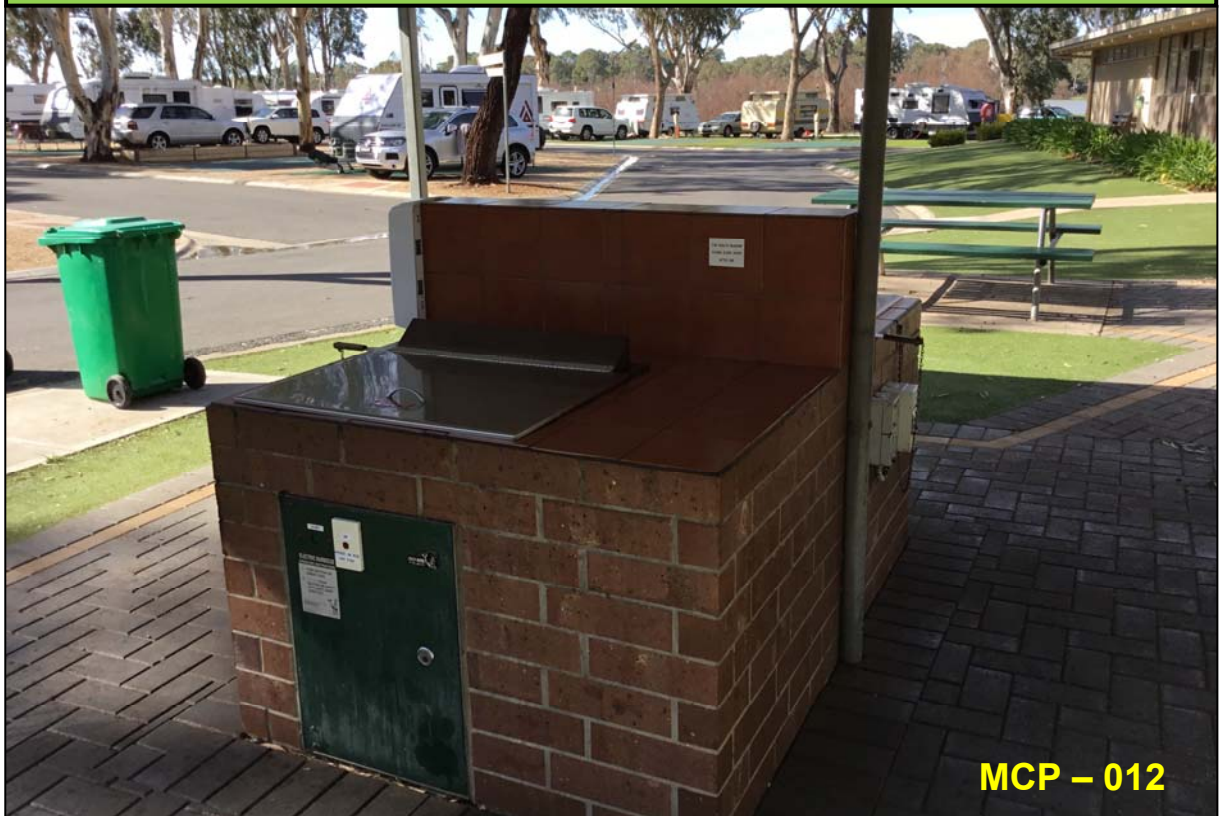
The Barbeque and shelter are both in very good condition, the BBQ is regularly cleaned which was undertaken on the day of inspection.
