# OPEN SPACE SERVICES

## Playground Audit

# PALMER PLAYGROUND

MID MURRAY COUNCIL

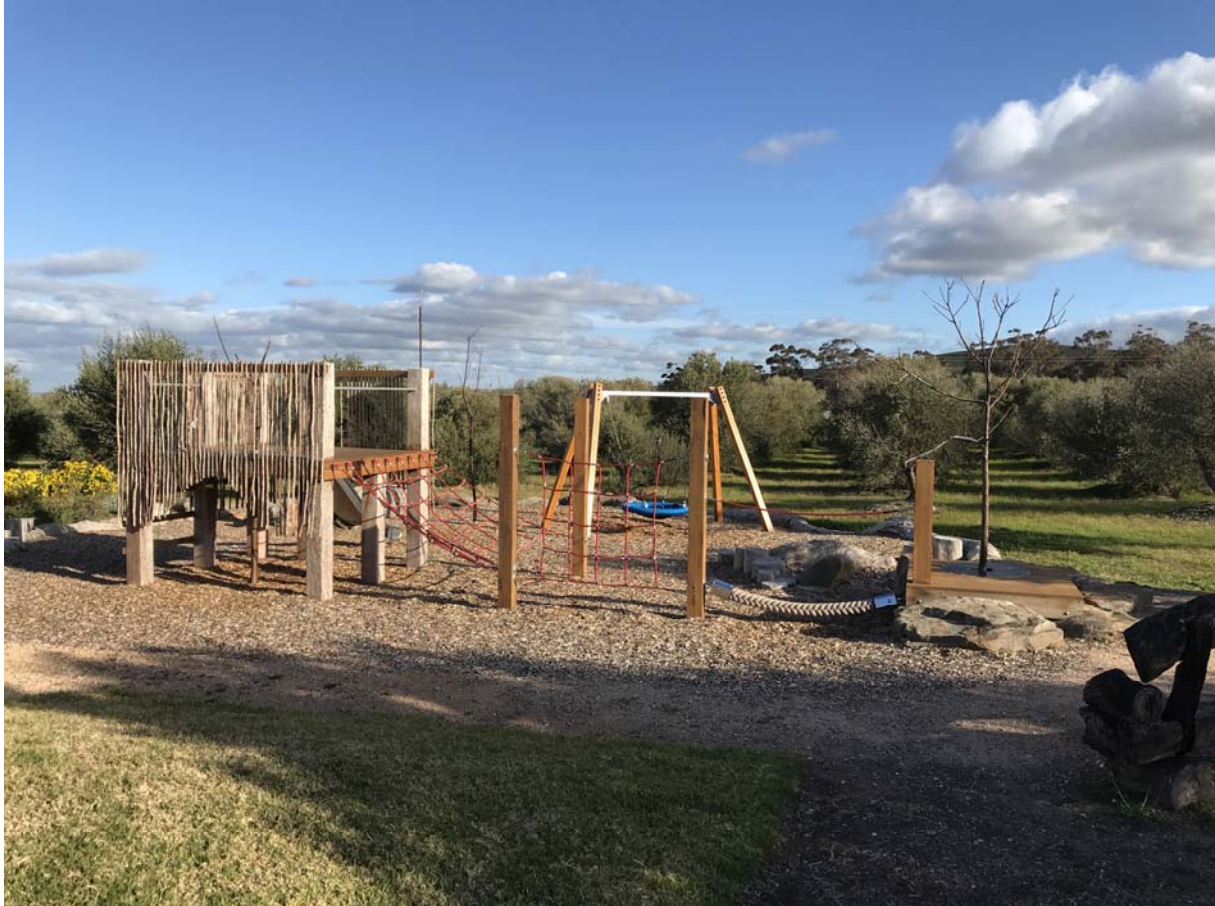
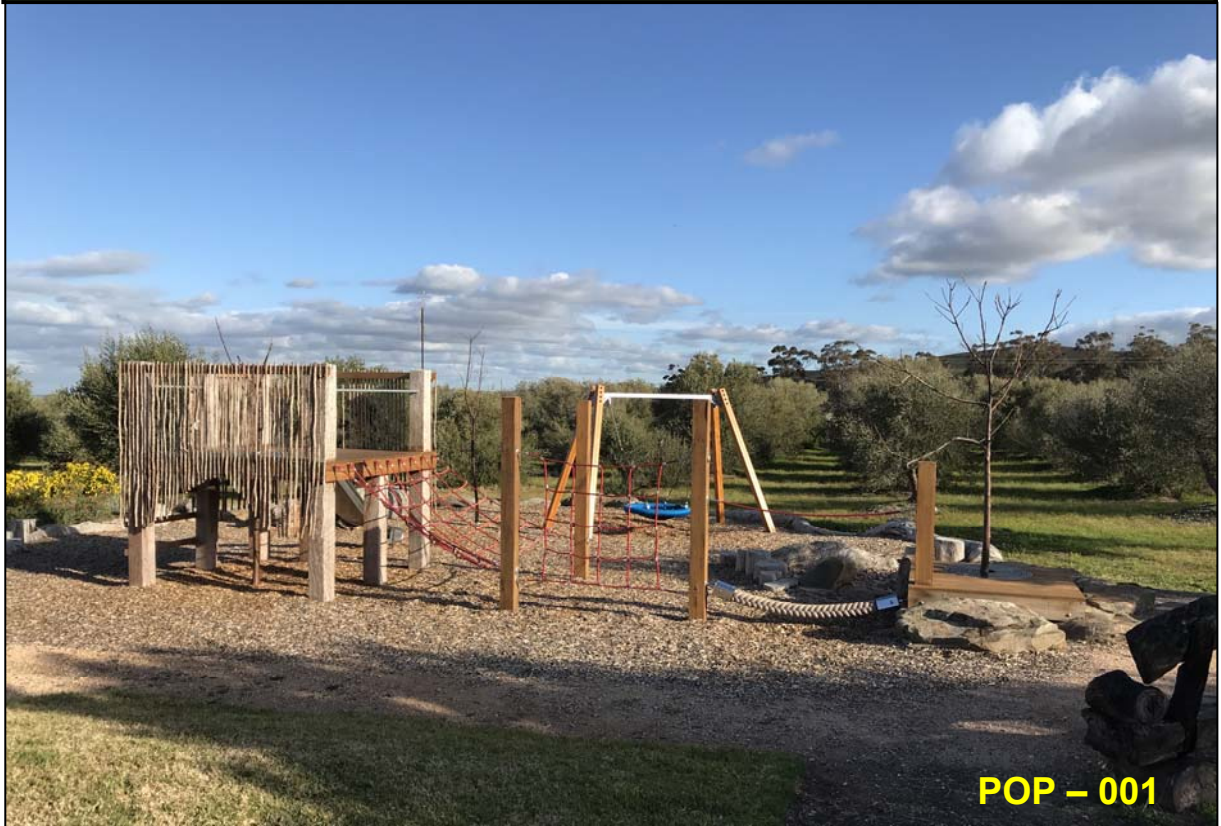
This play feature is a new install and as such has no areas of real wear as yet, all the components are within standards and do comply.

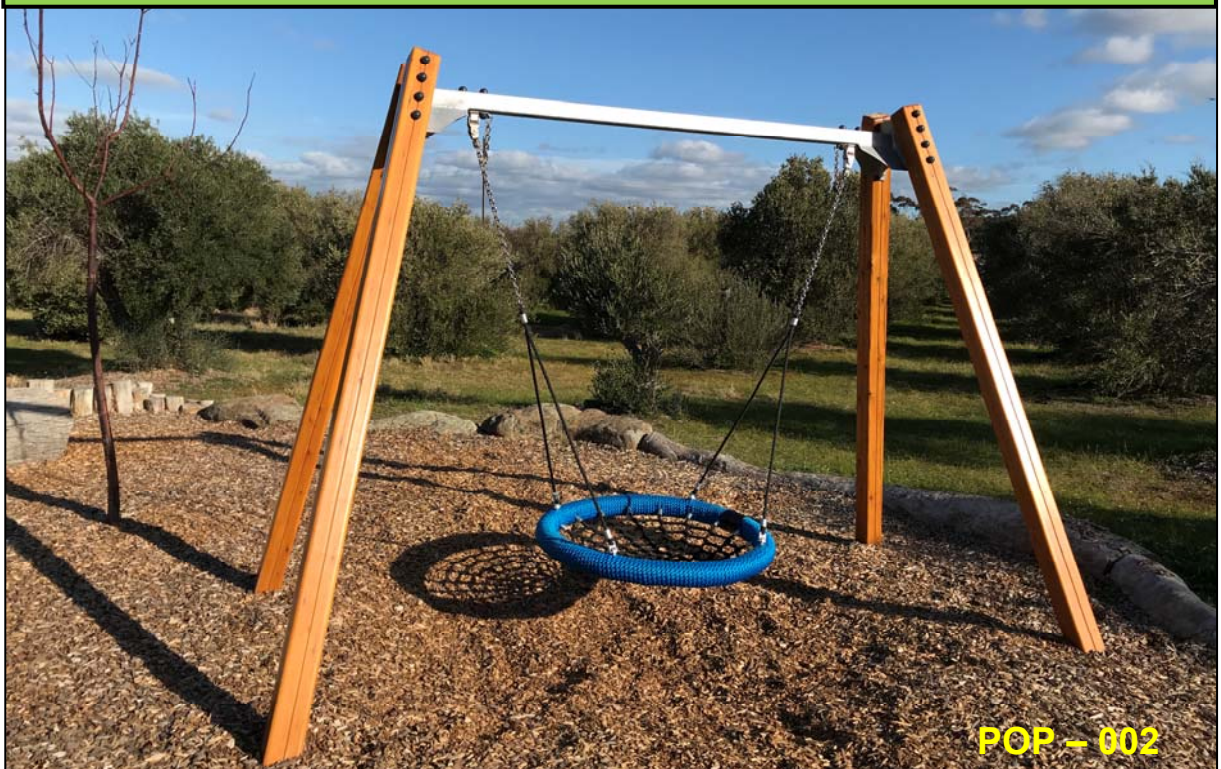
The net swing is only a year old and is still in as new condition, there is ample softfall within the swing zone.

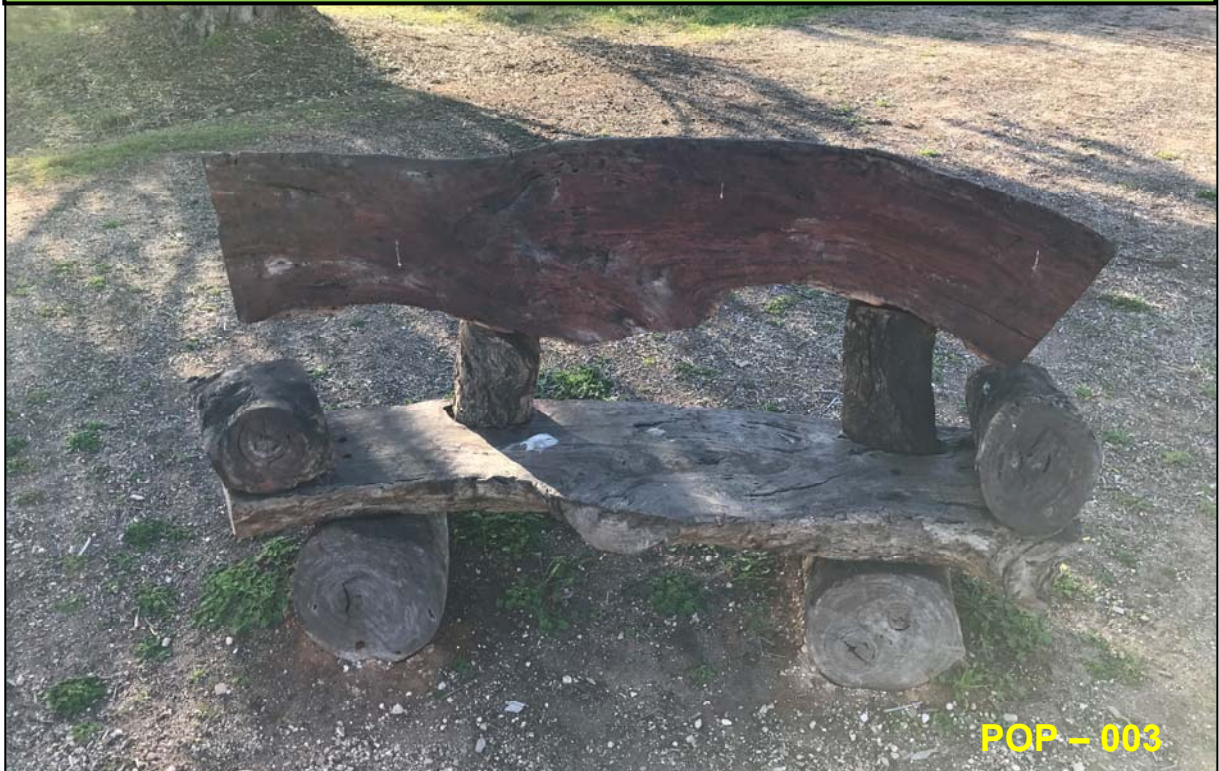
This natural wood seat being also a newly installed item is in good as installed Item, there is no splintering or shrinkage in the wood, this will change as it weathers and treatment should be undertaken in the way of tung oil to keep the seat from deuterating.

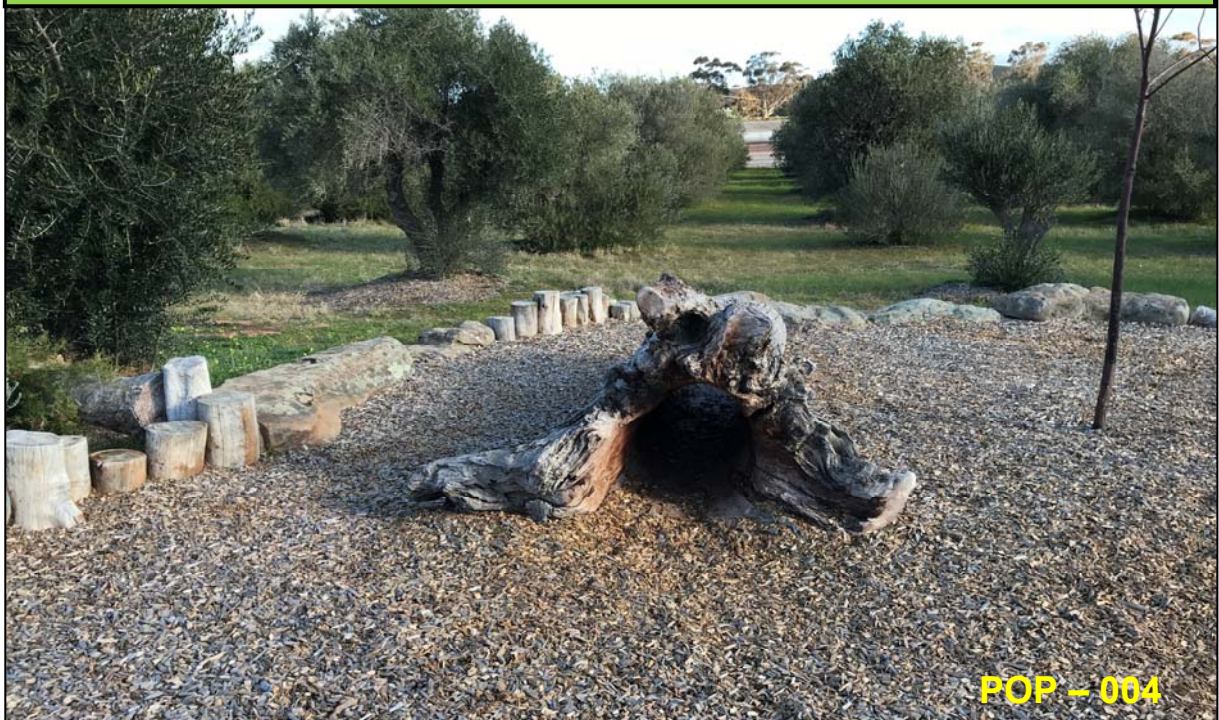
This climbing stump is in an area where there is the required amount of softfall, this will deuterate in the future and will be picked up in future audits.

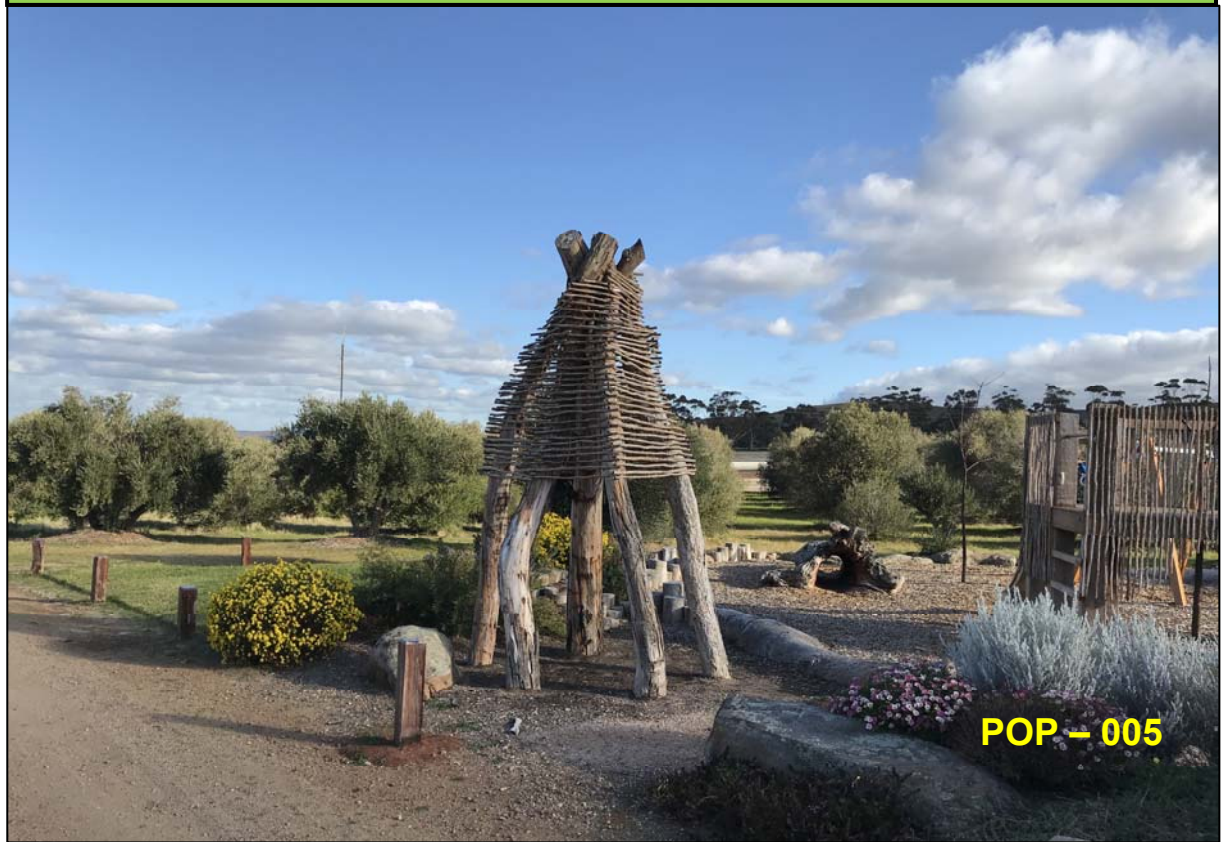
This visual structure has been designed where the uprights are the only part which is accessible, there are no areas of splintering but this will occur in the future.
