OPEN SPACE SERVICES

JULY 25, 2020

Playground Audit BLANCHETOWN PLAYGROUND

MID MURRAY COUNCIL

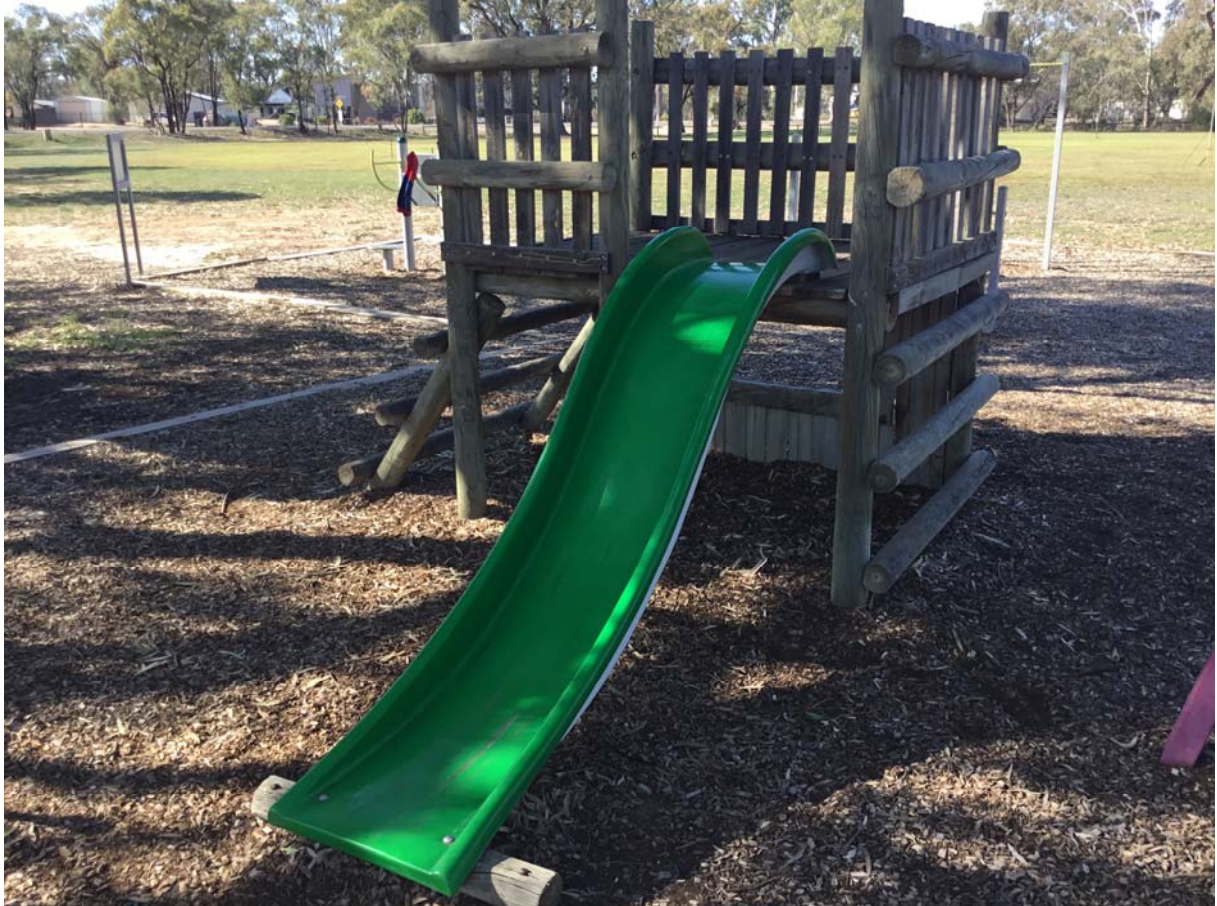
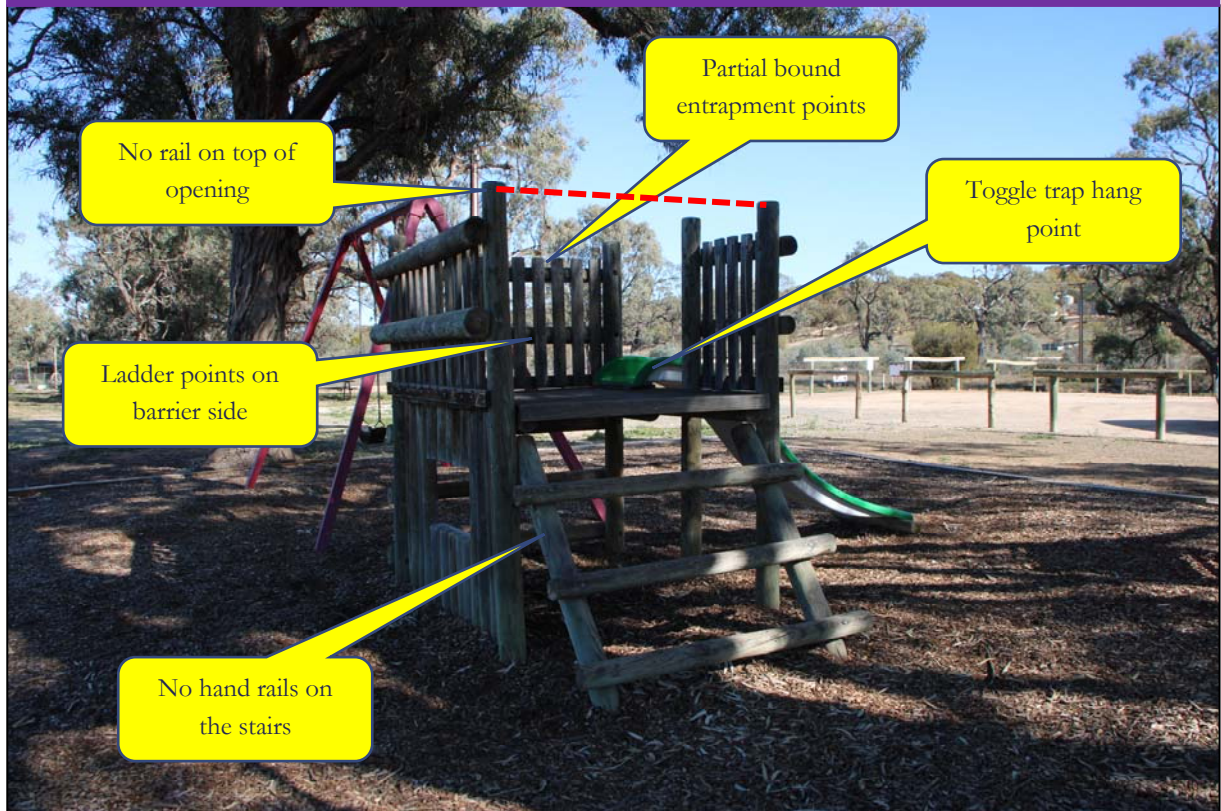
SN: BOP - 001

(Check cap ends, grommets, on bolts or screws.)				does not have enclosed tubing.	
Are all components free of corrosion and bulging and all nails and fixings flush with surface or countersunk?	Yes			The cubby house fixtures are all flush and no threads were protruding.	LOW
Are all bolts and fasteners secure?	Yes			All bolts were secure	LOW
Are all exposed protrusions and sharp edges removed? (Check for protruding nails, rivets and bolts, which may need to be covered or sawn off.)	Yes			No protrusions	LOW
Are platforms and other standing surfaces free of moss, mold and other unhygienic matter that may cause corrosion or slipping?	Yes			The swing frame is covered in tannin from the trees	LOW
Are all guardrails and barriers around decks and platforms secure, free of sharp edges and small enough for a child's grip?	Yes			All platforms are within specification	LOW
Are all equipment surfaces and parts in good order? (Check for splits, splinters, cracks, cuts and open joints. Look at specific pieces of equipment such as swings and slides. Swing seats should be made of a soft material rather than wood. Slides should have a smooth surface and gradual surface at the bottom.)		No		The cubby house has too many defects to remain, the slide, the ladder, no railing and no grab rails and the age contribute to its risk factor of high	HIGH

Are all entrapment points eliminated? (Check for any narrow openings, "V" shaped gaps or sharp angles hooks or protrusions, which could trap a child's head or limb.)	Yes			The barrier rails being affixed above the top pine rail is a partial bound entrapment point	HIGH
Are all steps, ladders, guardrails and nets large enough to let a child get their body right through?		No		The cubby house has two areas of ladder point, both are not to specification.	HIGH
Are slides free from toggle hang points where clothing and hats can get caught up in them?		No		The slide has an area which was tested as it did fowl up near the attachment to the platform.	MEDIUM
Is there enough space between equipment so that children can move freely between areas without bumping or running into each other?	Yes			Once the cubby house is removed there will only be the swings stand alone.	LOW
Is the playground set out to allow for unobstructed supervision?	Yes			The playground items are can be seen from observation areas close to the play equipment.	LOW

This old structure is a permapine structure with Copper Chrome Arsenic based wood, the ladder on the side does not have any handrails for stabilizing yourself to get up the top platform. Because it is greater than 600 from ground level the area of climb needs to have proper handrails grips so they can be used for younger children to steady themselves as a climb up the structure. The slide has a toggle entrapment due to the size of the width of the planks and the gap which allows the toggle to be caught within the gap however this does not cause the toggle to become wedged within that as you slide down the toggle does dislodge on both sides. This structure should not be used and I would recommend that it is removed as soon as possible.

- Remove from the playground. **(Defect)**

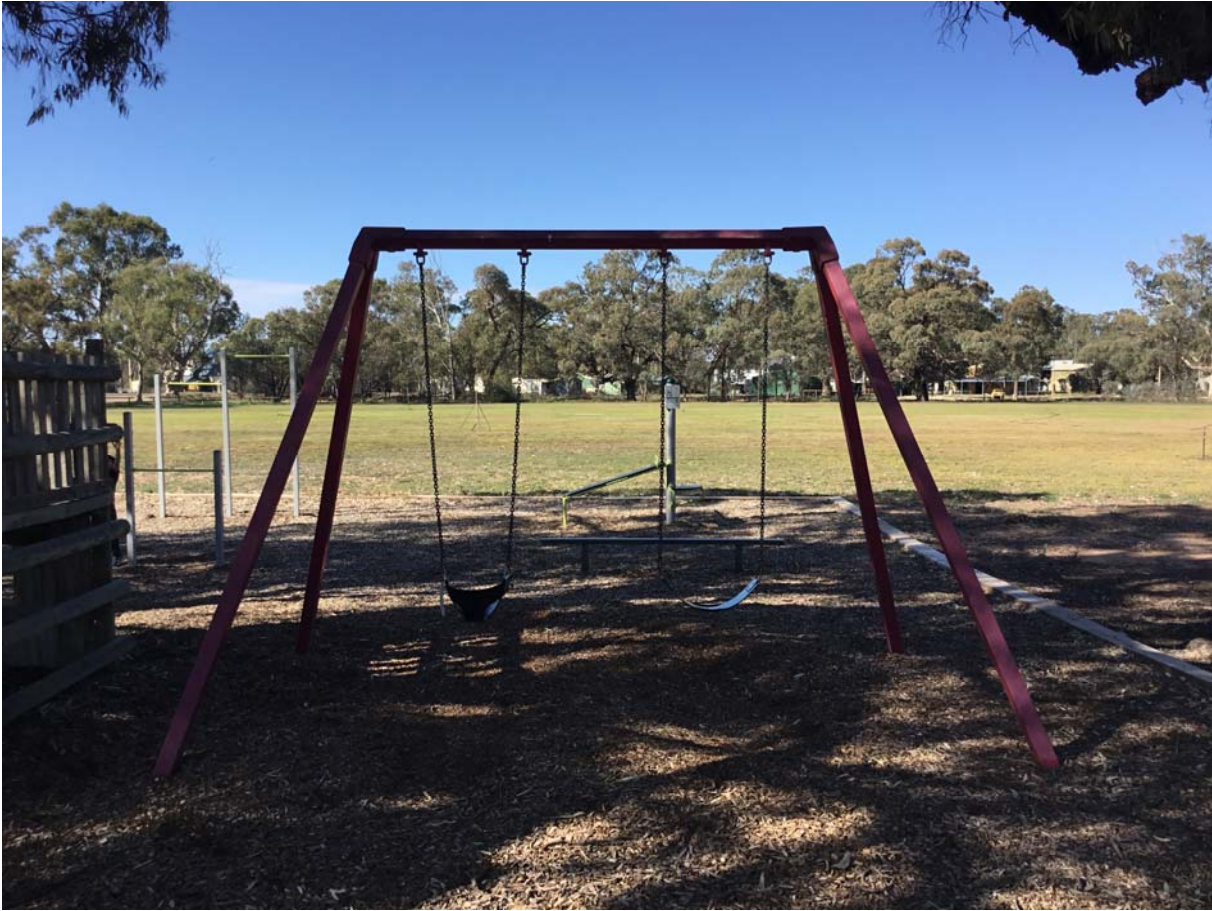
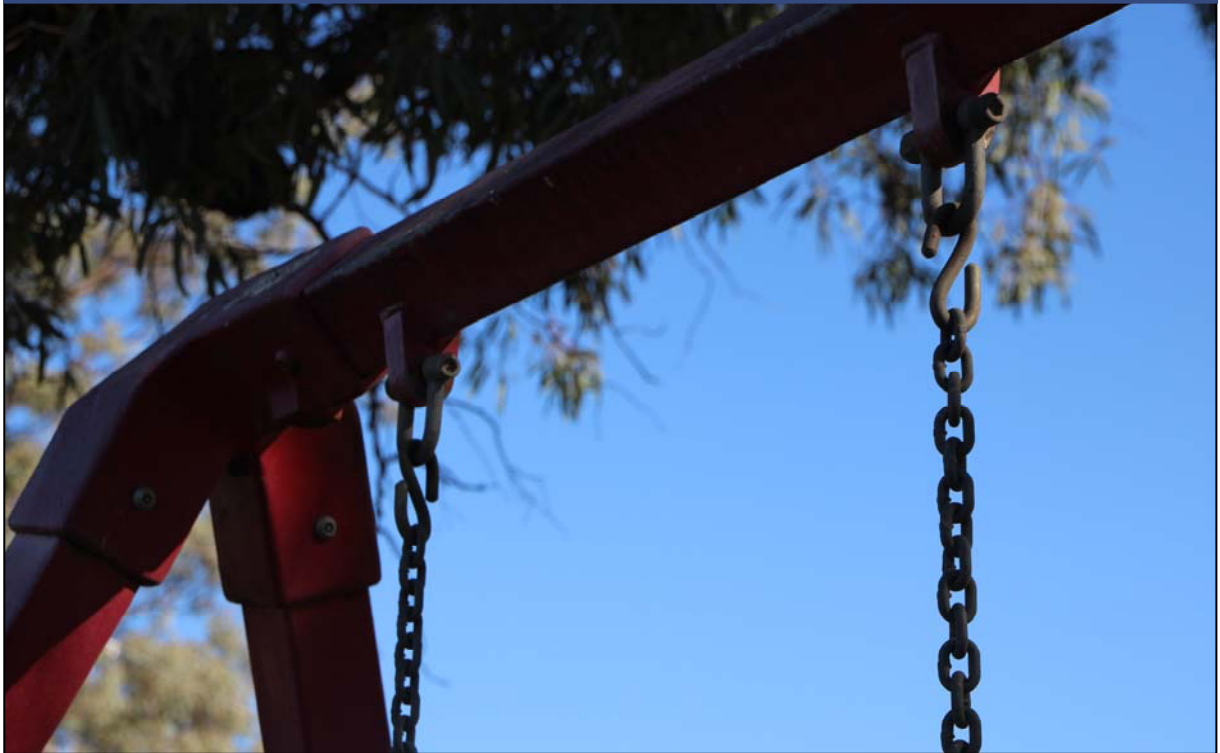
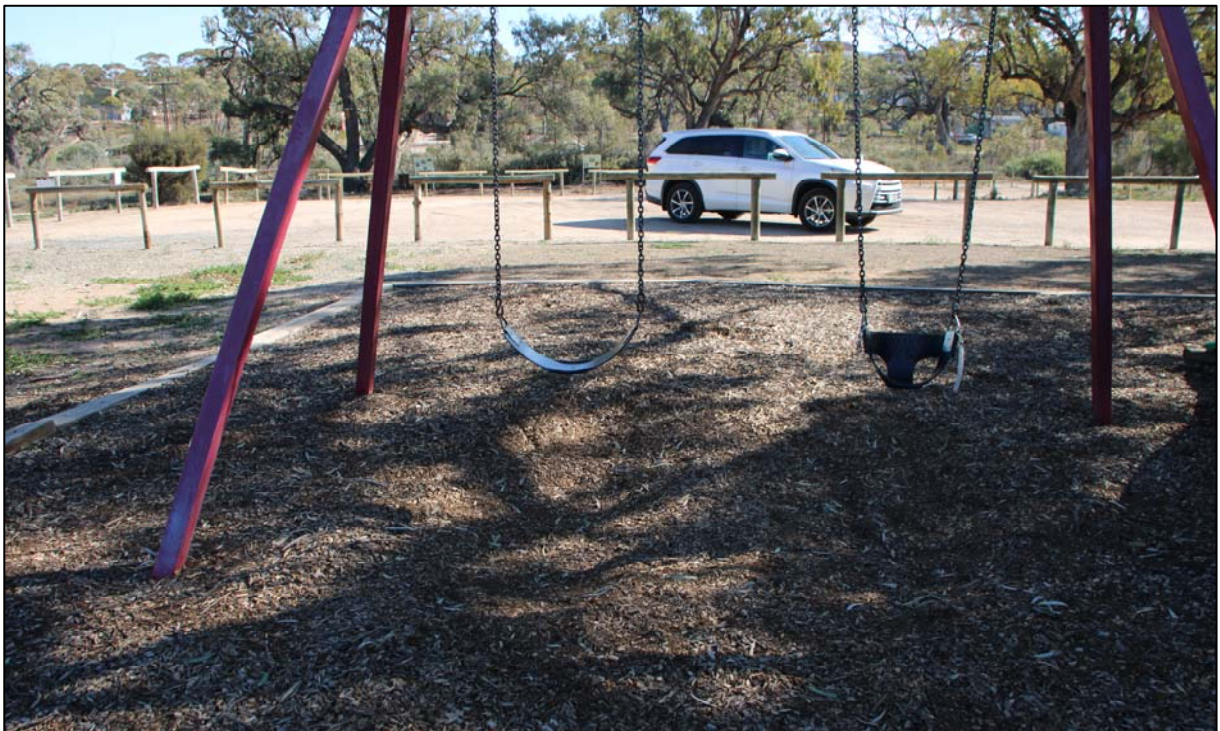
SN: BOP - 002

The swings are still in good condition the rubber has been replaced on the baby swing and the other swing is not that old. the swing seats are too low and this is why the area beneath the swing has been kicked out, raising the seats will reduce this significantly. The “S” hooks on the top will also require further clamping as they are almost at the stage where they can be lifted off the top hanger. Softfall will need to be replaced beneath the swings. The overall condition of the swings is good but has tannin staining from the *Eucalyptus largiflorens* that has grown over top of it.

- The "S" hooks need to be pressed to stop removal. **(Remedial)**
- Lift swings to 500mm above mulch at the lowest point of swing **(Remedial)**
- Top up sofffall to a depth of 300mm **(Remedial)**

Softfall will require top up under the swings for now, if the cubby house is removed, no top up is needed for that area.

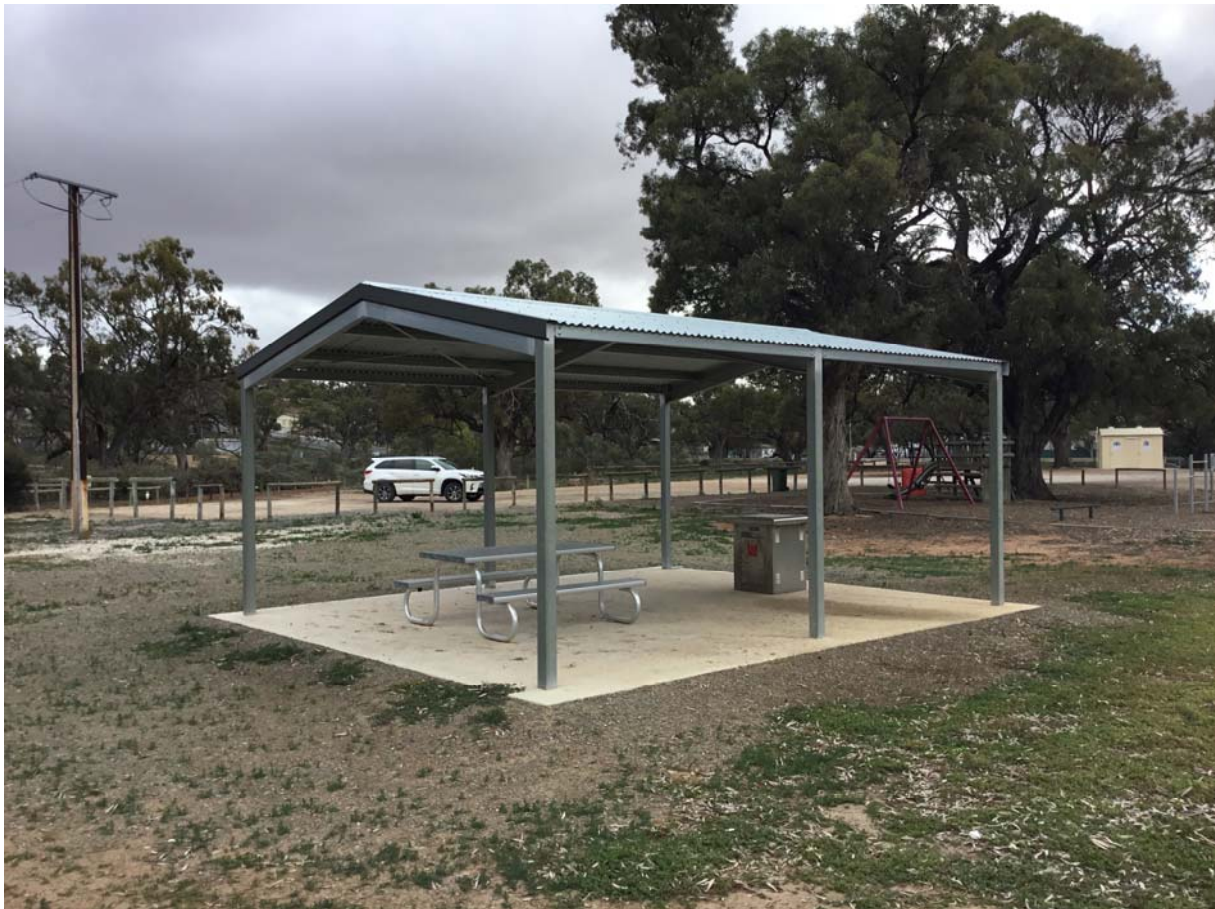
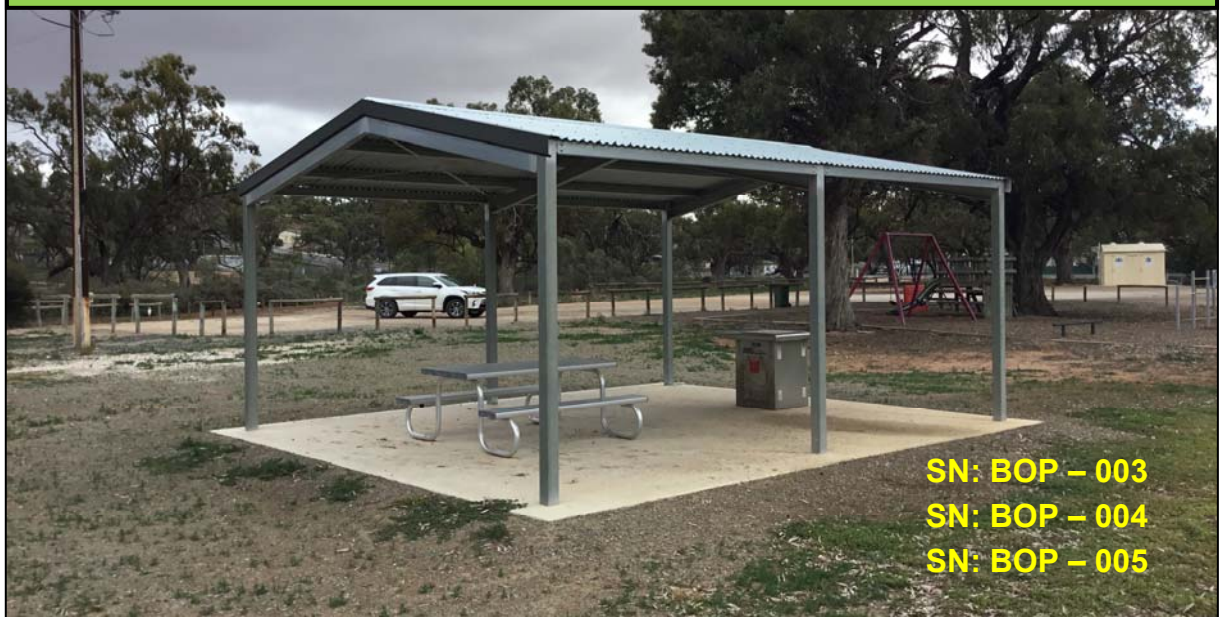
SN: BOP – 003
 SN: BOP – 004
 SN: BOP – 005

This shade structure is only newly installed along with the barbecue and the seat and table, the barbecue is in good condition and is fixed solid to the concrete.

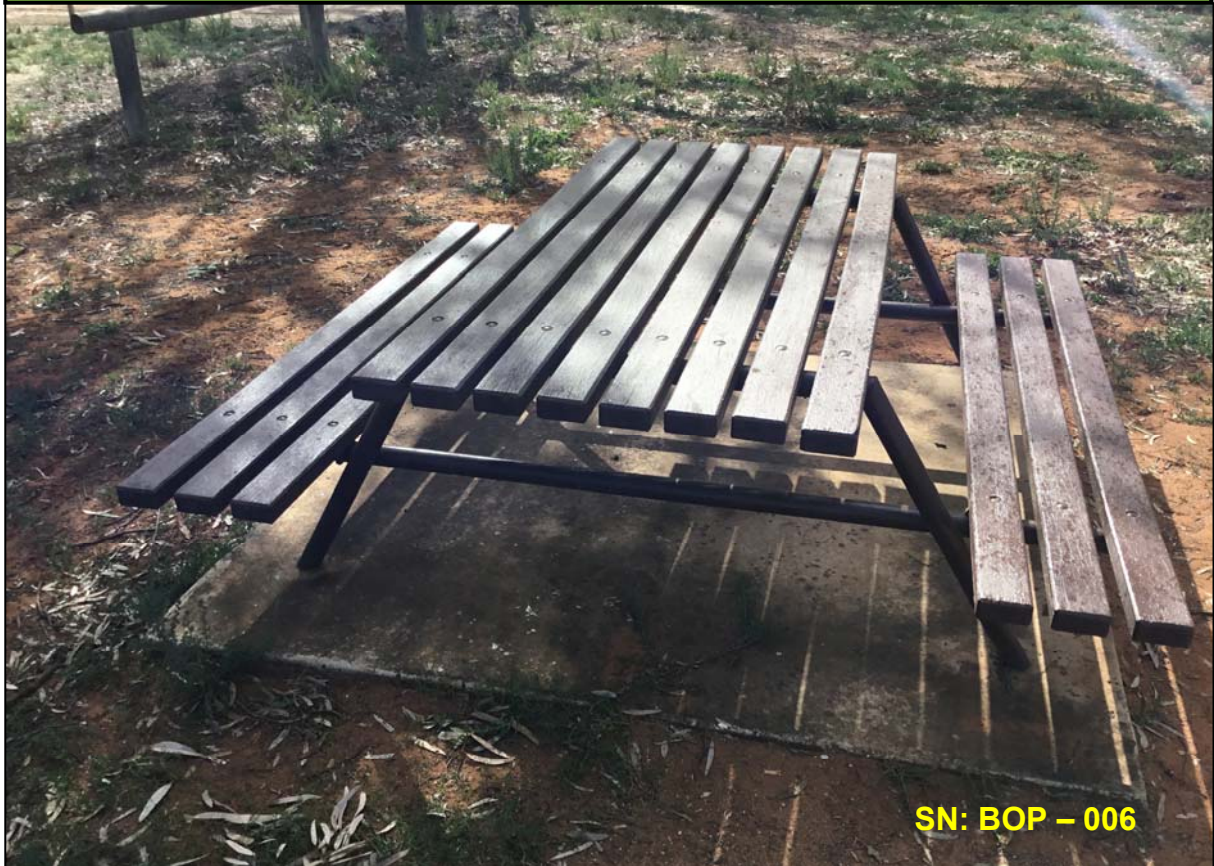
This bench seat and table is secure both on the ground and in the slats to the frame

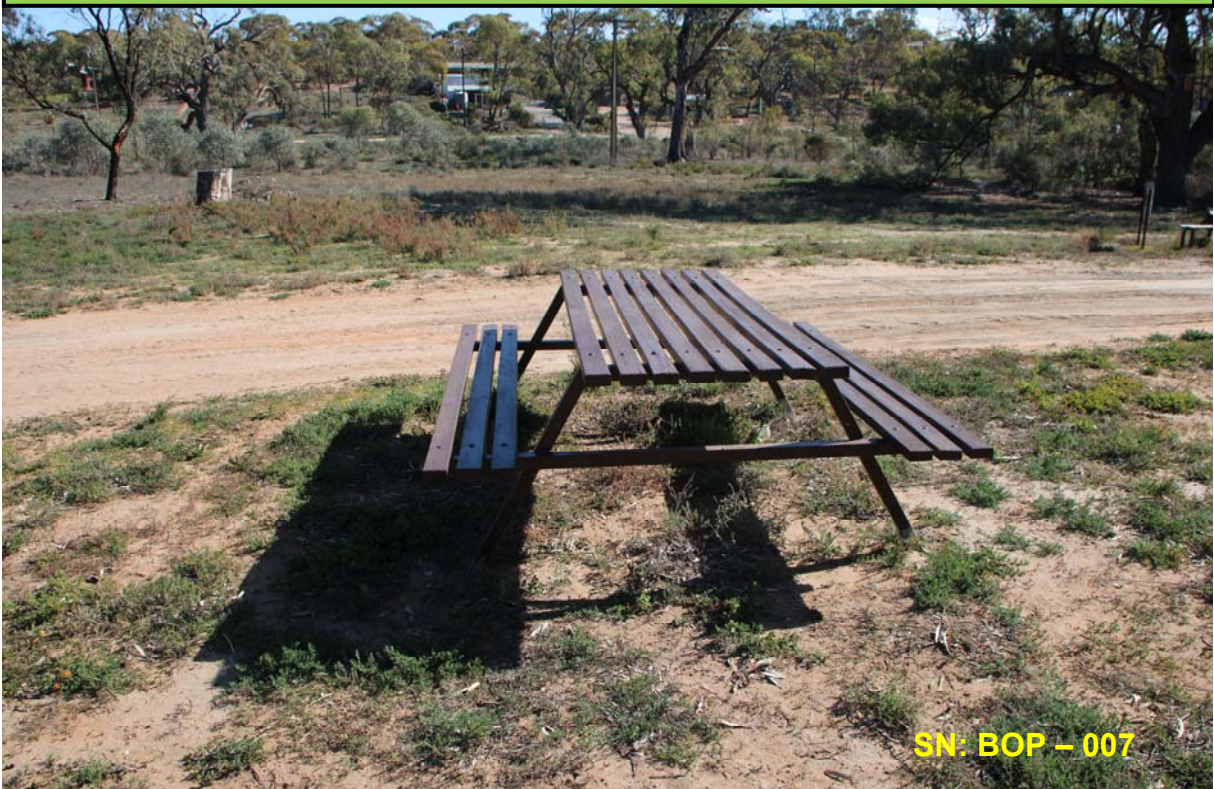
This seat is not affixed to a slab but is secure in its own weight, all the slats are secure to the frame and is a stable item with no risk or hazards.
