JULY 25, 2020

Playground Audit

BLANCHETOWN FITNESS

MID MURRAY COUNCIL

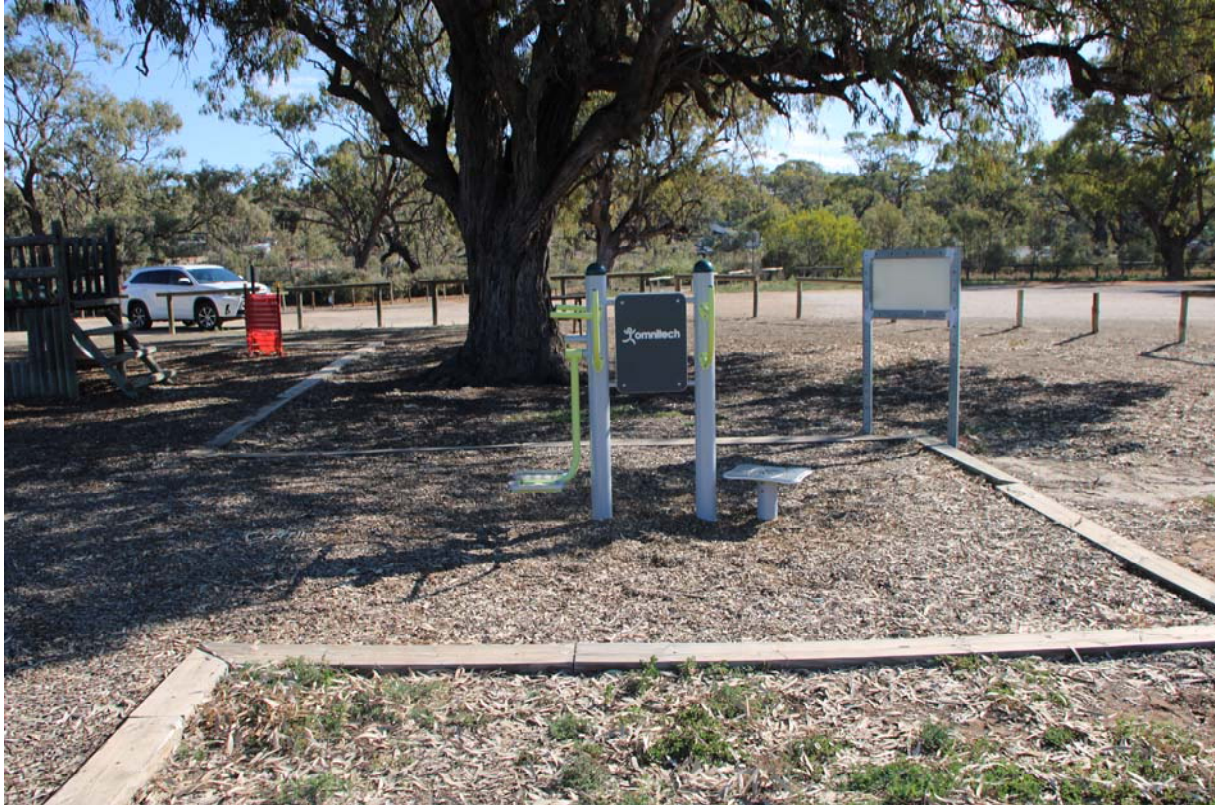
OPERATIONAL INSPECTION		
Fitness Equipment	Findings	Rating
Excessive wear of moving parts (including chain links).	No moving parts	LOW
Are all bolts and fasteners secure?	All bolts and fixtures are secure	LOW
The structural adequacy and/or stability of all fitness equipment NOTE: Equipment that relies on a single anchor or attachment point should be carefully inspected.	The structural stability is acceptable on the item.	LOW
Excessive corrosion, particularly within structural members.	No corrosion was found on the equipment.	LOW
Are all structural attachments affixed tightly to their respective anchor points and attachment points sound with no wear or pull out from fixture points?	The equipment is secure with no wear	LOW

Equipment is as new condition; the equipment operates as it should.

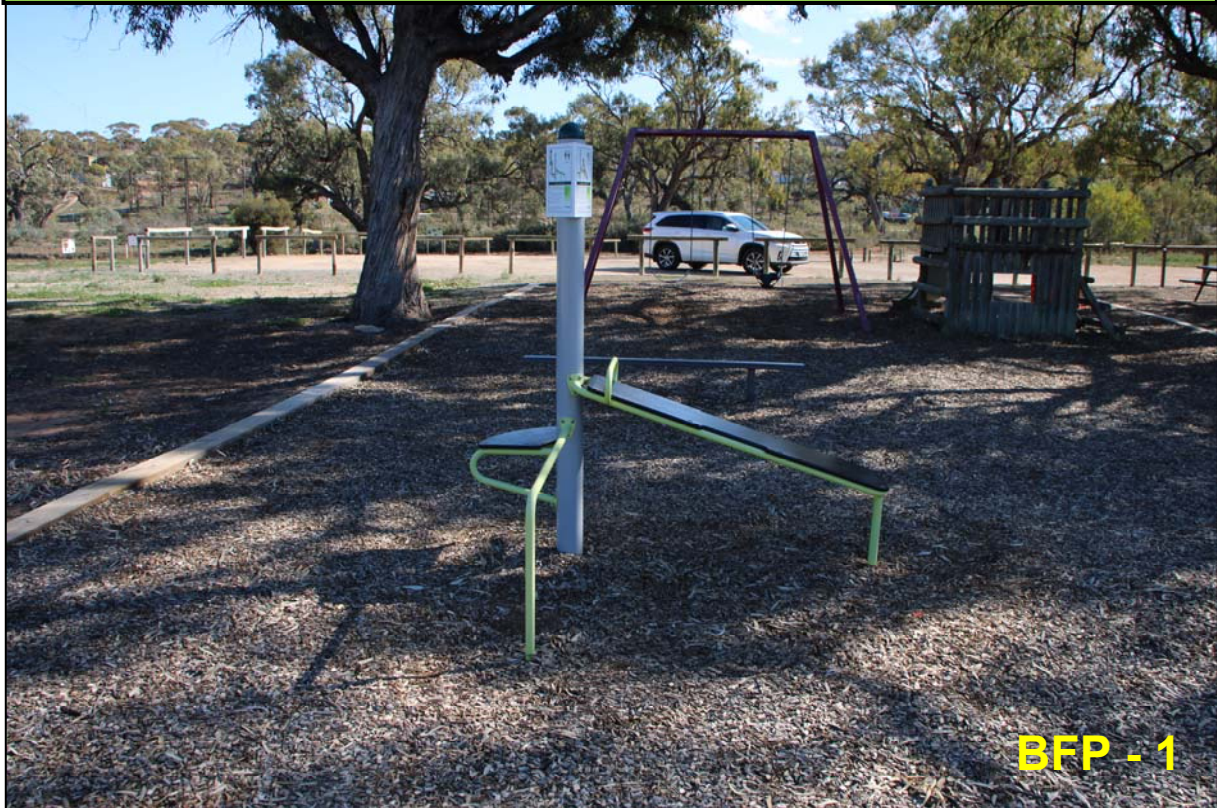
OPERATIONAL INSPECTION		
Fitness Equipment	Findings	Rating
Excessive wear of moving parts (including chain links).	No moving parts	LOW
Are all bolts and fasteners secure?	All bolts and fixtures are secure	LOW
The structural adequacy and/or stability of all fitness equipment NOTE: Equipment that relies on a single anchor or attachment point should be carefully inspected.	The structural stability is acceptable on the item.	LOW
Excessive corrosion, particularly within structural members.	No corrosion was found on the equipment.	LOW
Are all structural attachments affixed tightly to their respective anchor points and attachment points sound with no wear or pull out from fixture points?	The equipment is secure with no wear	LOW

Equipment is as new condition; the equipment operates as it should.

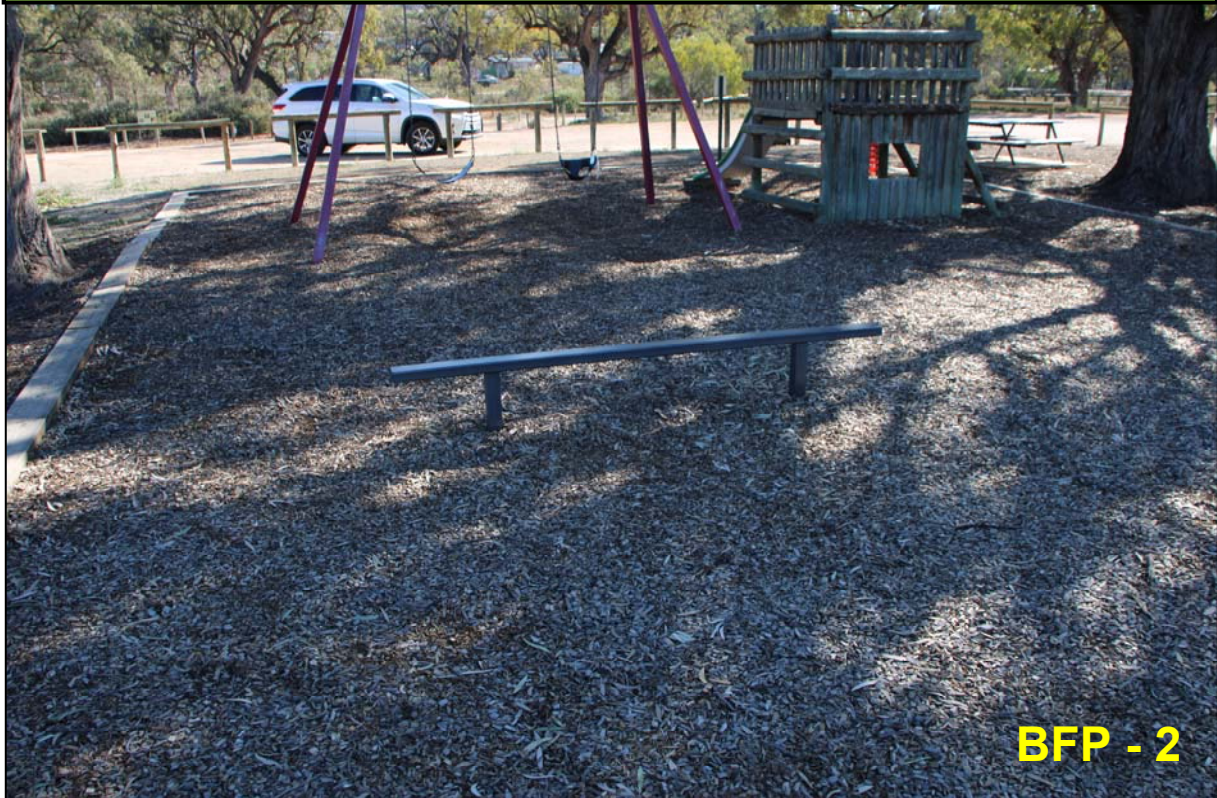
BFP - 2

OPERATIONAL INSPECTION		
Fitness Equipment	Findings	Rating
Excessive wear of moving parts (including chain links).	No moving parts	LOW
Are all bolts and fasteners secure?	No bolts or fasteners on this equipment.	LOW
The structural adequacy and/or stability of all fitness equipment NOTE: Equipment that relies on a single anchor or attachment point should be carefully inspected.	The structural stability is acceptable on the item.	LOW
Excessive corrosion, particularly within structural members.	No corrosion was found on the equipment.	LOW
Are all structural attachments affixed tightly to their respective anchor points and attachment points sound with no wear or pull out from fixture points?	The equipment is a series of rigid structure with no moving parts.	LOW

Equipment is as new condition; the equipment operates as it should.

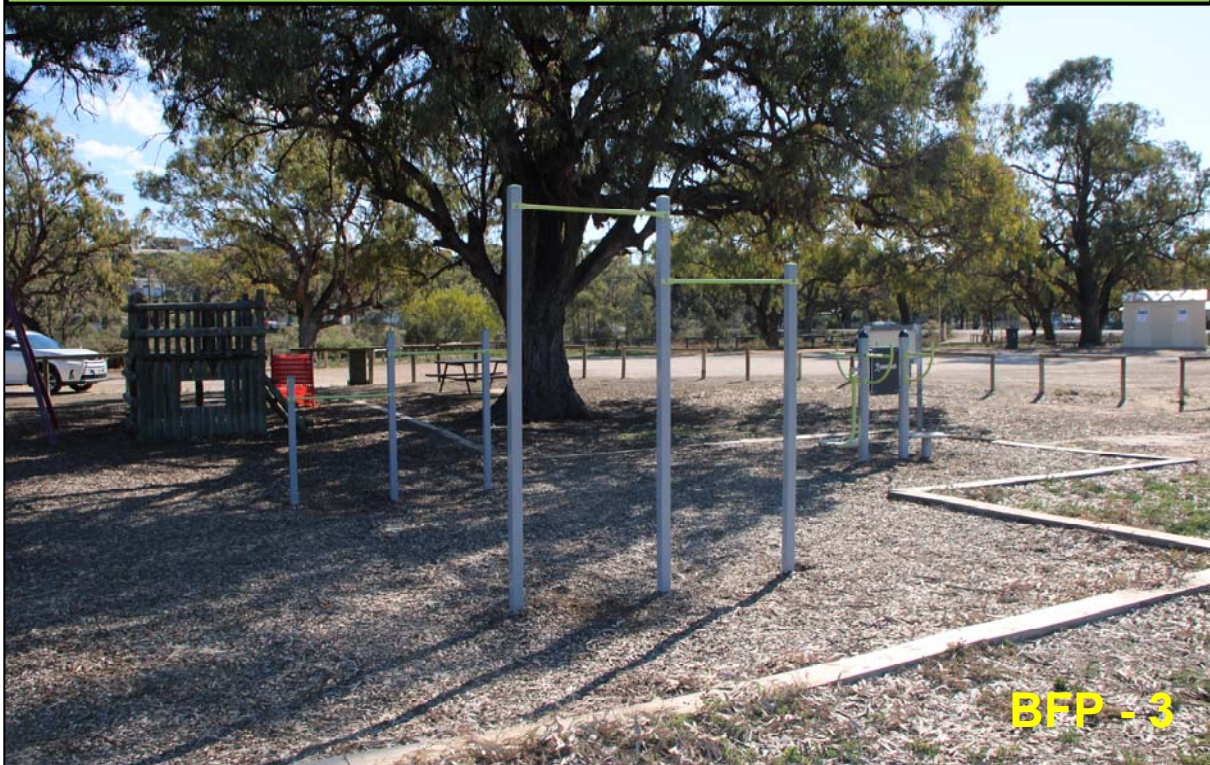
OPERATIONAL INSPECTION		
Fitness Equipment	Findings	Rating
Excessive wear of moving parts (including chain links).	No moving parts	LOW
Are all bolts and fasteners secure?	No bolts or fasteners on this equipment.	LOW
The structural adequacy and/or stability of all fitness equipment NOTE: Equipment that relies on a single anchor or attachment point should be carefully inspected.	The structural stability is acceptable on the item.	LOW
Excessive corrosion, particularly within structural members.	No corrosion was found on the equipment.	LOW
Are all structural attachments affixed tightly to their respective anchor points and attachment points sound with no wear or pull out from fixture points?	The equipment is a series of rigid structure with no moving parts.	LOW

Equipment is as new condition; the equipment operates as it should.

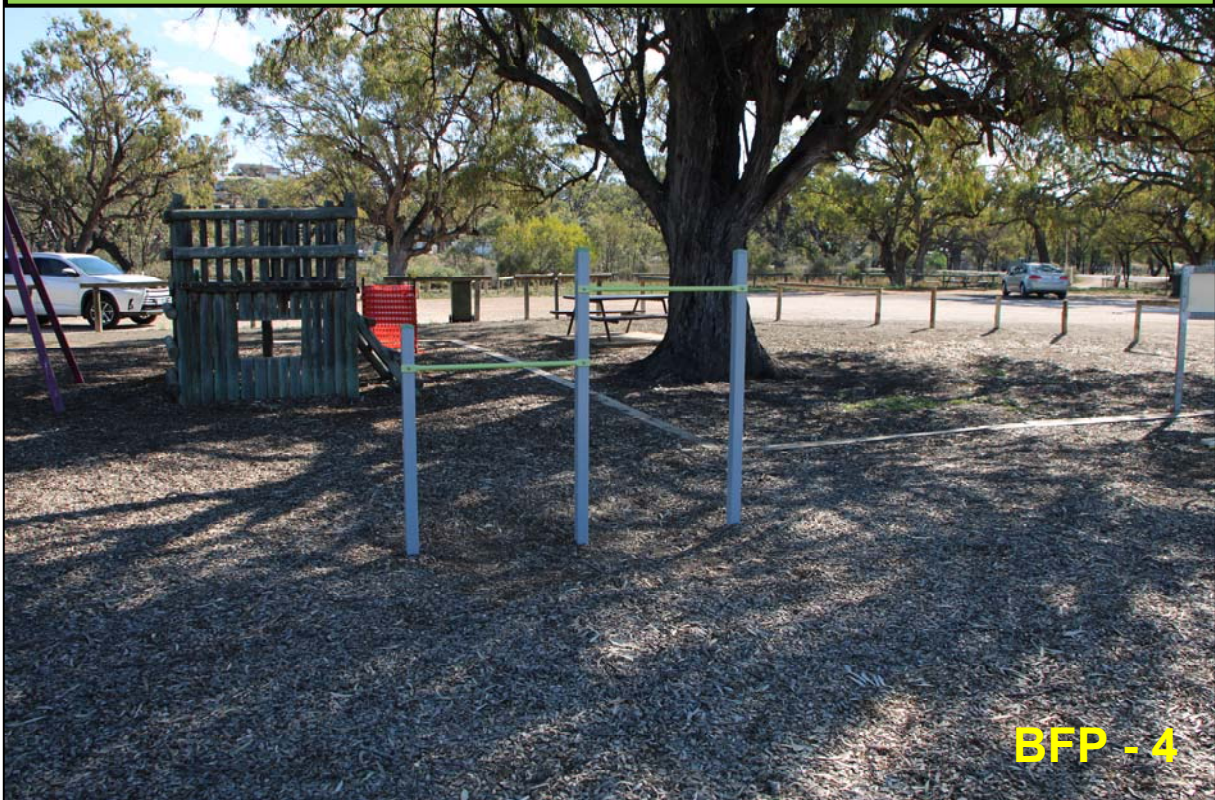
BFP - 4

OPERATIONAL INSPECTION		
Fitness Equipment	Findings	Rating
Excessive wear of moving parts (including chain links).	No wear as it is only quite new.	LOW
Are all bolts and fasteners secure?	No bolts or fasteners on this equipment.	LOW
The structural adequacy and/or stability of all fitness equipment NOTE: Equipment that relies on a single anchor or attachment point should be carefully inspected.	The structural stability is acceptable on the item.	LOW
Excessive corrosion, particularly within structural members.	No corrosion was found on the equipment.	LOW
Are all structural attachments affixed tightly to their respective anchor points and attachment points sound with no wear or pull out from fixture points?	The equipment is a series of rigid structure with no moving parts.	LOW

Equipment is as new condition; the equipment operates as it should.
