OPEN SPACE SERVICES

Playground Audit

WAB RESERVE BOW HILL

MID MURRAY COUNCIL

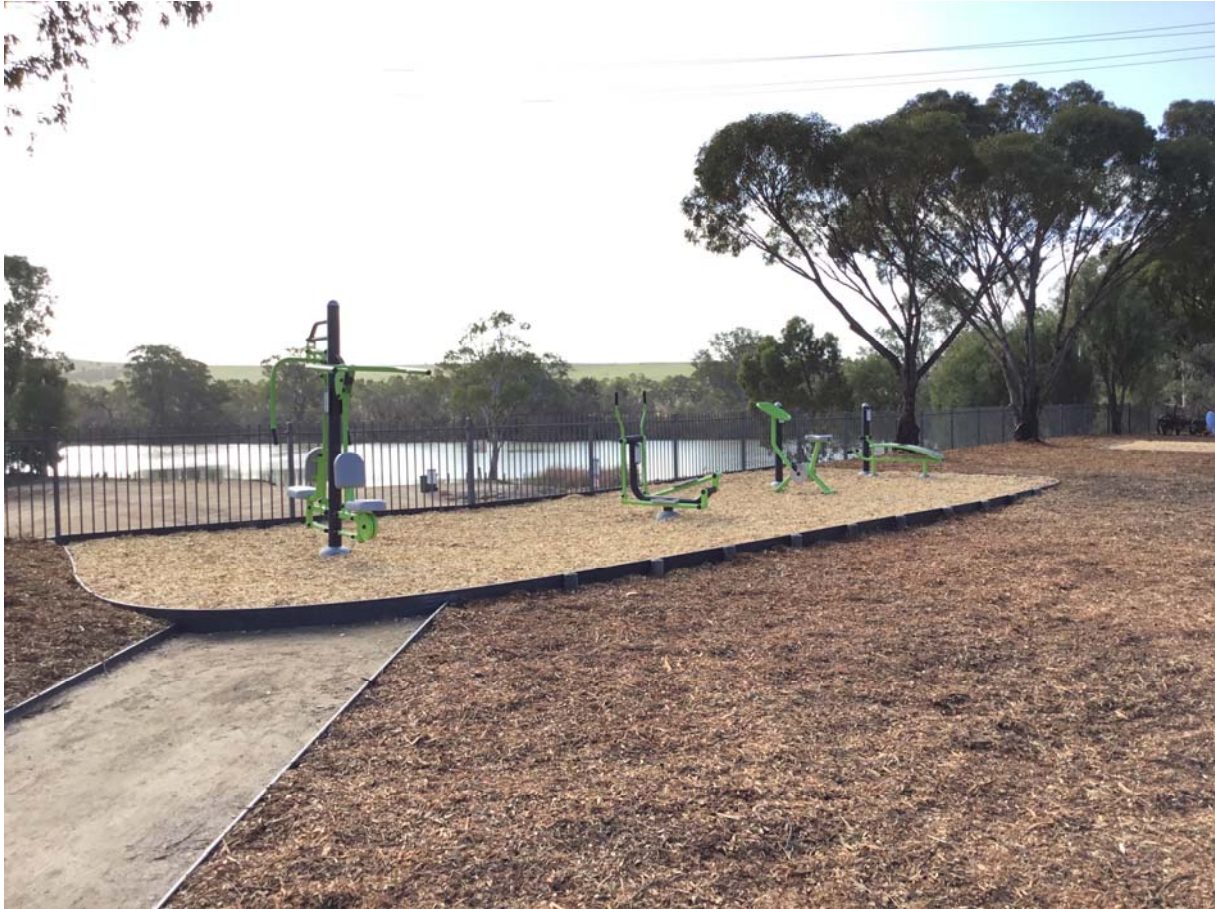
SN: WAB – 012

OPERATIONAL INSPECTION		
Play Equipment	Findings	Rating
Excessive wear of moving parts (including chain links).	The "S" hooks have very little wear and are closed.	LOW
Any protrusions and sharp edges.	No sharp edges or protrusions were found.	LOW
Are there any entrapments, hang points or catch points on any of the equipment?	No hang points or entrapment was found.	LOW
The structural adequacy and/or stability of all playground equipment including ancillary items. NOTE: Equipment that relies on a single anchor or attachment point should be carefully inspected.	All uprights were sound and had no movements.	LOW
Excessive corrosion, particularly within structural members.	The flake rust is bad on these uprights and will require either replacement or removal over the next two years.	MEDIUM
Impact and attenuating edges of swing seats, pommels and other moving equipment that can impact users.	All edges were as designed with no areas of concern.	LOW
