JULY 25, 2020

## Playground Audit

# MORGAN RIVERFRONT RESERVE

MID MURRAY COUNCIL

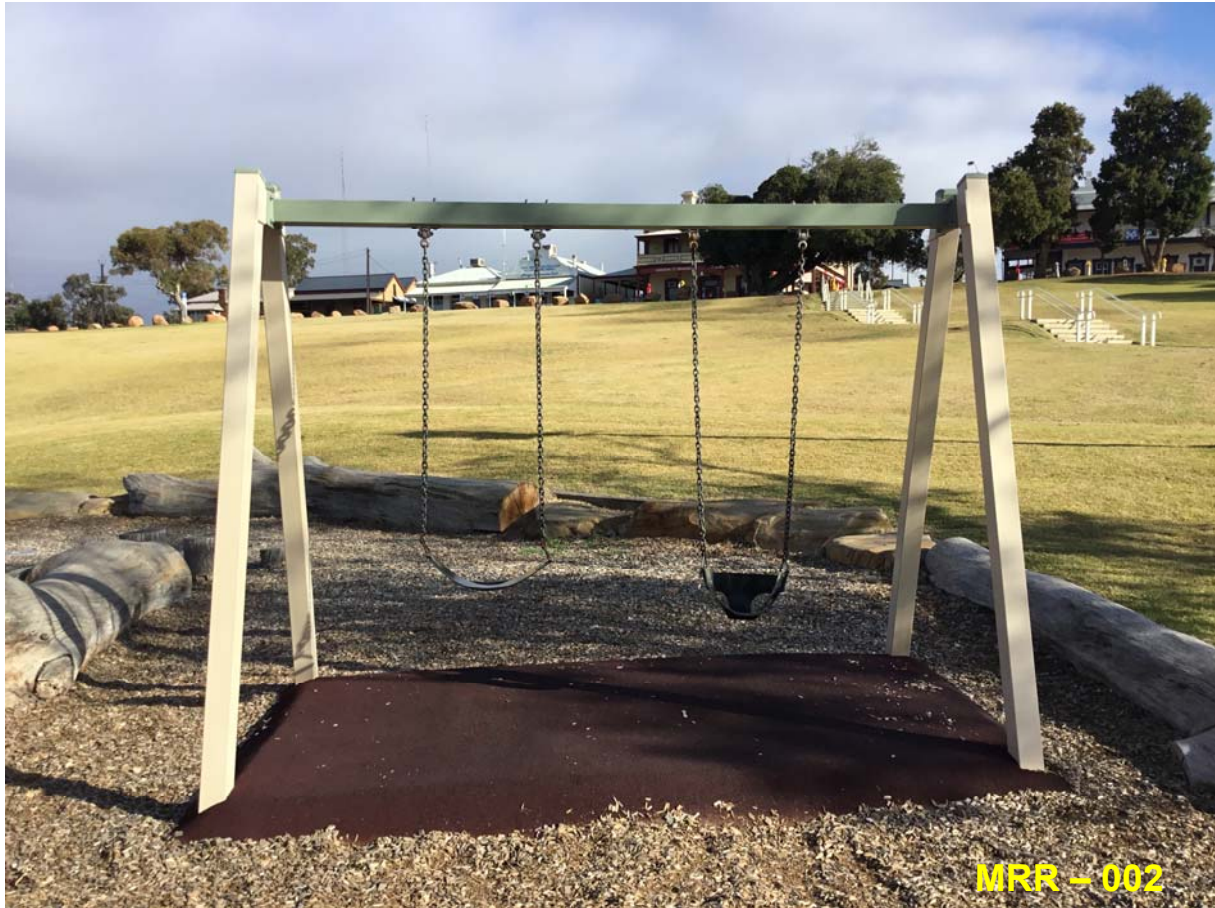
SN: MRR - 002

OPERATIONAL INSPECTION		
Play Equipment	Findings	Rating
Excessive wear of moving parts (including chain links).	No excessive wear on any of the parts.	LOW
Any protrusions and sharp edges.	No sharp edges or protrusions were found.	LOW
Are there any entrapments, hang points or catch points on any of the equipment?	No hang points or entrapment was found.	LOW
The structural adequacy and/or stability of all playground equipment including ancillary items. NOTE: Equipment that relies on a single anchor or attachment point should be carefully inspected.	All uprights were sound and had no movements.	LOW
Excessive corrosion, particularly within structural members.	No rust was found as the sofffall can not be moved.	LOW
Impact and attenuating edges of swing seats, pommels and other moving equipment that can impact users.	All edges were as designed with no areas of concern.	LOW
Foundations for exposed concrete, rot and corrosion.	No exposed concrete was found and no base corrosion was identified.	LOW

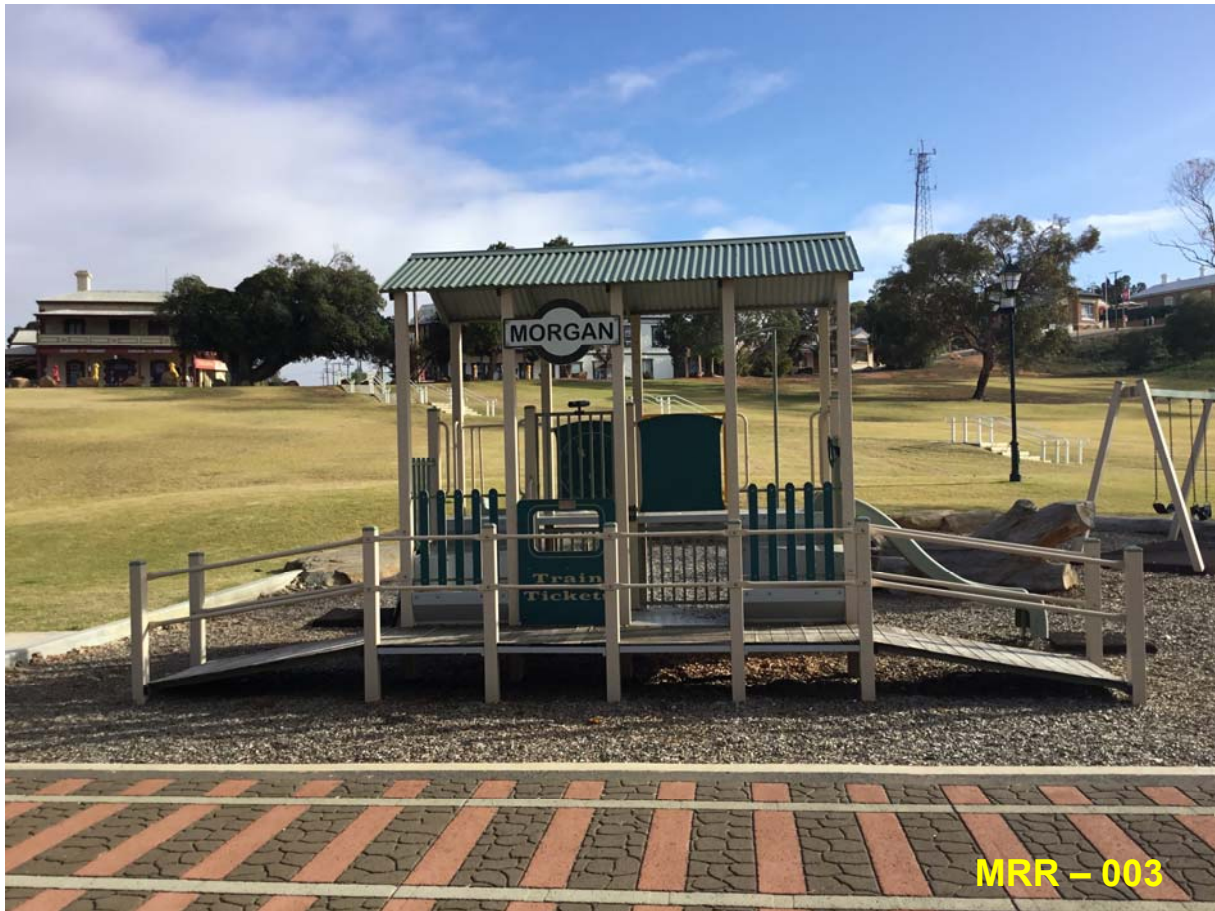
SN: MRR - 003

OPERATIONAL INSPECTION		
Play Equipment	Findings	Rating
Excessive wear of moving parts (including chain links).	There are very few moving parts in this area, no chain links or swivel points.	LOW
Any protrusions and sharp edges.	No sharp edges or protrusions were found.	LOW
Are there any entrapments, hang points or catch points on any of the equipment?	No hang points or entrapment was found.	LOW
The structural adequacy and/or stability of all playground equipment including ancillary items. NOTE: Equipment that relies on a single anchor or attachment point should be carefully inspected.	All uprights were sound and had no movements.	LOW
Excessive corrosion, particularly within structural members.	The upright supports do have flaking rust creeping up support posts which will require attention over the next few years, there is also rust starting to bare on the corner platforms.	MEDIUM
Impact and attenuating edges of swing seats, pommels and other moving equipment that can impact users.	All edges were as designed with no areas of concern.	LOW

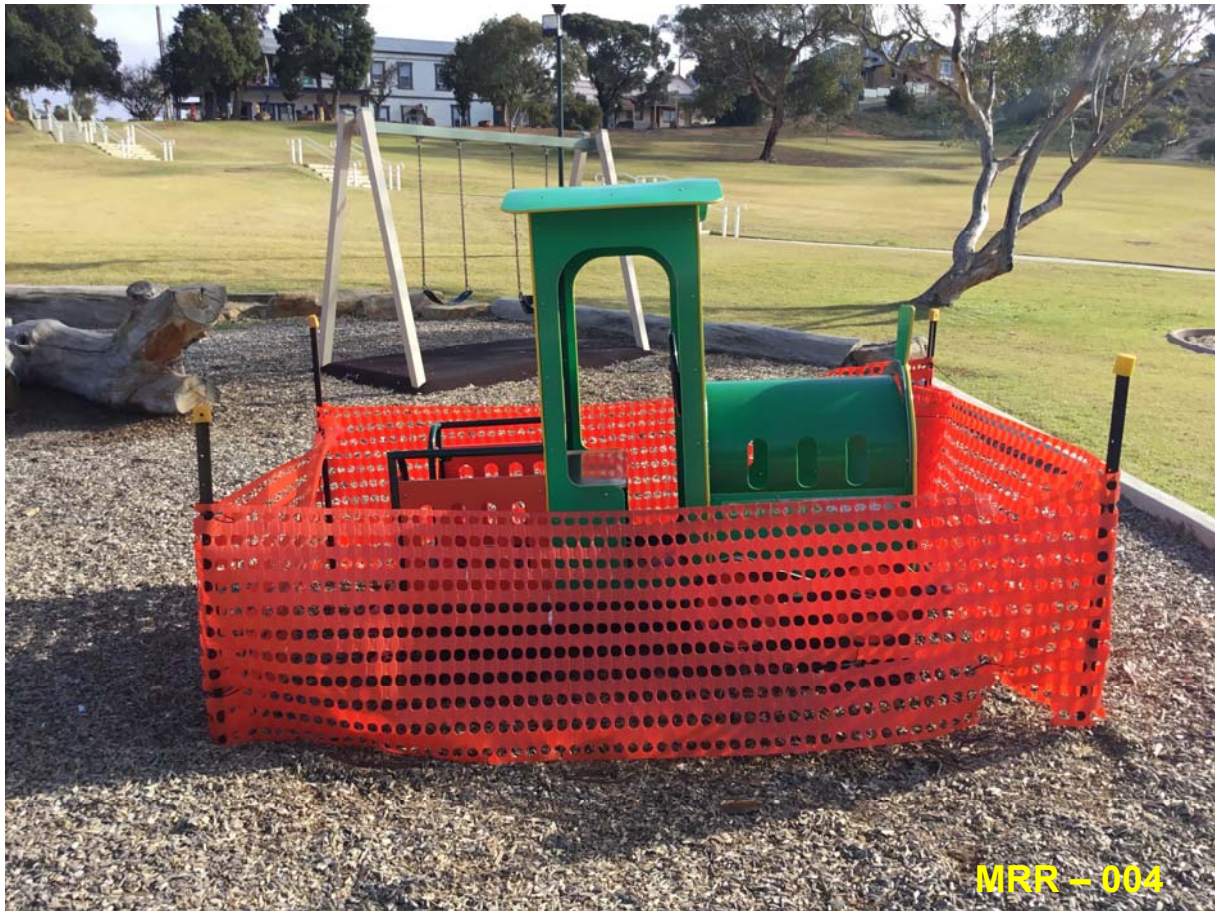
SN: MRR - 004

OPERATIONAL INSPECTION		
Play Equipment	Findings	Rating
Excessive wear of moving parts (including chain links).	No moving parts only compression parts that can and do fail, the spring and components have been removed for repair.
