OPEN SPACE SERVICES

JULY 25, 2020

Playground Audit CADELL TENNIS COURT PLAYGROUND

MID MURRAY COUNCIL

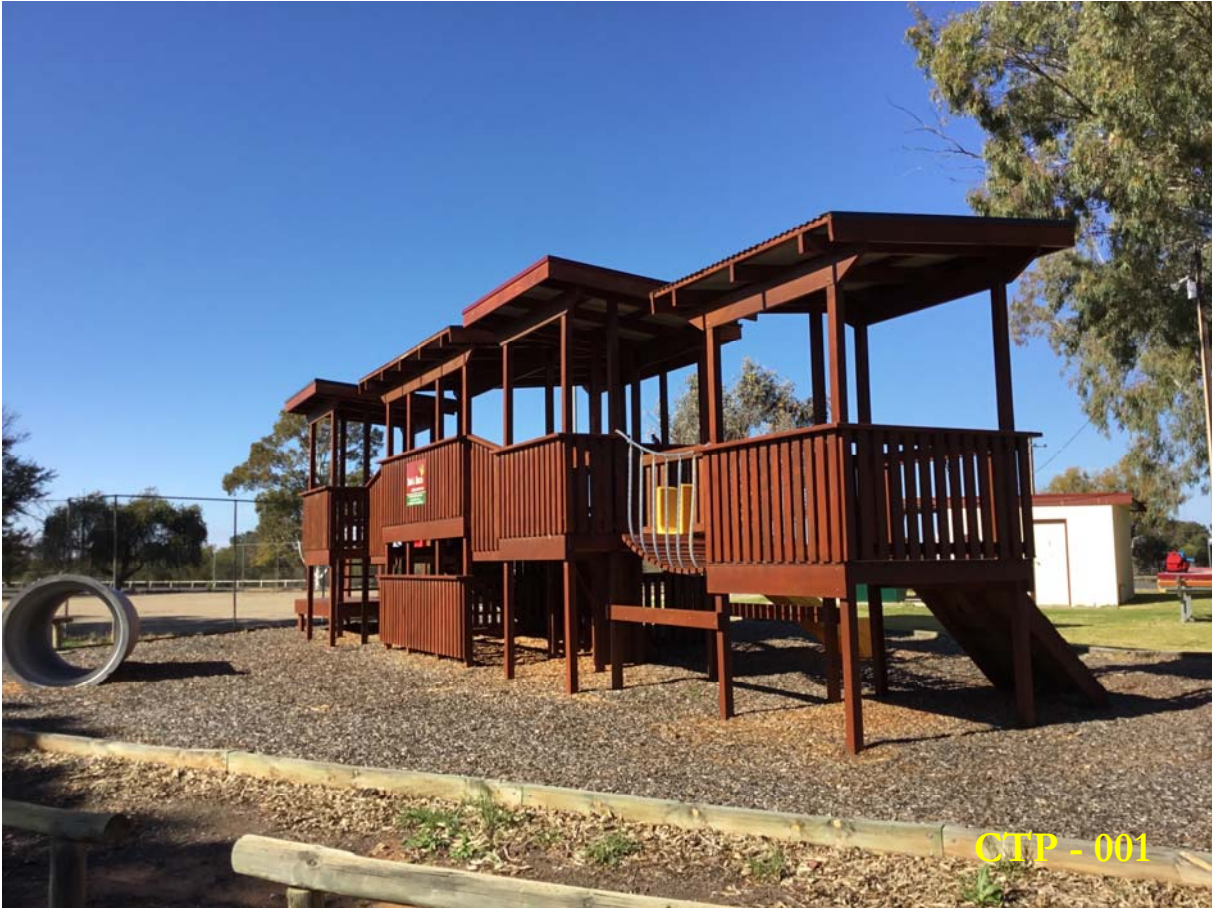
SN: CTP - 001

Multi-Platform Structure

OPERATIONAL INSPECTION		
Play Equipment	Findings	Rating
Excessive wear of moving parts (including chain links).	There is very little wear as the structure is not that old.

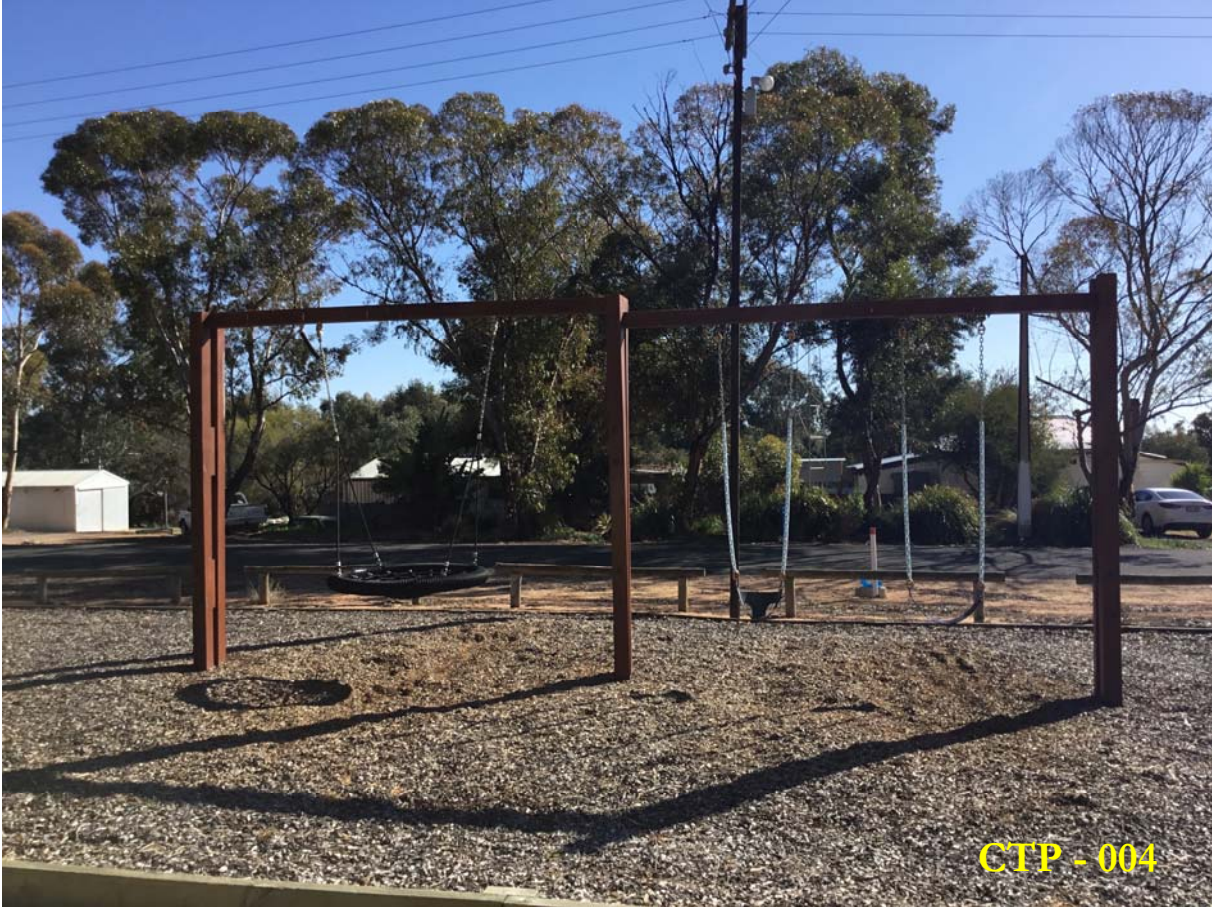
SN: CTP - 004

Swings

OPERATIONAL INSPECTION		
Play Equipment	Findings	Rating
Excessive wear of moving parts (including chain links).	Being only quite new, there is very little wear on the chains or swing attachments.	LOW
Any protrusions and sharp edges.	No sharp edges or protrusions were found.	LOW
Are there any entrapments, hang points or catch points on any of the equipment?	No hang points or entrapment was found.	LOW
The structural adequacy and/or stability of all playground equipment including ancillary items. NOTE: Equipment that relies on a single anchor or attachment point should be carefully inspected.	All uprights were sound and had no movements.	LOW
Excessive corrosion, particularly within structural members.	There are areas of excessive rust on the attachment links and on the monkey bar fixture points. The springer also will need removal or replacement due to heavy rusting	MEDIUM
Impact and attenuating edges of swing seats, pommels and other moving equipment that can impact users.	All edges were as designed with no areas of concern.	LOW

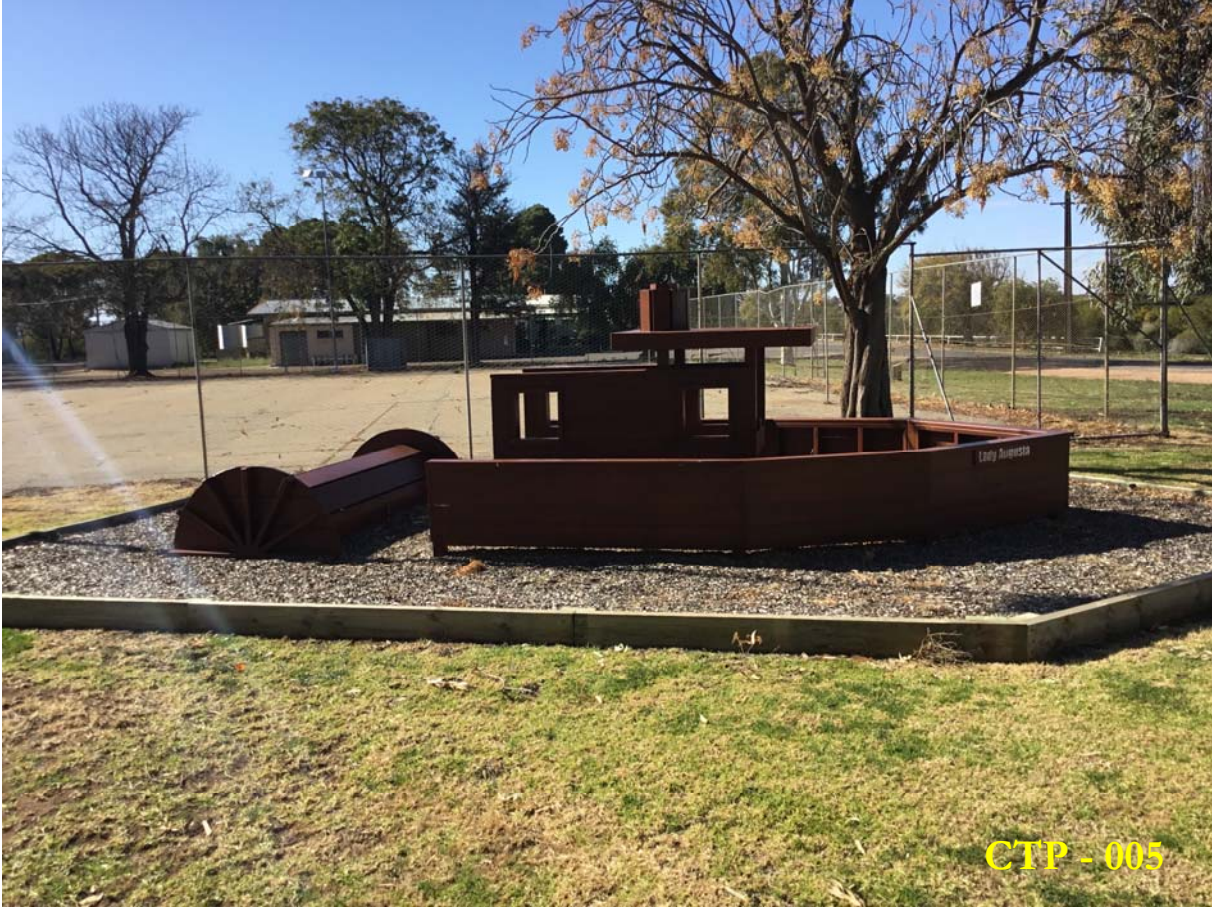
SN: CTP - 005

Wooden Paddleboat

OPERATIONAL INSPECTION		
Play Equipment	Findings	Rating
Excessive wear of moving parts (including chain links).	No moving parts	LOW
Any protrusions and sharp edges.	The structures have all been built without any obvious protruding or sharp edges that would create a risk.	LOW
Are there any entrapments, hang points or catch points on any of the equipment?	There were no entrapment areas that were identified.	LOW
The structural adequacy and/or stability of all playground equipment including ancillary items. NOTE: Equipment that relies on a single anchor or attachment point should be carefully inspected.	The item is only low and used as a role play item it is not intended as a climbing play item.	LOW
Excessive corrosion, particularly within structural members.	None found	LOW
Impact and attenuating edges of swing seats, pommels and other moving equipment that can impact users.	No moving equipment in this area.	LOW
