AUGUST 1, 2020

Playground Audit

GREENWAYS SPORTING GROUND

MID MURRAY COUNCIL

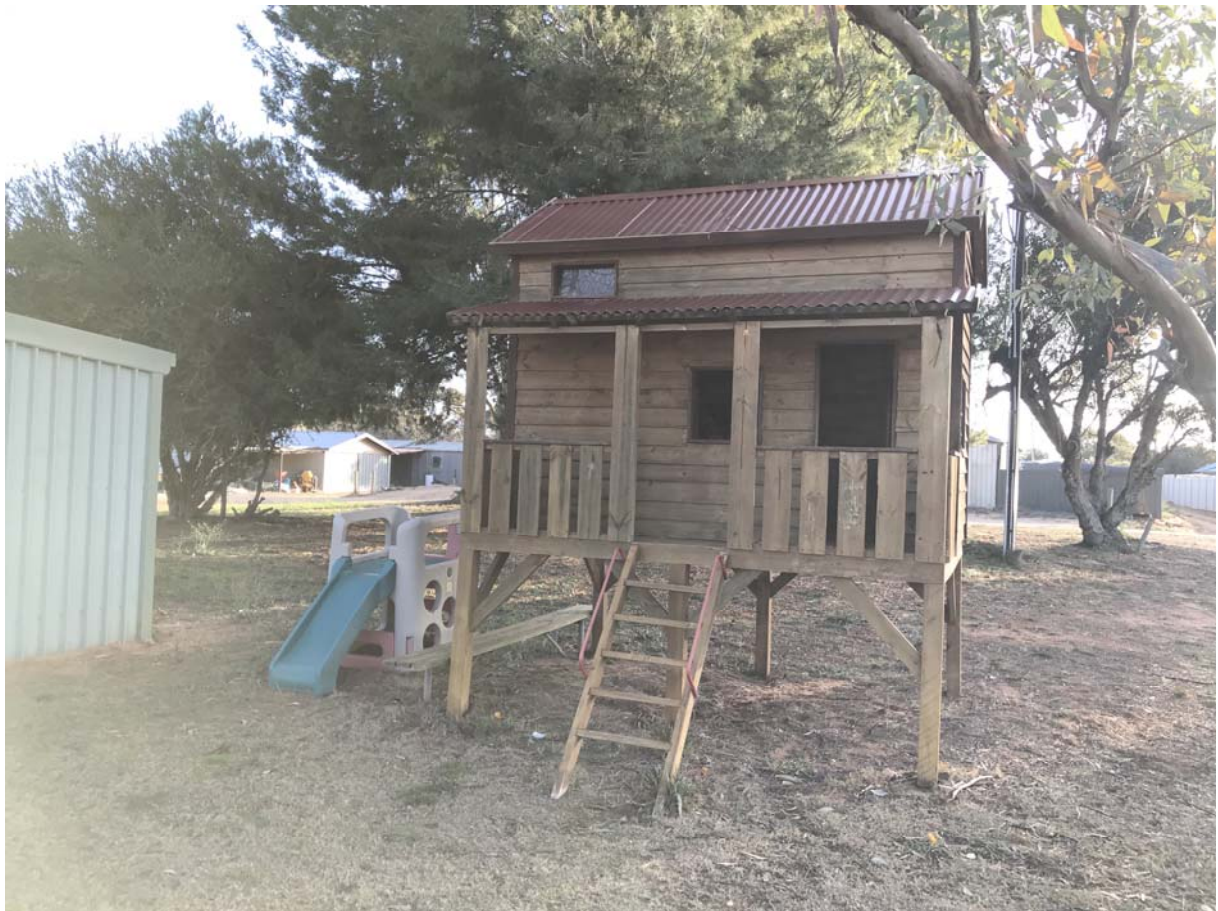
SN: GSG – 003

OPERATIONAL INSPECTION		
Play Equipment	Findings	Rating
Excessive wear of moving parts (including chain links).	The stairs are broken at the attachment point.	MEDIUM
Any protrusions and sharp edges.	There were no significant	MEDIUM
Are all bolts and fasteners secure?	The stair attachment on one side needs to be replaced due to breakages and the screw not being secure.	LOW
Are there any entrapments, hang points or catch points on any of the equipment?	The top three treads of the ladder are hanging points where the body can go through but not the head and is above 600mm	HIGH
The structural adequacy and/or stability of all playground equipment including ancillary items. NOTE: Equipment that relies on a single anchor or attachment point should be carefully inspected.	The structural stability is acceptable on all the item, the bench seating is movable.	LOW
Does it extend at least 1.5m from all equipment that is less than 1.5m in height, or 2.5m from equipment that is up to 3m in height?	There is no softfall under any of the play structures.	HIGH
