JULY 26, 2020

CAMBRAI OS & P PARK

MID MURRAY COUNCIL

Playground Audit

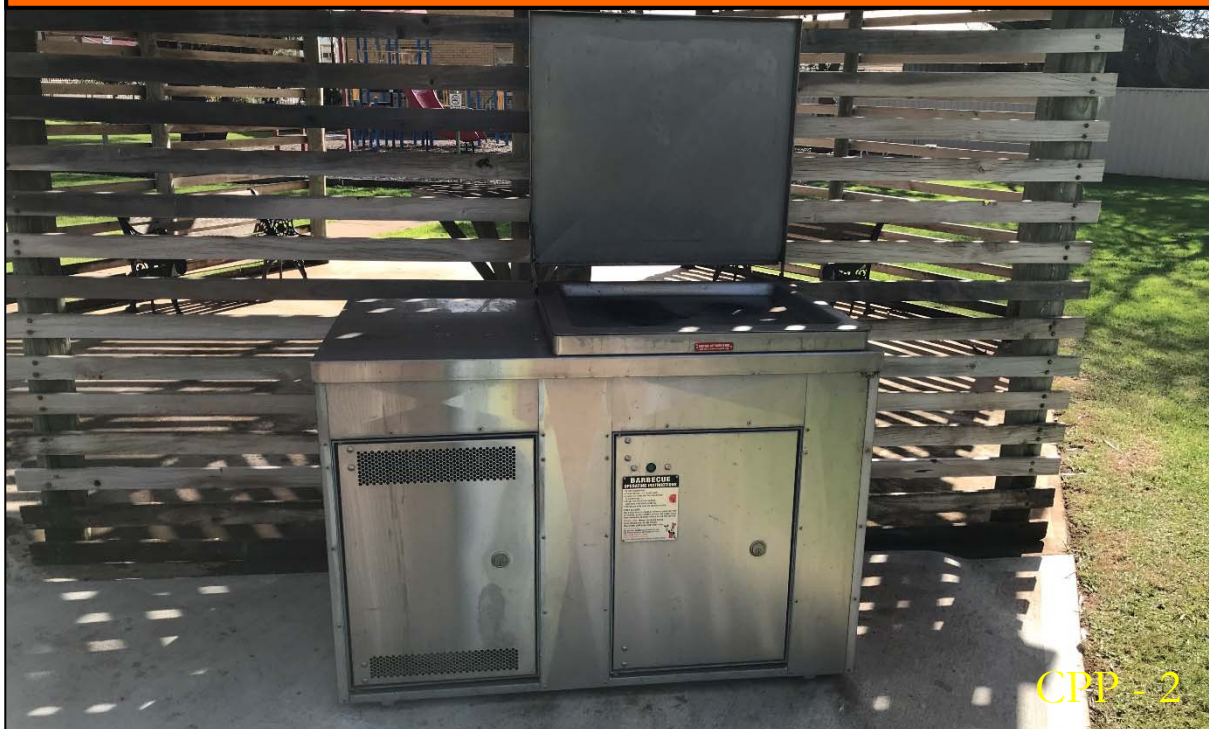
The barbecue looks quite new and does not have any damage within the hour to cover, the holder for the lid has been damaged where it looks like it's been pulled down without being released properly and the pop rivet has almost been pulled out. This is only a minor problem and has most likely been picked up in audits before me anyway. The Barbecue is functional and starts and heat up straight away.
