OPEN SPACE SERVICES

AUGUST 26, 2020

Playground Audit LEN WHITE RESERVE SWAN REACH

MID MURRAY COUNCIL

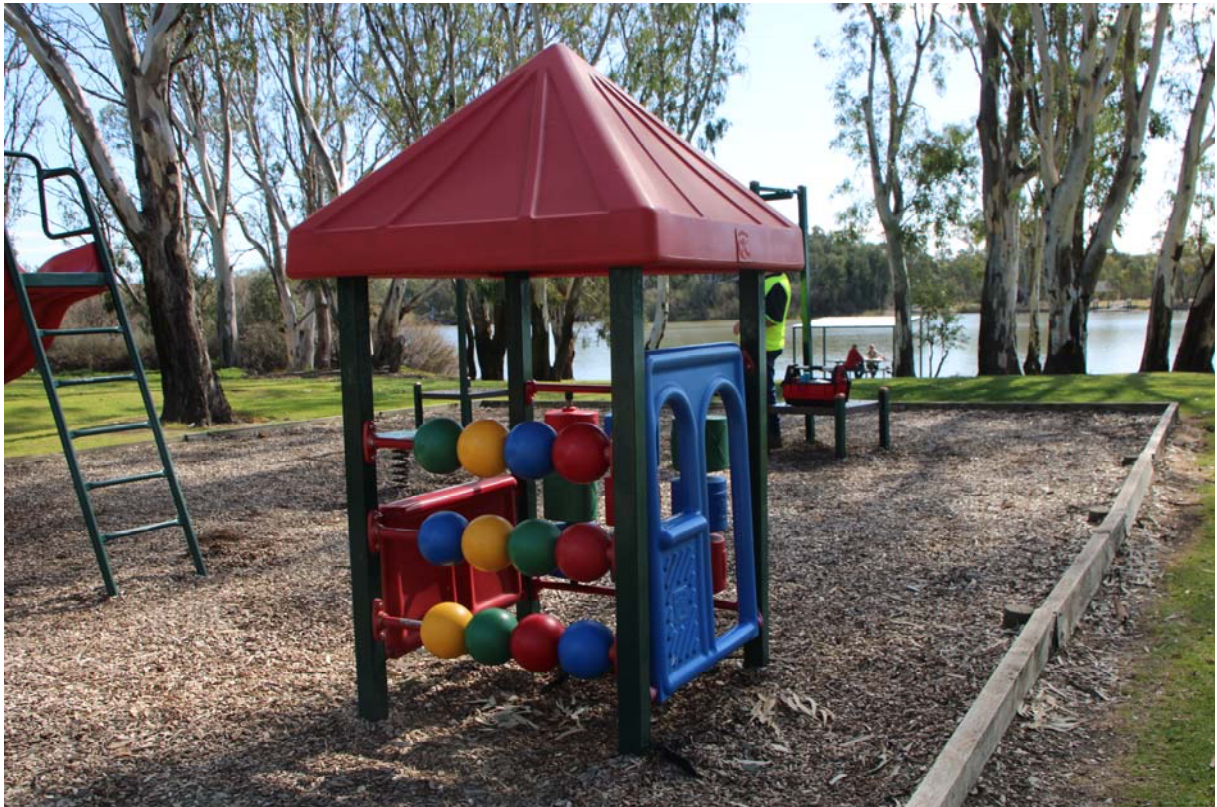
SN: LWR - 006

OPERATIONAL INSPECTION		
Play Equipment	Findings	Rating
Excessive wear of moving parts (including chain links).	There is no excess wear on the chains or S hooks	MEDIUM
Any protrusions and sharp edges.	No sharp edges or protrusions were found.	LOW
Are all bolts and fasteners secure?	All bolts nuts and fasteners were secure on the equipment	LOW
Are there any entrapments, hang points or catch points on any of the equipment?	No hang points or entrapment was found.	LOW
The structural adequacy and/or stability of all playground equipment including ancillary items. NOTE: Equipment that relies on a single anchor or attachment point should be carefully inspected.	The structural stability is acceptable on the item.	LOW
Excessive corrosion, particularly within structural members.	The structural uprights on the swing and also the springer has flake rust and corrosion present.	MEDIUM
Is there adequate softfall within all areas of impact with a minimum height of 600mm that is easily accessible to all uses of the items.	Softfall depth is adequate around the swings, kickout was happening but there was 300mm under the area of kickout. The springer wake board had no softfall but is under 600mm.	LOW
