JULY 29, 2020

Playground Audit

MANNUM OVAL COMPLEX PLAYGROUND

MID MURRAY COUNCIL

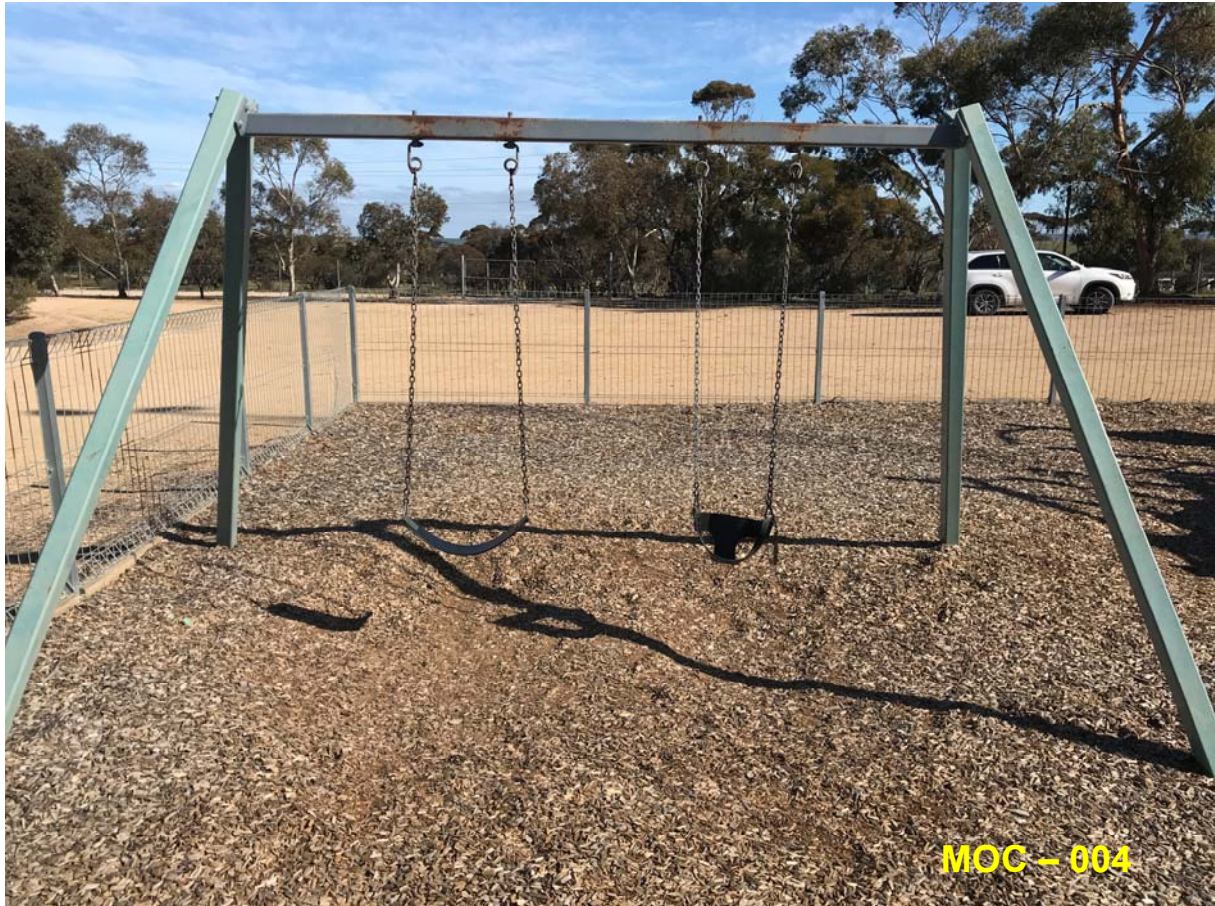
SN: MOC – 004 (Swing Set)

OPERATIONAL INSPECTION		
Play Equipment	Findings	Rating
Excessive wear of moving parts (including chain links).	The "S" hooks are at 45% and will require replacing on both swings.	MEDIUM
Any protrusions and sharp edges.	No sharp edges or protrusions were found.	LOW
Are there any entrapments, hang points or catch points on any of the equipment?	No hang points or entrapment was found.	LOW
The structural adequacy and/or stability of all playground equipment including ancillary items. NOTE: Equipment that relies on a single anchor or attachment point should be carefully inspected.	All uprights were sound and had no movements.	LOW
Excessive corrosion, particularly within structural members.	All uprights have flaking rust from the ground up, the rust has caused voids in the steel.	MEDIUM
Impact and attenuating edges of swing seats, pommels and other moving equipment that can impact users.	All edges were as designed with no areas of concern.	LOW
