OPEN SPACE SERVICES

AUGUST 3, 2020

Playground Audit MANNUM CARAVAN PARK

MID MURRAY COUNCIL

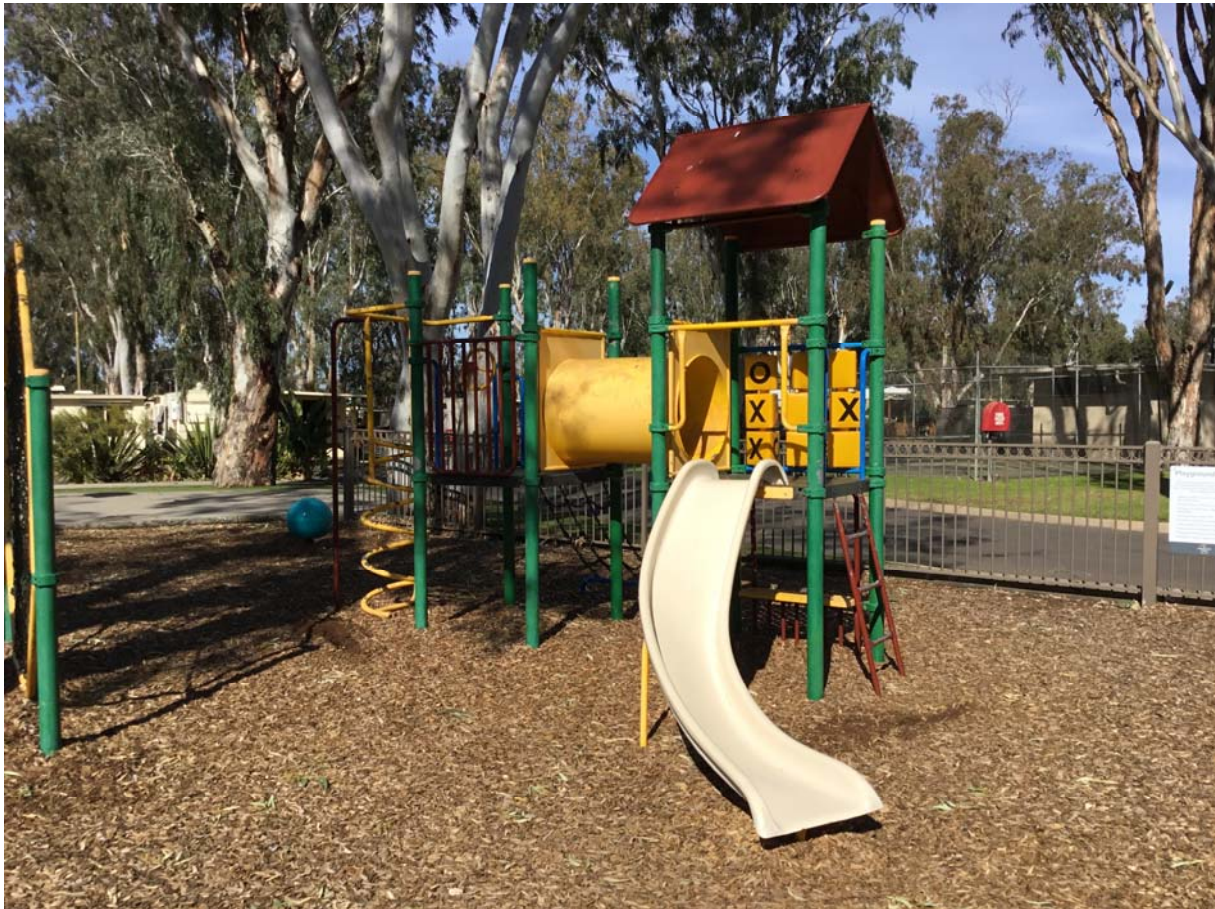
SN: MCP – 005

OPERATIONAL INSPECTION		
Play Equipment	Findings	Rating
Excessive wear of moving parts (including chain links).	No excessive wear was found, the equipment has normal wear from use.	LOW
Any protrusions and sharp edges.	No sharp edges or protrusions were found.	LOW
Are there any entrapments, hang points or catch points on any of the equipment?	No hang points or entrapment was found.	LOW
The structural adequacy and/or stability of all playground equipment including ancillary items. NOTE: Equipment that relies on a single anchor or attachment point should be carefully inspected.	All uprights were sound and had no movements.	LOW
Excessive corrosion, particularly within structural members.	No excessive corrosion or rust was found.	LOW
Impact and attenuating edges of swing seats, pommels and other moving equipment that can impact users.	All edges were as designed with no areas of concern.	LOW
Trees for potential hazards. NOTE: This may require the skills and competencies of a professional arborist.	The River Red gum will require pruning away from the chain web.	MEDIUM

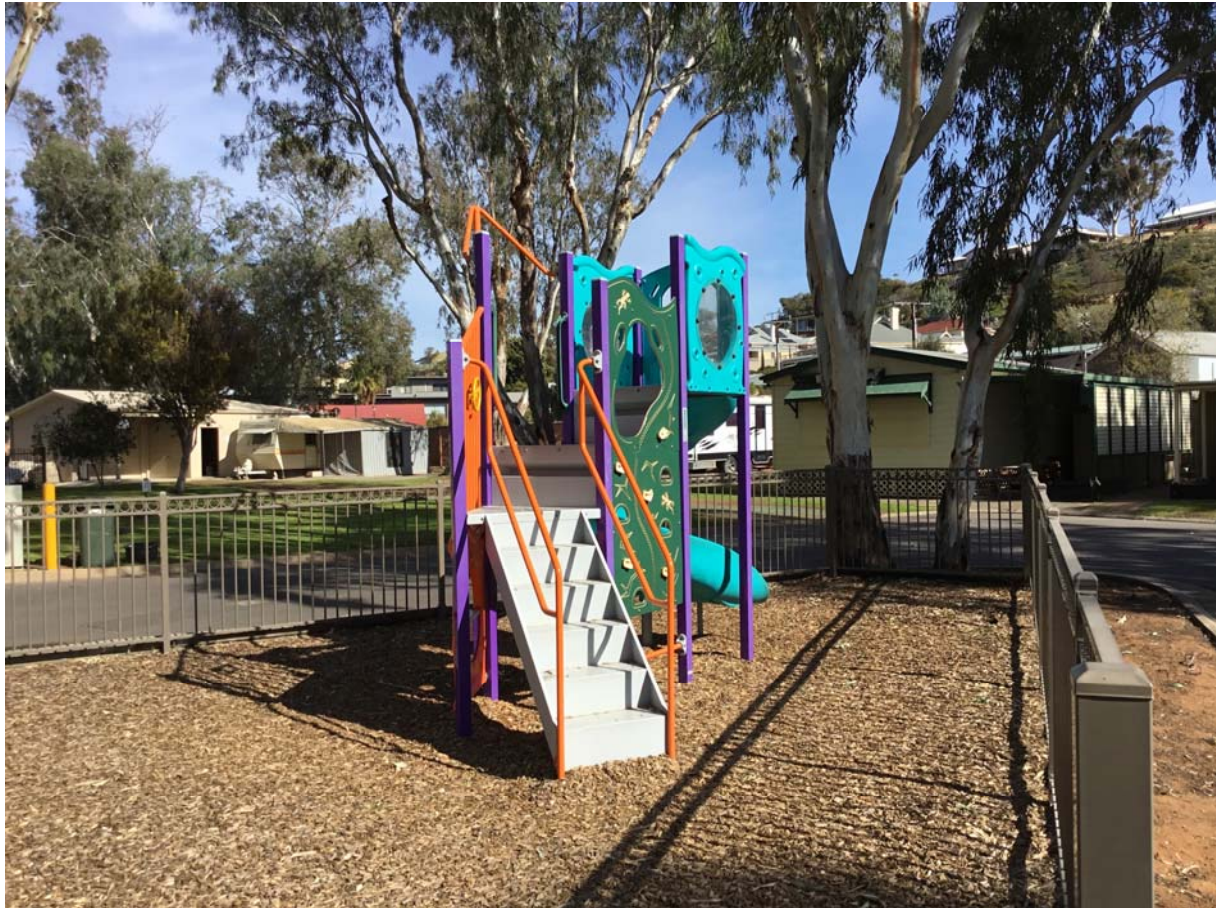
SN: MCP – 006

OPERATIONAL INSPECTION		
Play Equipment	Findings	Rating
Excessive wear of moving parts (including chain links).	There are no moving parts	LOW
Any protrusions and sharp edges.	No sharp edges or protrusions were found.	LOW
Are there any entrapments, hang points or catch points on any of the equipment?	No hang points or entrapment was found.	LOW
The structural adequacy and/or stability of all playground equipment including ancillary items. NOTE: Equipment that relies on a single anchor or attachment point should be carefully inspected.	All uprights were sound and had no movements.	LOW
Excessive corrosion, particularly within structural members.	No excessive rusting or corrosion was present	LOW
Impact and attenuating edges of swing seats, pommels and other moving equipment that can impact users.	All edges were as designed with no areas of concern.	LOW
Foundations for exposed concrete, rot and corrosion.	All foundations were in good condition	LOW

The amount of softfall is inadequate and needs to be a minimum of 200mm with a 100mm overfill for gradual decay of lower chips.

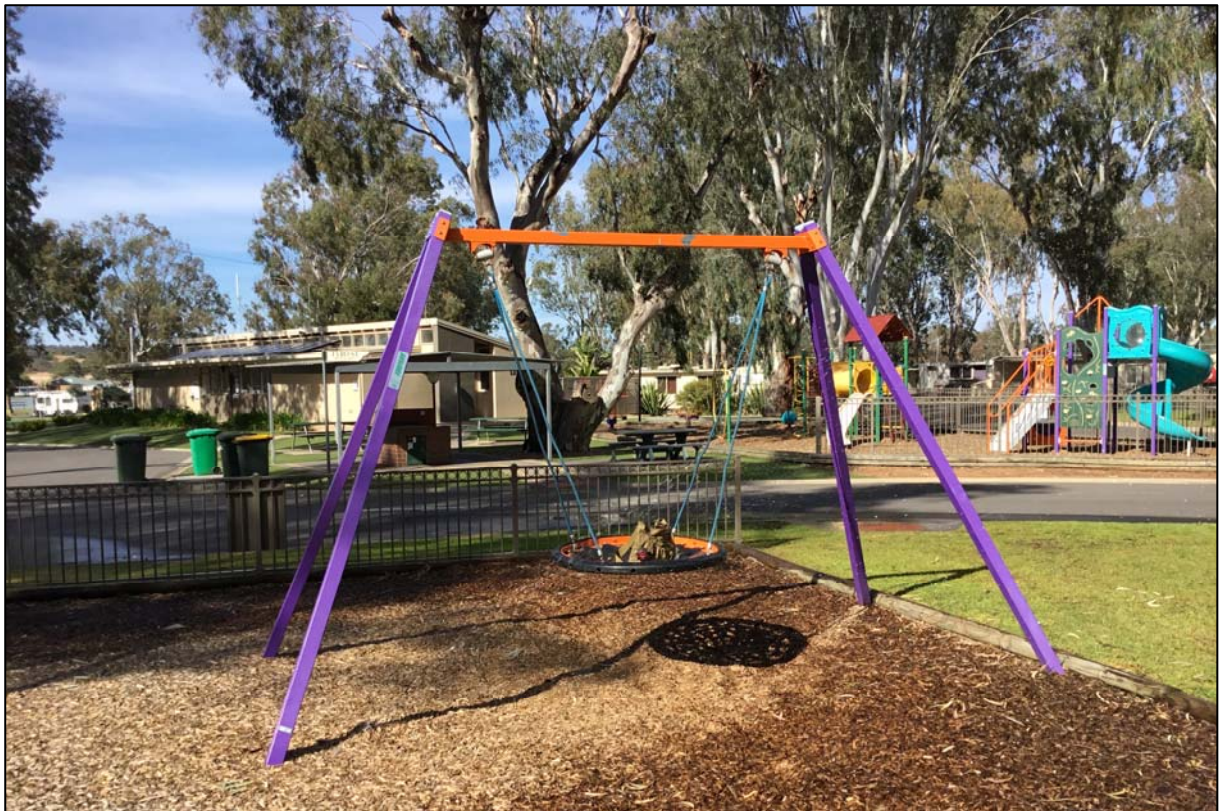
SN: MCP – 008

OPERATIONAL INSPECTION		
Play Equipment	Findings	Rating
Excessive wear of moving parts (including chain links).	There is only minor wear on the S hooks, the swings have only been installed 5 years ago.	LOW
Any protrusions and sharp edges.	No sharp edges or protrusions were found.	LOW
Are there any entrapments, hang points or catch points on any of the equipment?	No hang points or entrapment was found.	LOW
The structural adequacy and/or stability of all playground equipment including ancillary items. NOTE: Equipment that relies on a single anchor or attachment point should be carefully inspected.	All uprights were sound and had no movements.	LOW
Excessive corrosion, particularly within structural members.	No excessive rusting or corrosion was present	LOW
Impact and attenuating edges of swing seats, pommels and other moving equipment that can impact users.	All edges were as designed with no areas of concern.	LOW
